COASTAL INSPECTION SERVICES LLC

Inspection Report

Sample Report - 04

Date: 9/8/2021	Time: 8:30am	Report ID: Sample Report -04
Property: Sample Report Norfolk VA 23505	Customer: Sample Report - 04	Real Estate Professional: Paul Farrell

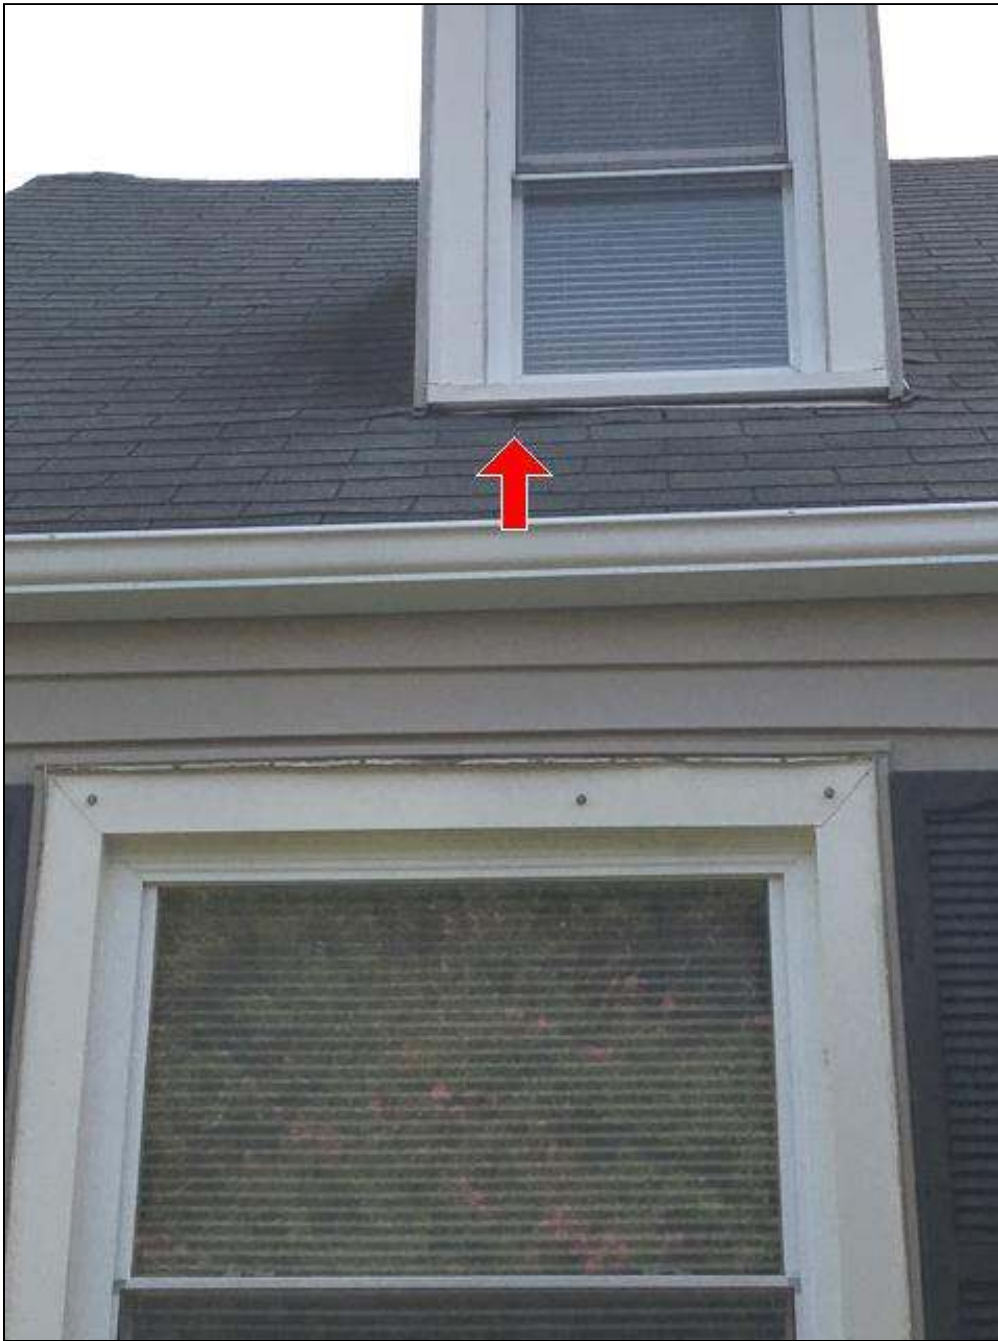
1.1 Item 1(Picture)

1.1 (1) Repair: Lifted flashings below the front dormers need repair by a licensed roofer.

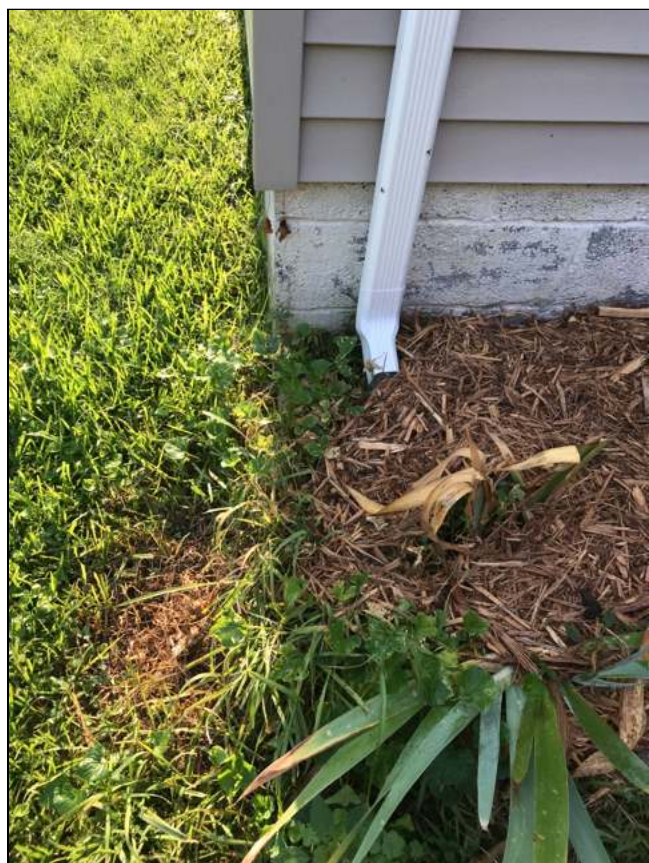
1.3 Item 2(Picture)

1.3 (2) Repair: Downspout extensions should be installed to direct water away from the house and keep moisture from collecting near and next to the house. Water from downspouts should be discharged at least 5 feet away from the house.

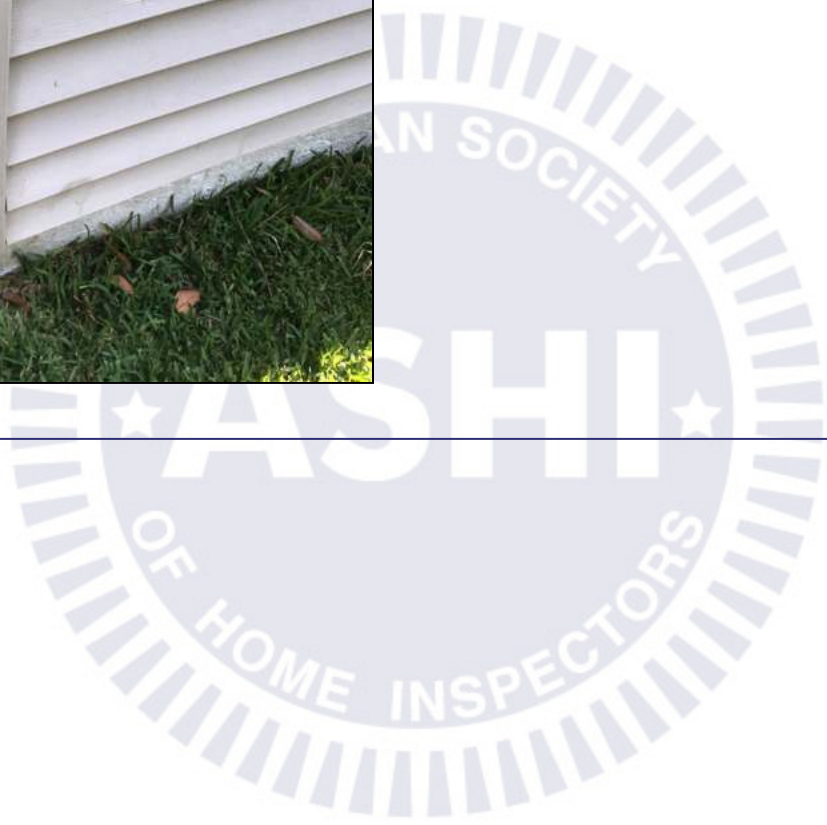
2.0 (3) Repair: Screening should be installed over the open crawlspace vents to prevent vermin entry. Some of the vents do not have screening and some are damaged which could easily allow animals to enter.

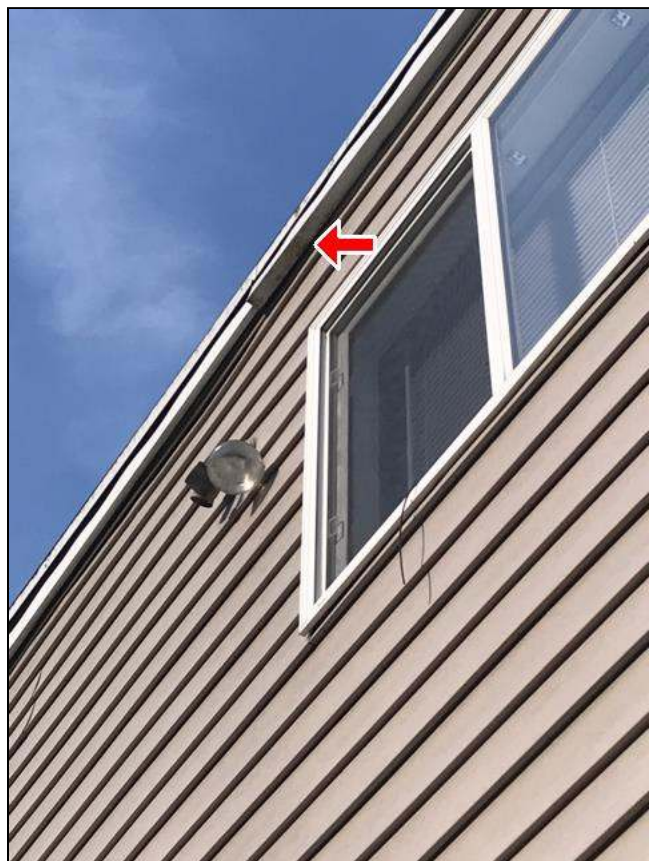
2.5 Item 1(Picture)

2.5 Repair: Loose flashing at the roof edge back left corner of the house needs repair by a qualified professional.

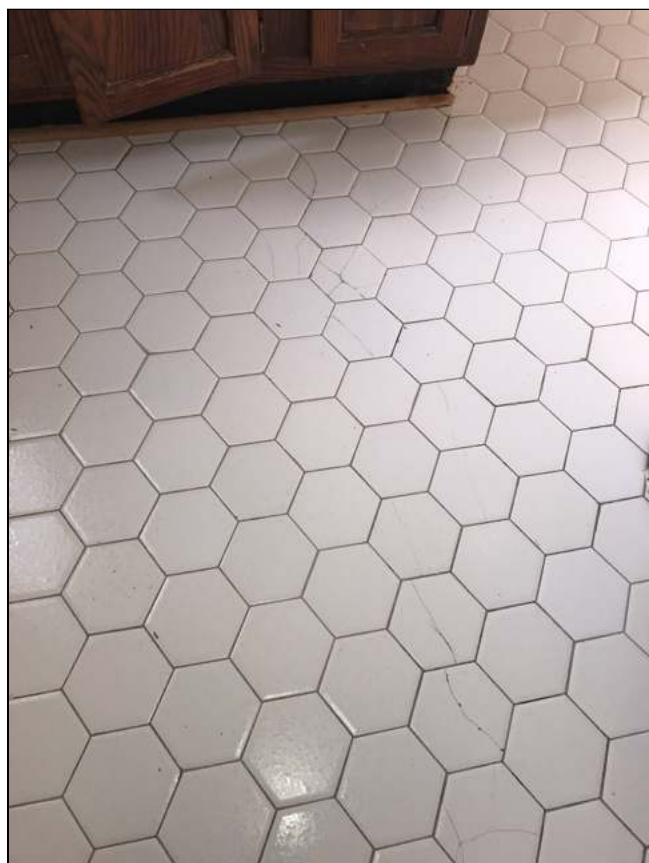
4.2 Item 1(Picture)

4.2 (1) Repair: Soft floor, cracked tile and water damaged cabinet observed in the second-floor bathroom are all indicators that something may have leaked. Tiles, grout, openings and moisture damaged materials should be assessed and repaired/ replaced by a licensed contractor.

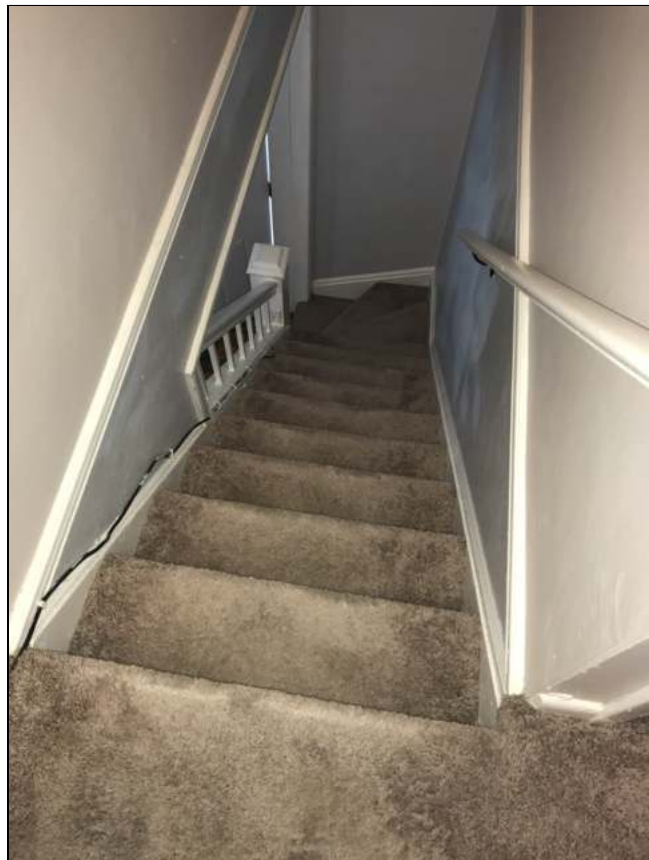
4.3 Item 1(Picture)

4.3 Repair: A proper railing should be installed at the stair system, lower railing is difficult to use and not standard. Even though this is an old house, railings should still be added for safety purposes.

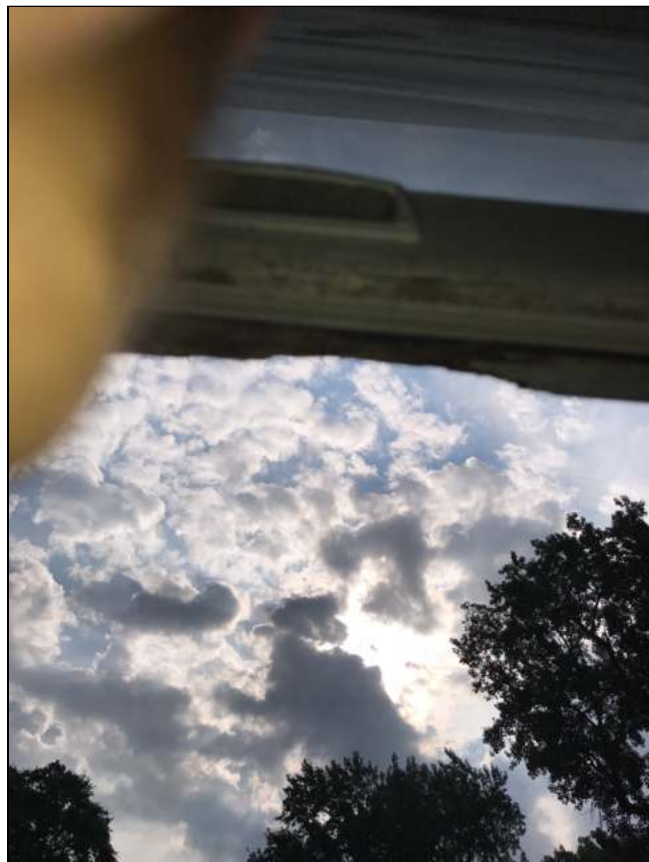
4.6 Item 1(Picture)

4.6 (1) Repair: Rear second-floor window adjacent to the bathroom is rotted/ moisture damaged and the window lifters are inoperative, this should be assessed and repaired/replaced by a licensed contractor. Please also note based on the amount of additional caulking this window appears to have had some previous issues.

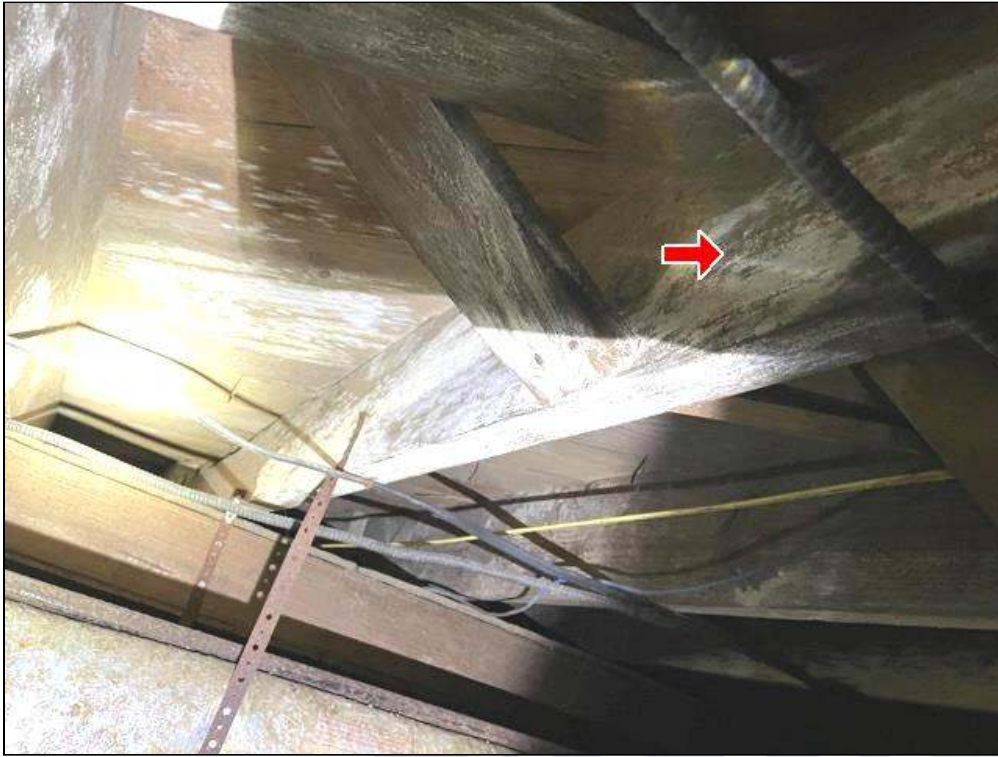
5.0 Item 1(Picture)

5.0 Repair: There are some signs of potential organic material seen on the floor joists, this material should be assessed by a qualified professional and treatment/ cleaning be completed of this material. The moisture issue also needs to be repaired as well to keep this material from occurring.

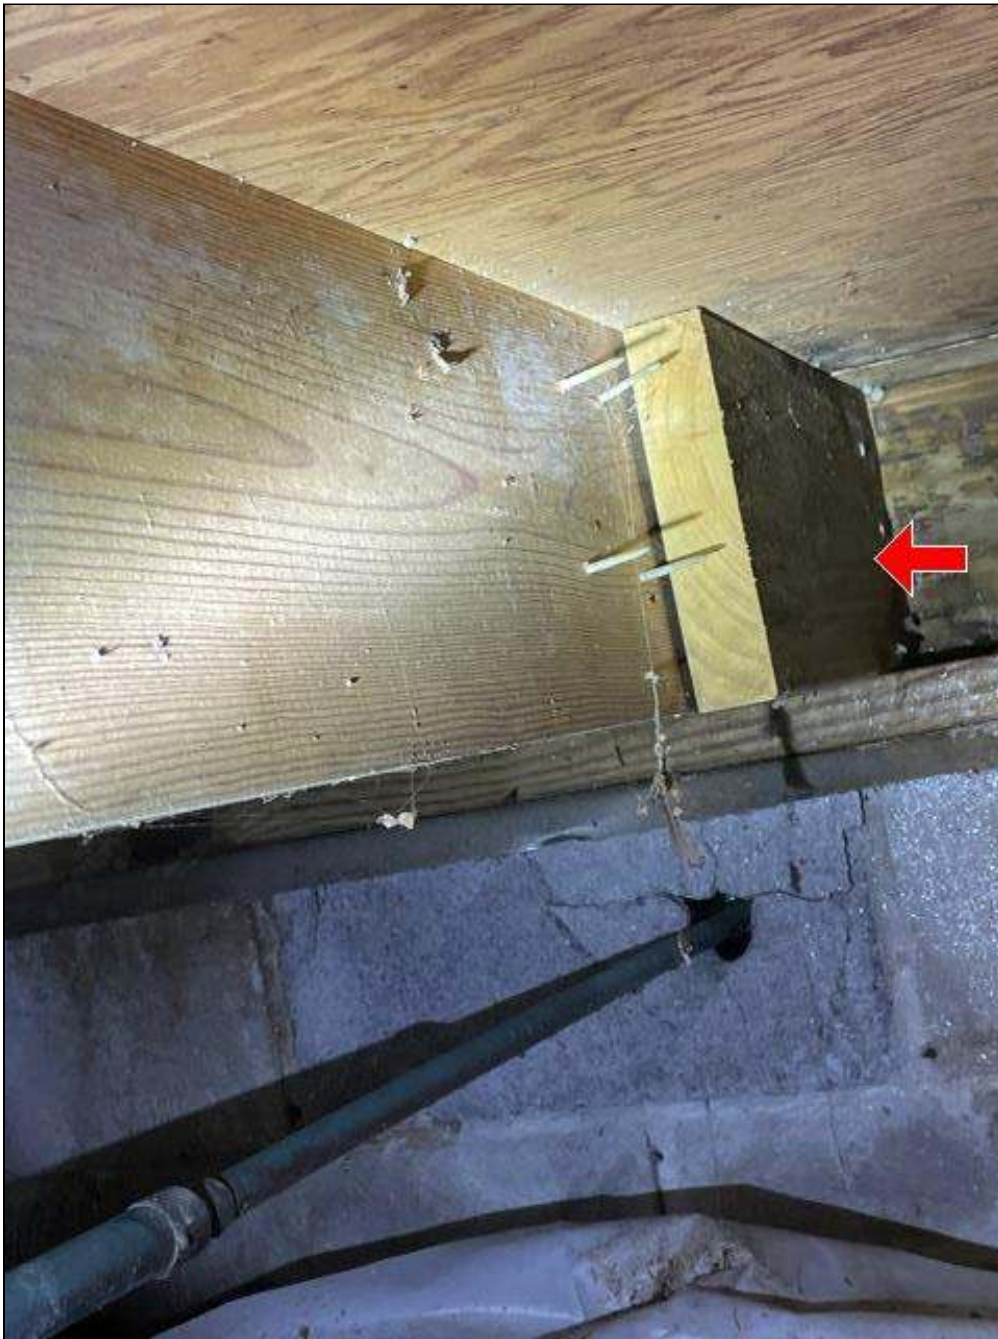
5.3 Item 1(Picture)

5.3 (1) Repair: Some prior repairs appears to have been made to the floor joists under the fireplace room at the back of the house. The areas have been sistered, but some of the wood is coming loose and the sistered areas do not appear to be long enough/ standard repairs. Recommend this be further assessed by a licensed contractor and repairs made as found necessary.

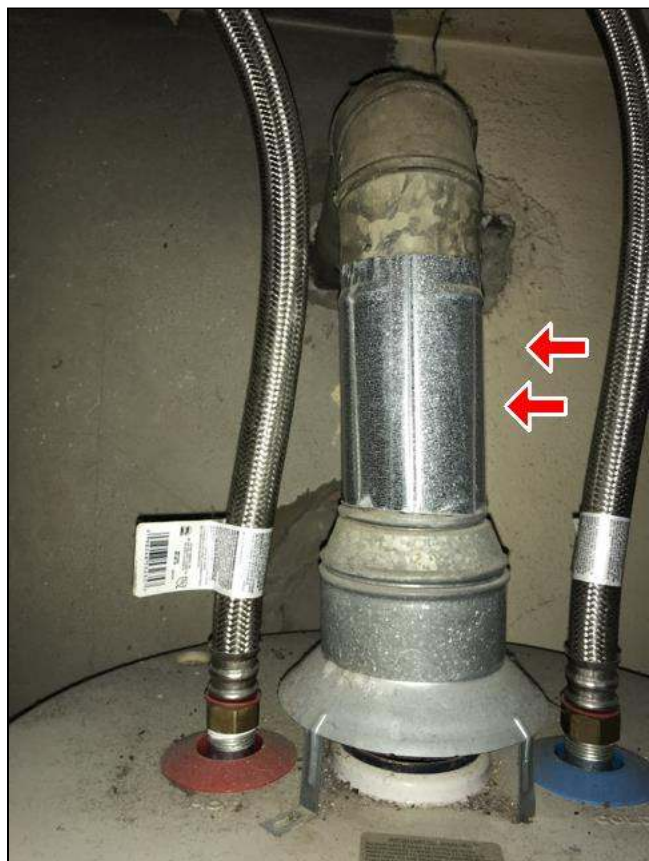
6.2 Item 2(Picture)

6.2 (2) Repair: The following repairs need to be assessed and handled by a licensed plumber for the water heater flue: there is a section of flue material that does not appear to be rated for this application and is not mechanically attached to the adjacent areas, gaps and openings around the flue penetration into the chimney need to be properly sealed as there appears to be spillage occurring.

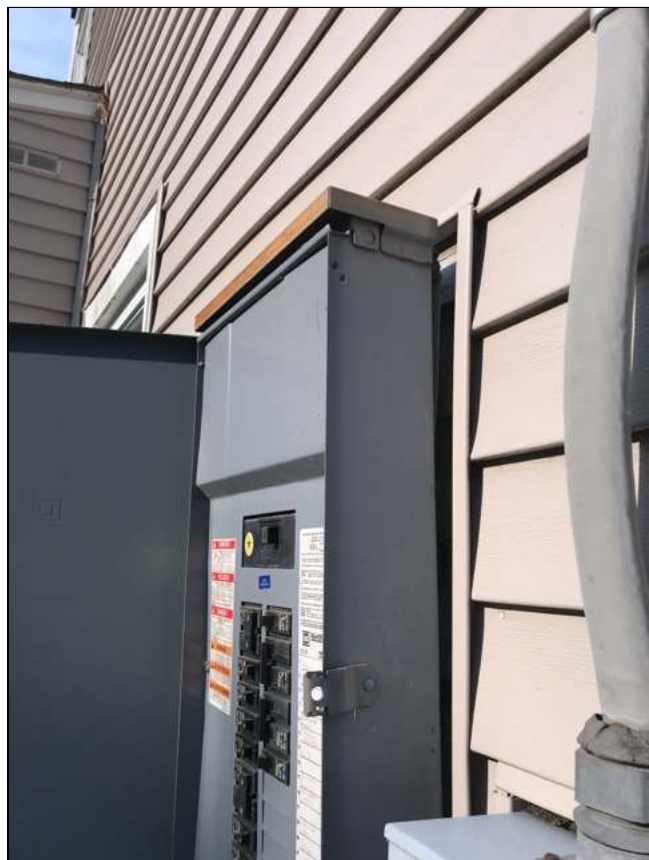
7.1 Item 1(Picture)

7.1 (1) Repair/ Concern: The main electrical panel is falling off the exterior wall of the house, this is a safety concern that needs assessment and repair by a licensed electrician.

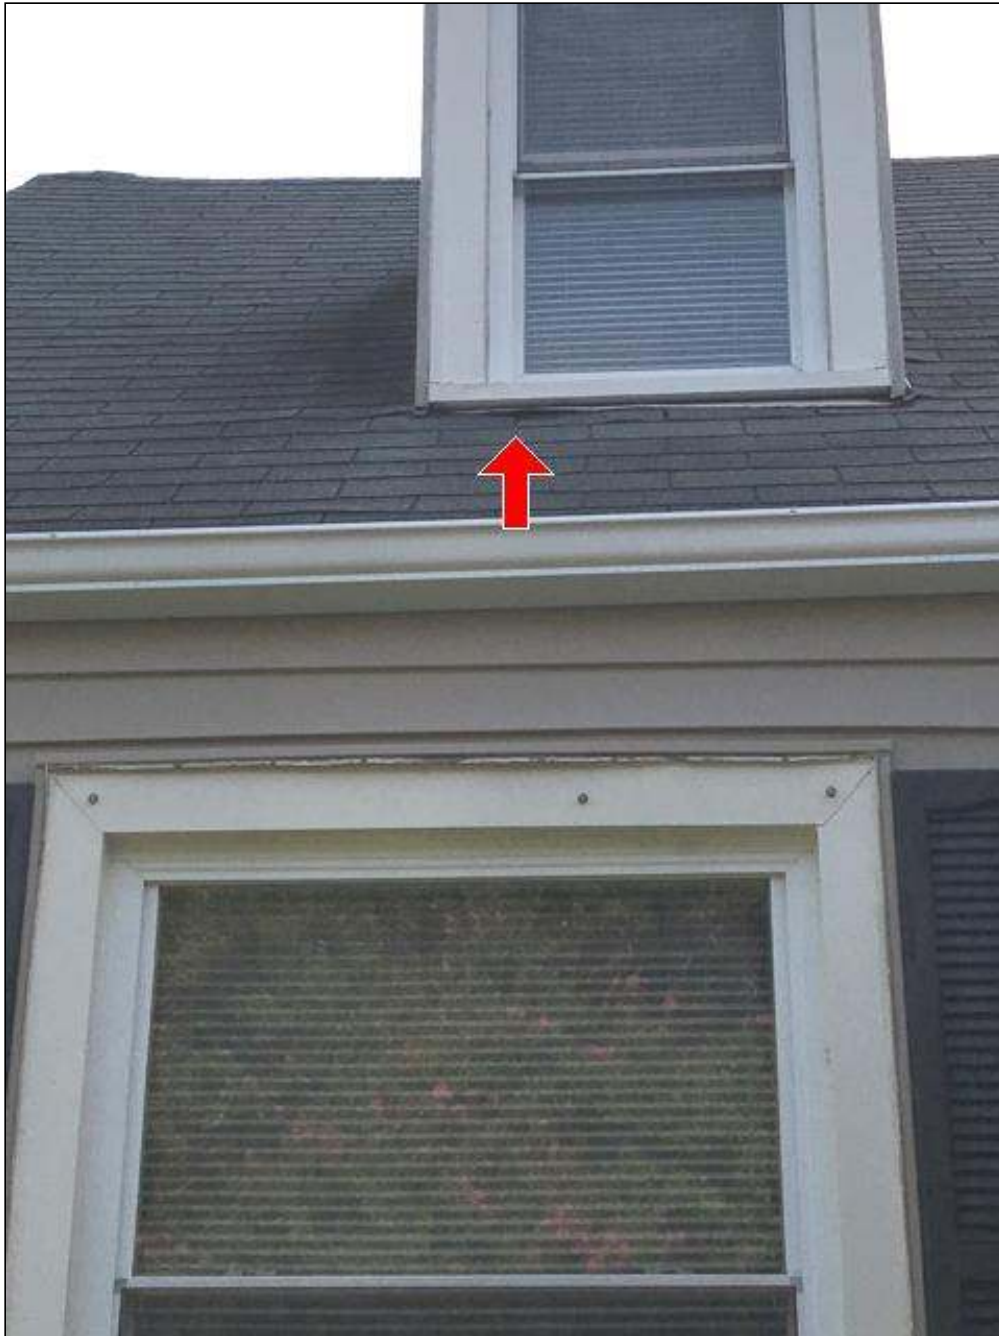
1.1 Item 1(Picture)

(1) Repair: Lifted flashings below the front dormers need repair by a licensed roofer.

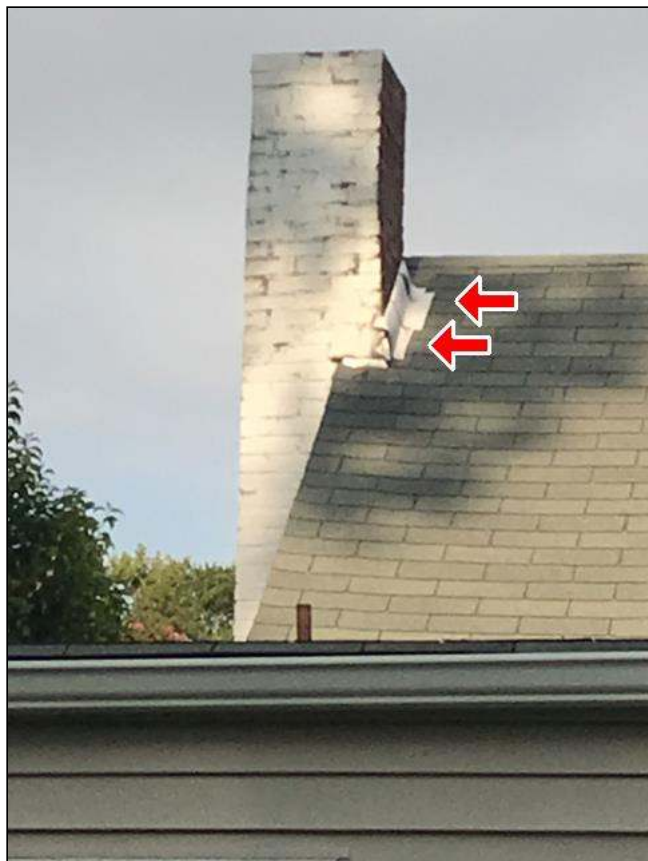
1.1 Item 3(Picture)

(3) Repair: Non-standard flashings observed the right side chimney, they should be assessed by a licensed roofer and repair/replacement made as found necessary.

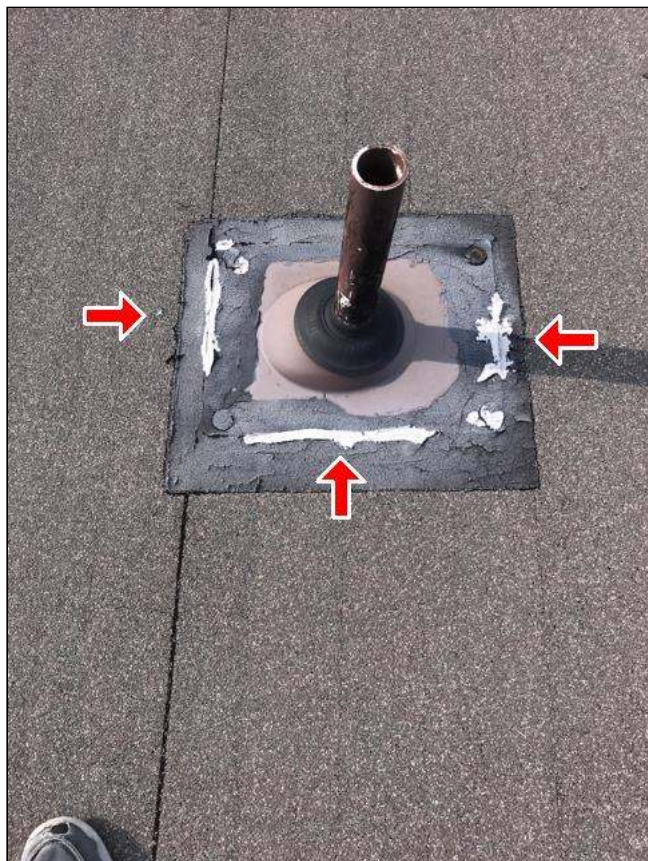
1.2 Item 4(Picture)

may have already been experiencing issues based on the additional caulking, which is failing, that has been installed. This should be assessed and repaired by a licensed roofer.

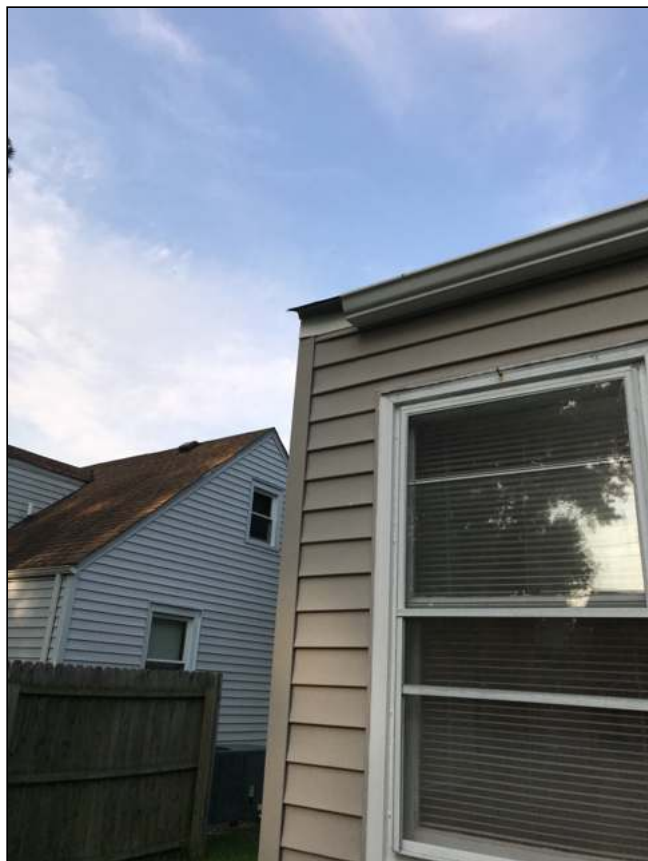
1.3 Item 1(Picture)

(1) Repair: Incomplete guttering at the back of the house needs repair/completion by a qualified professional.

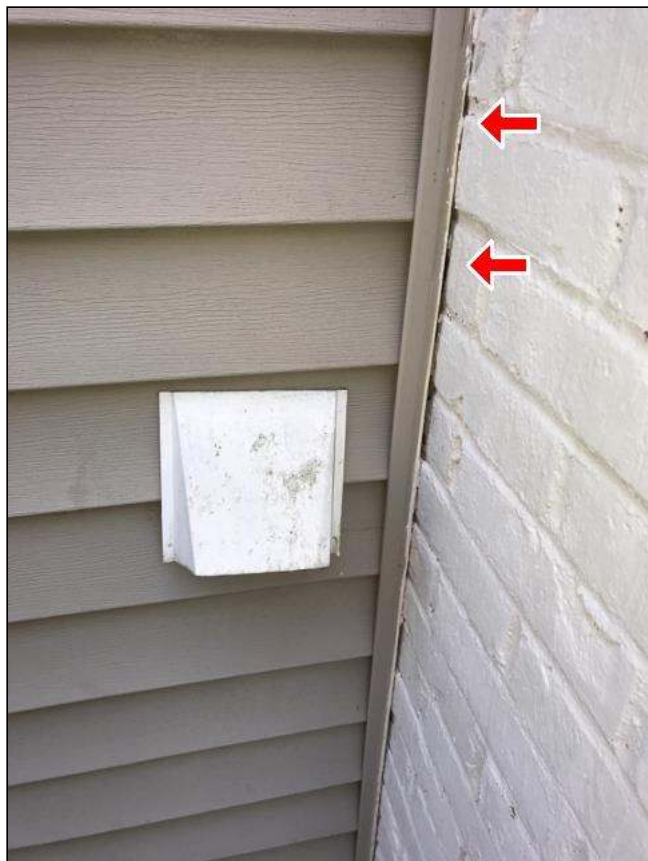
2.0 Item 1(Picture)

(1) Repair: Gaps/openings between the chimney chase and the vinyl siding on the right side of the house need to be caulked/sealed.

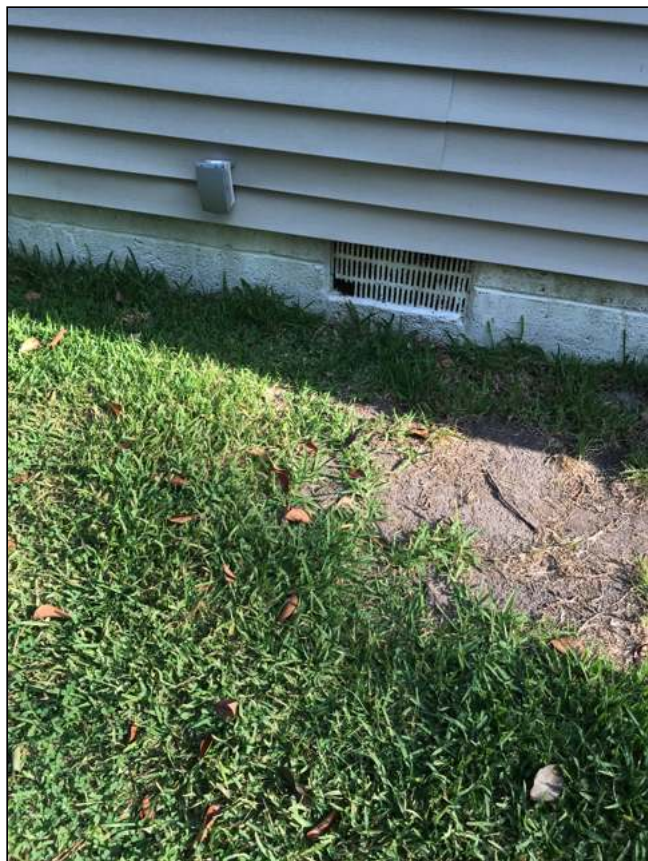
2.0 Item 4(Picture)

(3) Repair: Screening should be installed over the open crawlspace vents to prevent vermin entry. Some of the vents do not have screening and some are damaged which could easily allow animals to enter.

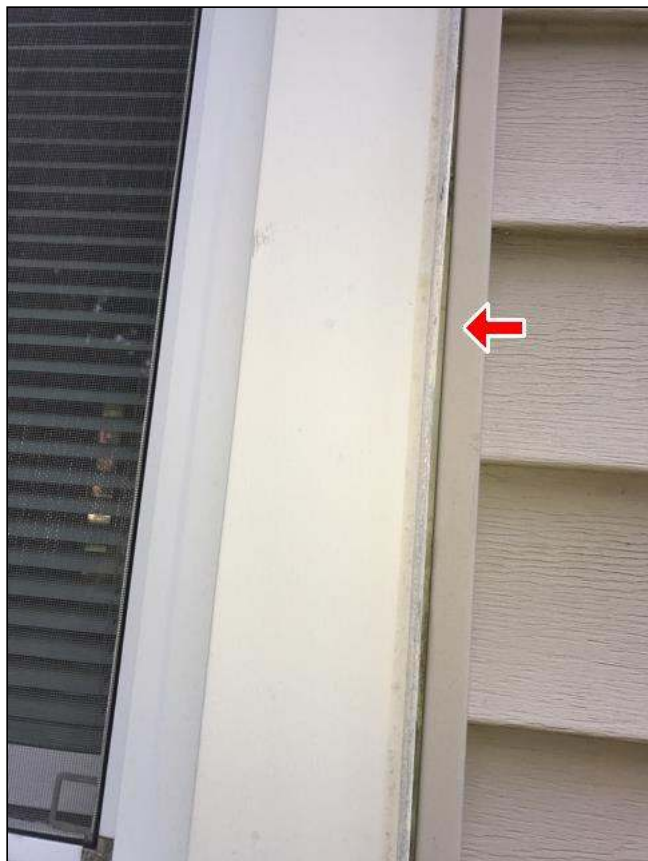
2.2 Item 1(Picture)

Repair: Gaps between the exterior windows and the vinyl siding need to be further assessed by a qualified professional and caulked/sealed to prevent water infiltration.

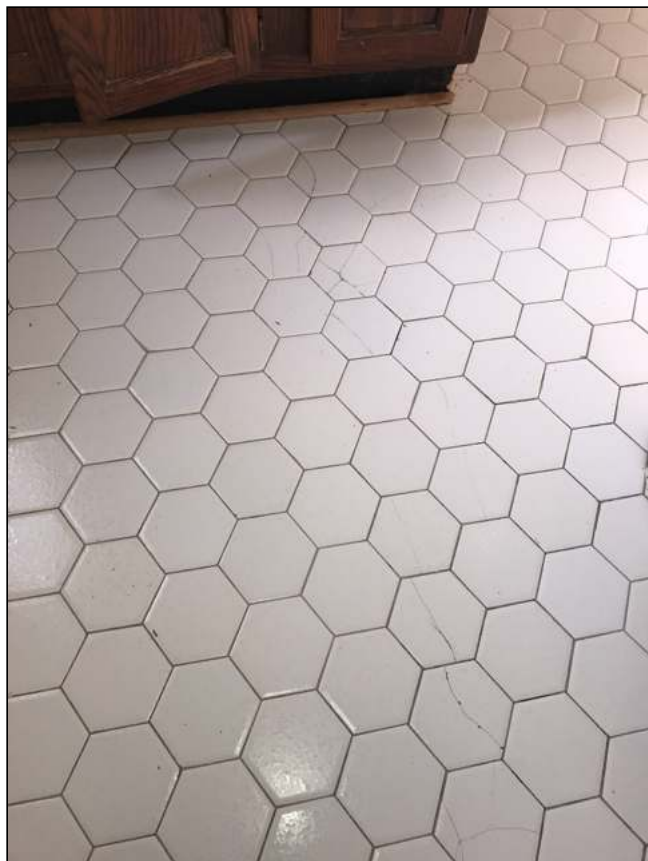
4.2 Item 1(Picture)

(1) Repair: Soft floor, cracked tile and water damaged cabinet observed in the second-floor bathroom are all indicators that something may have leaked. Tiles, grout, openings and moisture damaged materials should be assessed and repaired/ replaced by a licensed contractor.

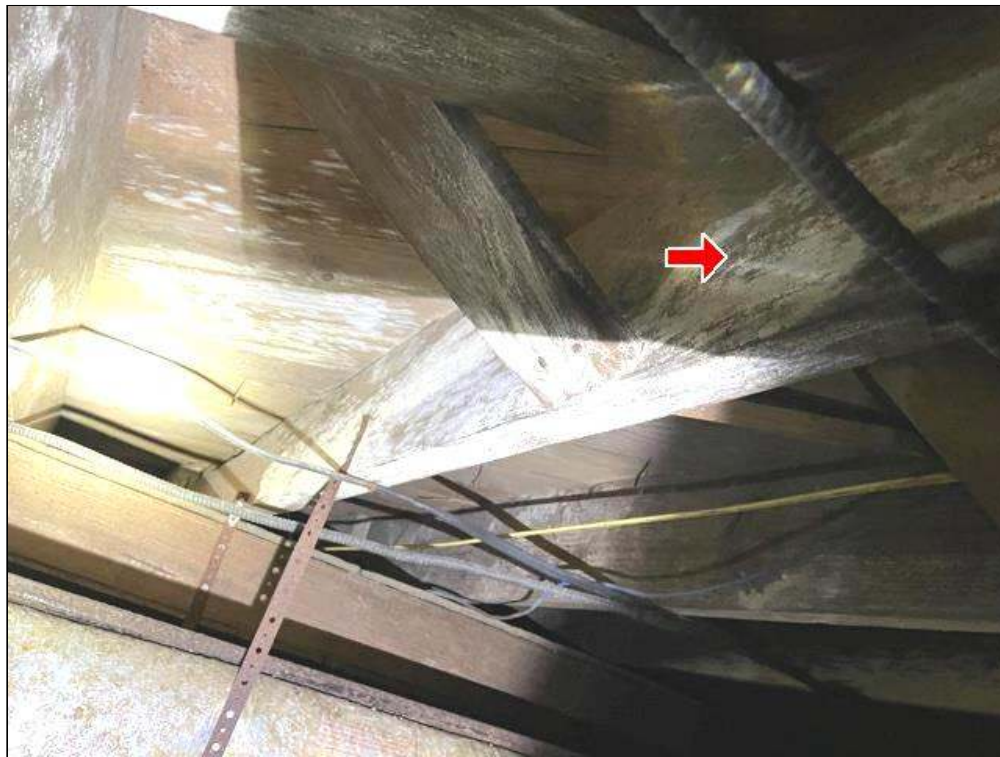
5.0 Item 1(Picture)

Repair: There are some signs of potential organic material seen on the floor joists, this material should be assessed by a qualified professional and treatment/ cleaning be completed of this material. The moisture issue also needs to be repaired as well to keep this material from occurring.

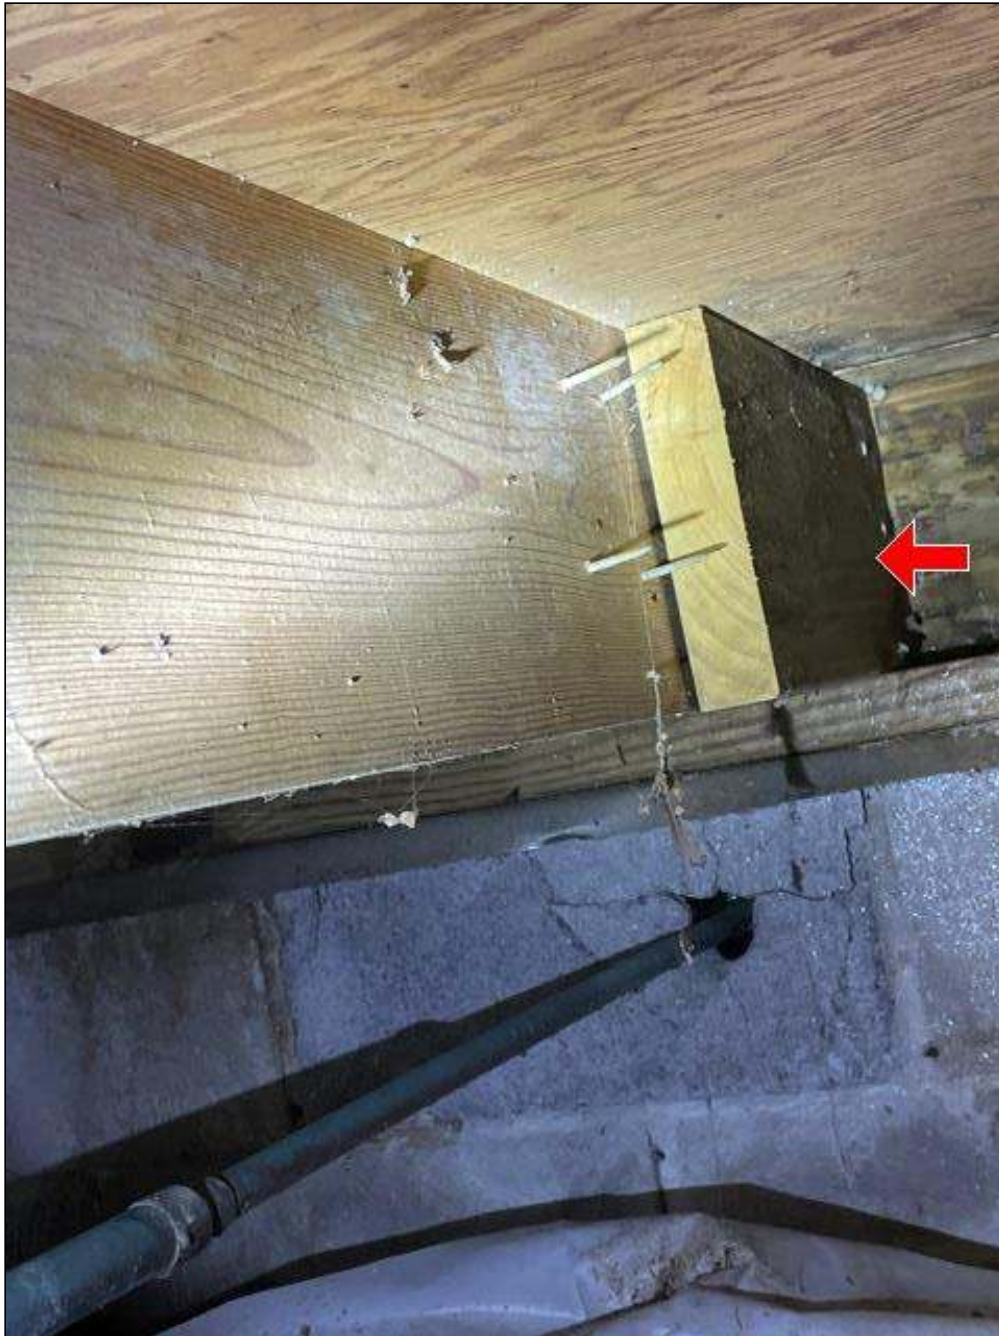
5.3 Item 1(Picture)

(1) Repair: Some prior repairs appears to have been made to the floor joists under the fireplace room at the back of the house. The areas have been sistered, but some of the wood is coming loose and the sistered areas do not appear to be long enough/ standard repairs. Recommend this be further assessed by a licensed contractor and repairs made as found necessary.

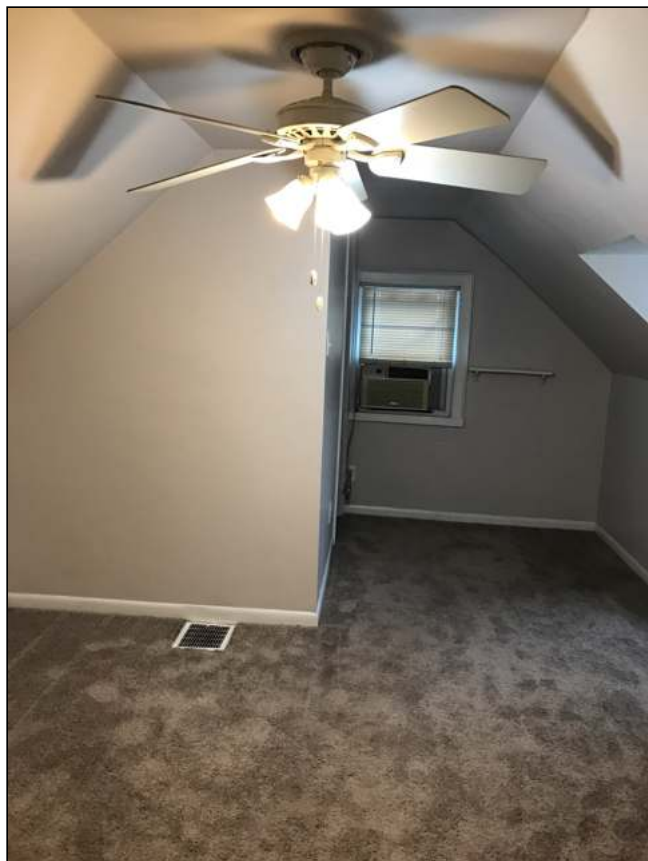
7.3 Item 2(Picture)

(2) Repair: Ceiling fan clearance in the second floor right side bedroom does not appear to be adequate and could cause injury due to its low clearance. This could allow someone's head or body to be struck by the fan when it is running. This should be assessed and repaired/replaced by a qualified professional.
