COASTAL INSPECTION SERVICES LLC

Inspection Report

Sample Report - 04

Date: 9/8/2021	Time: 8:30am	Report ID: Sample Report -04
Property: Sample Report Norfolk VA 23505	Customer: Sample Report - 04	Real Estate Professional: Paul Farrell

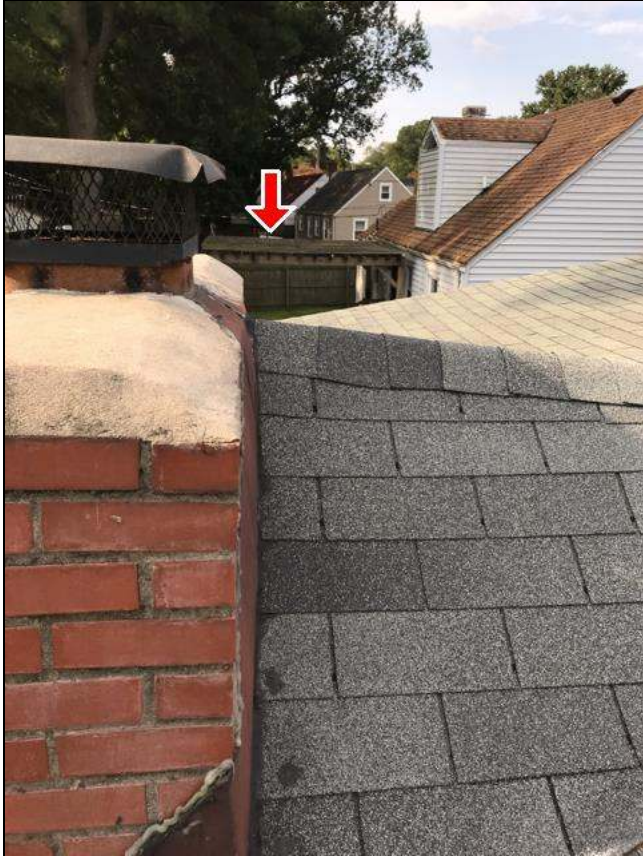
1.0 Item 1(Picture)

1.0 (1) Repair: The cricket for the rear chimney has some non standard conditions as it runs up to the top of the chimney crown, this upward angle means that water that gets on top of the cricket will flow back against the direction of the ridge shingles/shingles. There are gaps and openings at the flashings and multiple lines of caulking which are indicative of previous issues. It would be wise to have a licensed roofer assess this area and if necessary repairs should be made as necessary.

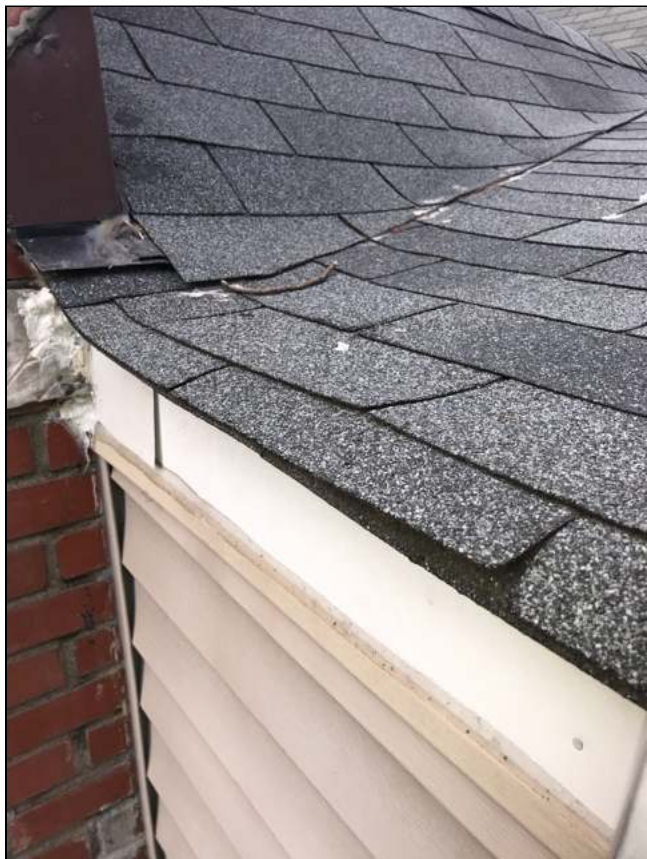
1.0 Item 5(Picture)

1.0 (2) Monitor: There are some very low slope/flat areas of the shingle roofing system that are vulnerable to water infiltration due to a lack of slope. This is primarily seen close to the edges of the roofing system near the rear chimney system. Please be aware of the possibility for an increased level of maintenance in these areas and an increased potential for water infiltration.

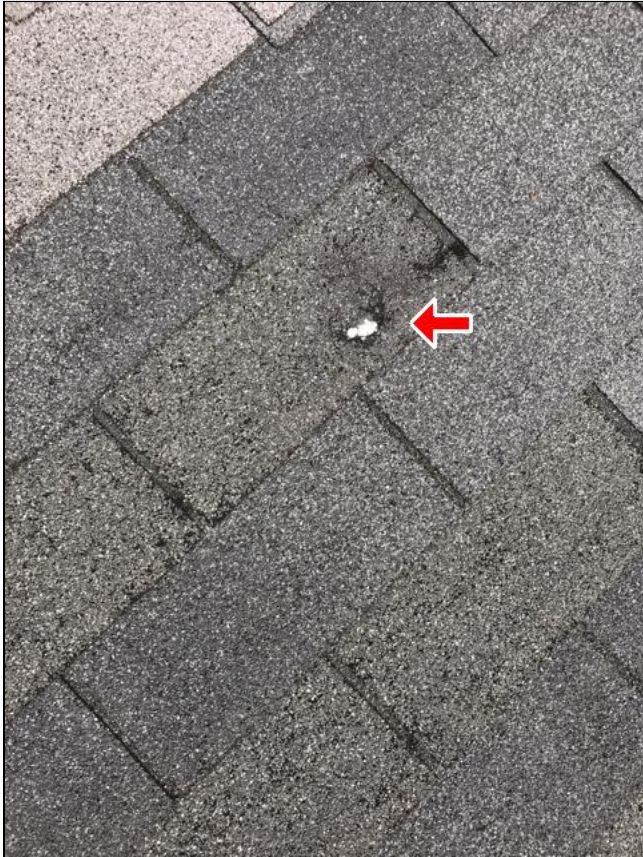
1.0 Item 6(Picture)

1.0 (4) Repair: The following shingle/roofing repairs are needed by a licensed roofer at the main house roofing system: hole in the shingle back of the house near the second-floor window, nail pops/damaged shingles need repair, exposed nail heads at the rear chimney/cricket need to be sealed, damaged shingles from old diverter flashing back of the house need repair/replacement.

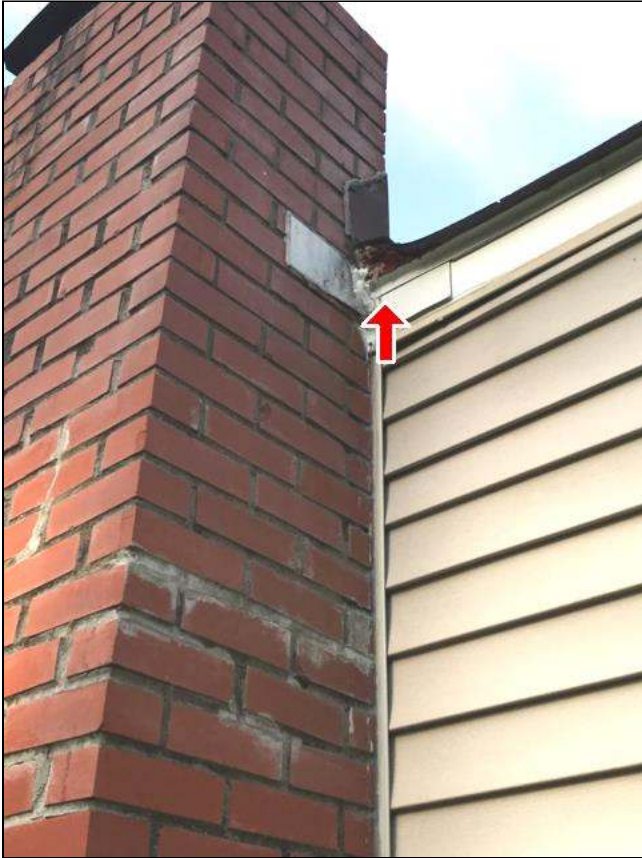
1.1 Item 2(Picture)

1.1 (2) Repair: A couple different types of foam have been installed at the flashings adjacent to the rear lower chimney system. This is not ideal nor recommended as this is considered a temporary repair and is not standard for this particular application. It is recommended you consider having a licensed roofer assess and permanent/ standard repairs be made in this area.

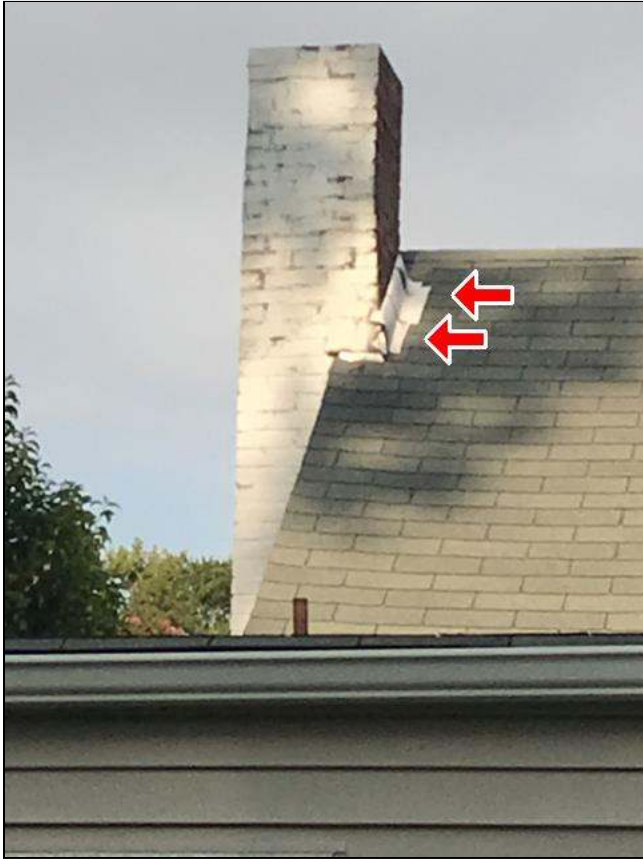
1.1 Item 3(Picture)

1.1 (3) Repair: Non-standard flashings observed the right side chimney, they should be assessed by a licensed roofer and repair/replacement made as found necessary.

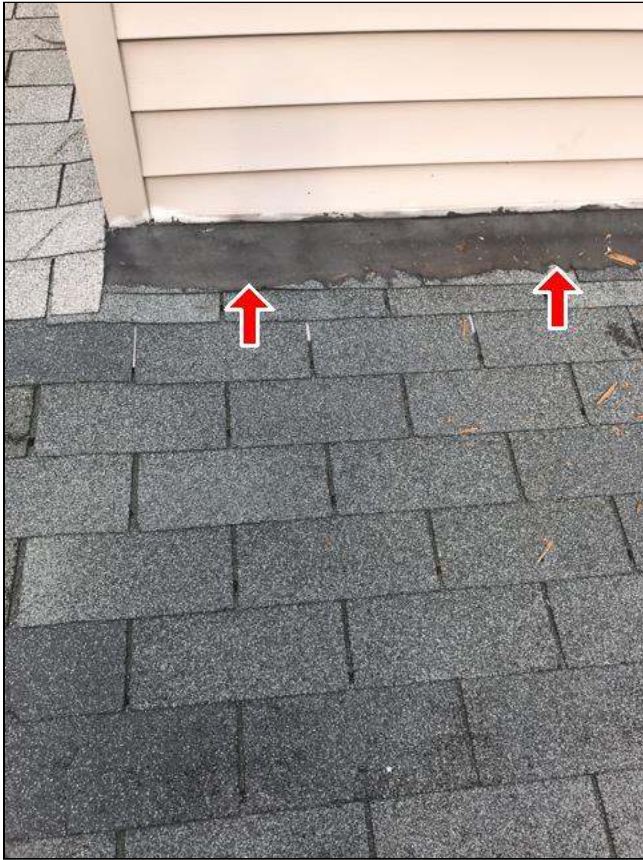
1.1 Item 4(Picture)

1.1 (4) Monitor: Flashing integration between the second-floor addition and the lower roofing at the back of the house has had a large amount of sealant installed in this area. This is not standard and is typically an indicator of a previous issue. Inspector could not see what is below this, is there flashing? Please be aware of this issue

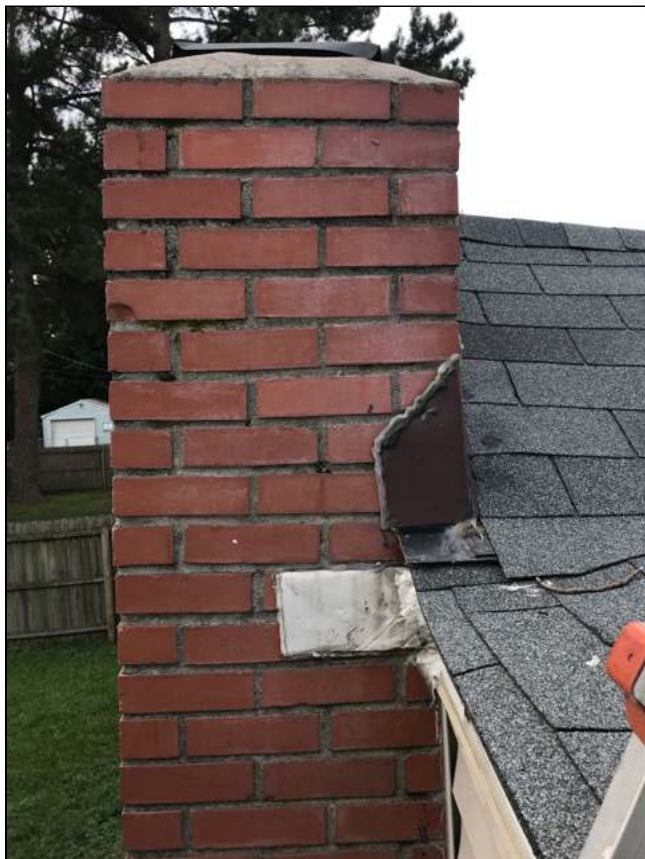
1.2 Item 1(Picture)

1.2 (1) Monitor: The upper 1/3 of the chimney is leaning towards the house noticeably, one side has some cracking and it also appears that some repairs were made to some mortar and brick at this chimney as well. Chimney appears to be functional based on exterior visual assessment, but this is something to be aware of and monitor and it is highly recommended you have the interior of the chimney inspected to make sure this movement has not damaged the flue.

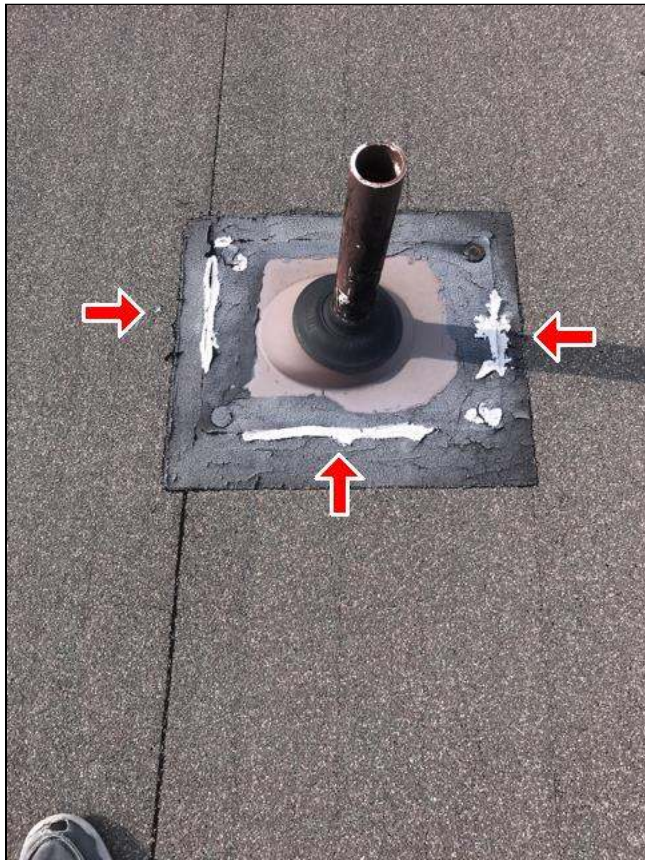
1.2 Item 4(Picture)

1.2 (2) Repair: Plumbing boot/penetration at the upper flat roof system is not designed for this application, it appears it may have already been experiencing issues based on the additional caulking, which is failing, that has been installed. This should be assessed and repaired by a licensed roofer.

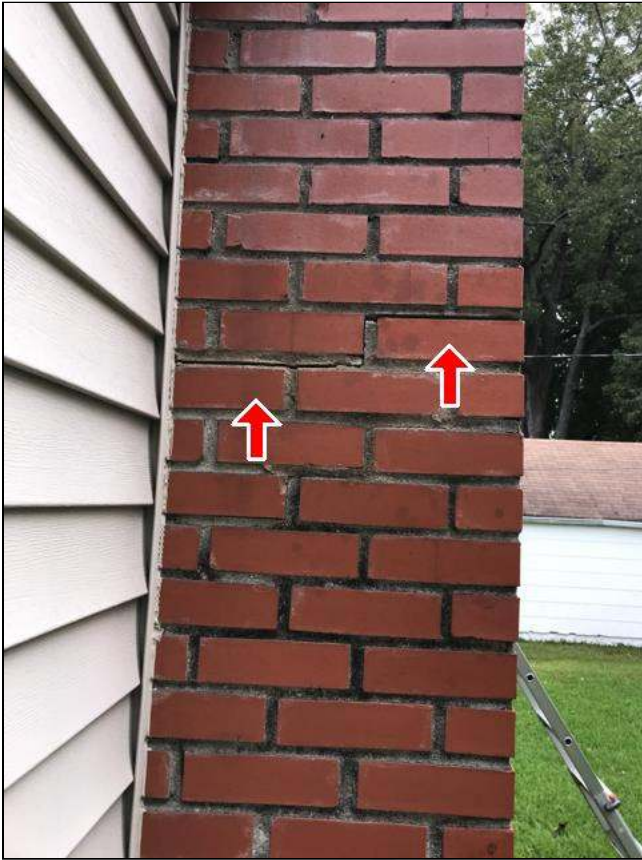
1.2 Item 5(Picture)

1.2 (3) Repair: Cracking in the chimney chase, back of the house, needs repaired by licensed mason. It is recommended while this is being assessed you have the mason determine whether or not other repairs are needed to the structure of this in order to keep the cracking/ movement from occurring further.

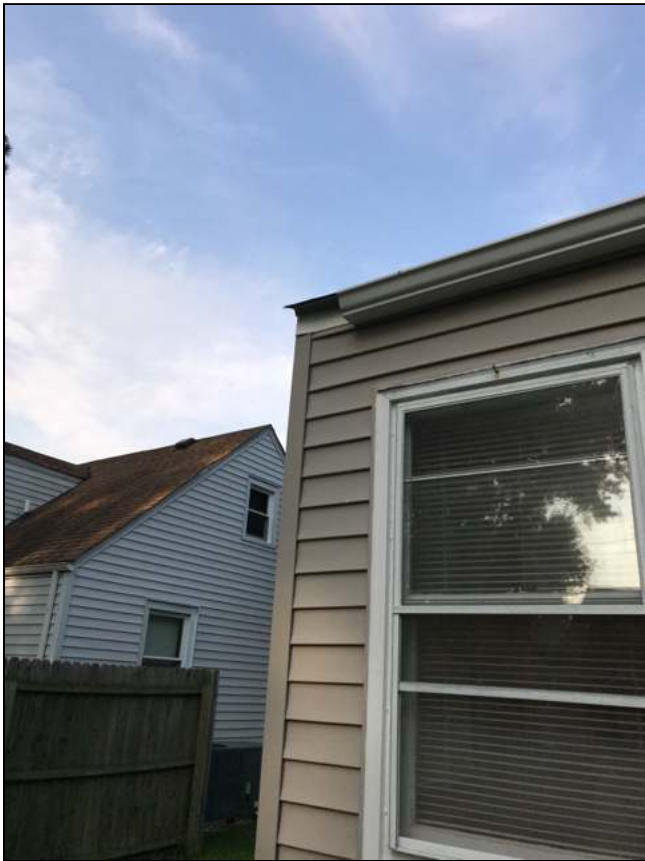
1.3 Item 1(Picture)

1.3 (1) Repair: Incomplete guttering at the back of the house needs repair/completion by a qualified professional.

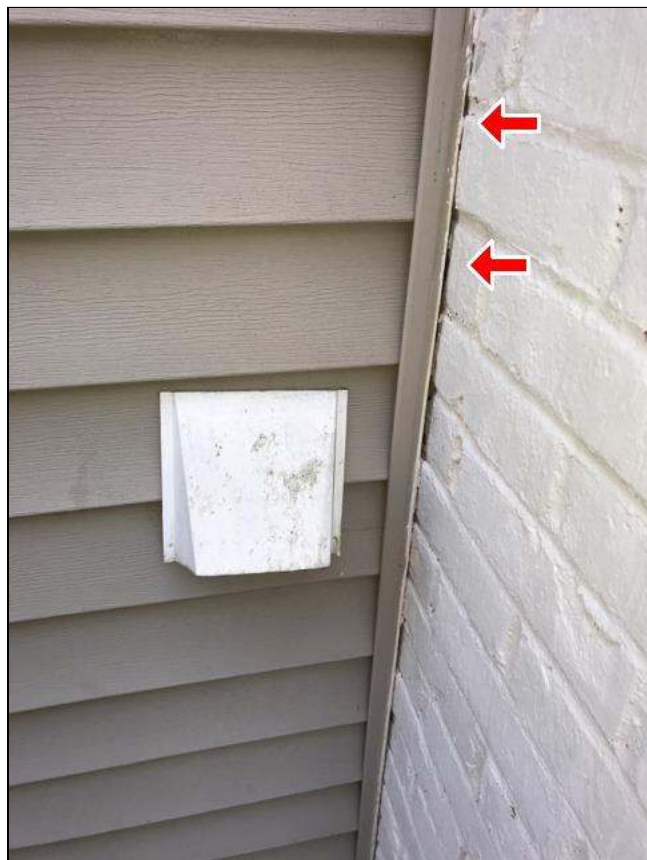
2.0 Item 1(Picture)

2.0 (1) Repair: Gaps/openings between the chimney chase and the vinyl siding on the right side of the house need to be caulked/sealed.

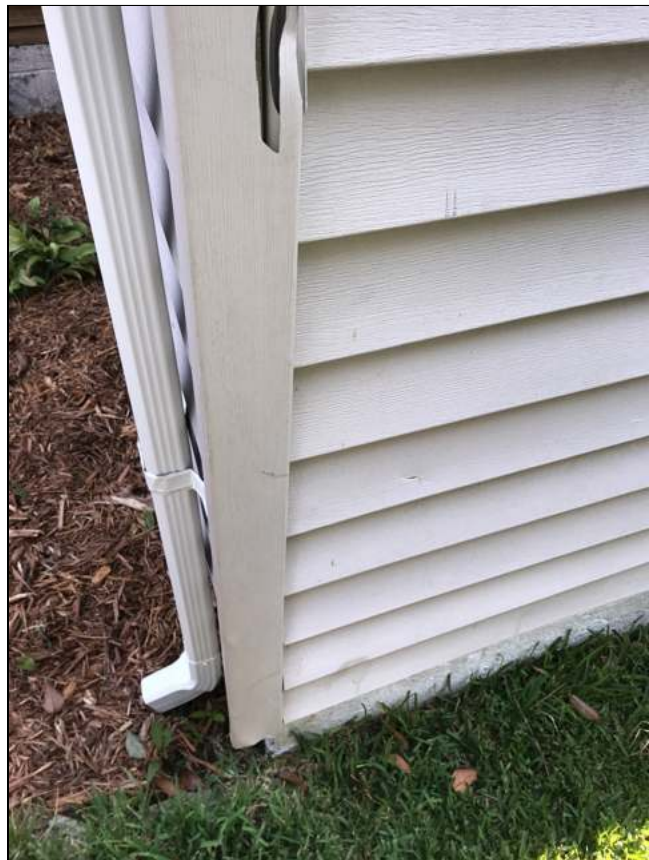
2.0 Item 3(Picture)

2.0 (2) Repair: Damaged siding needs to be assessed and repaired/ replaced by licensed siding professional or licensed contractor. This was observed: right side of the house, front right corner of the house.

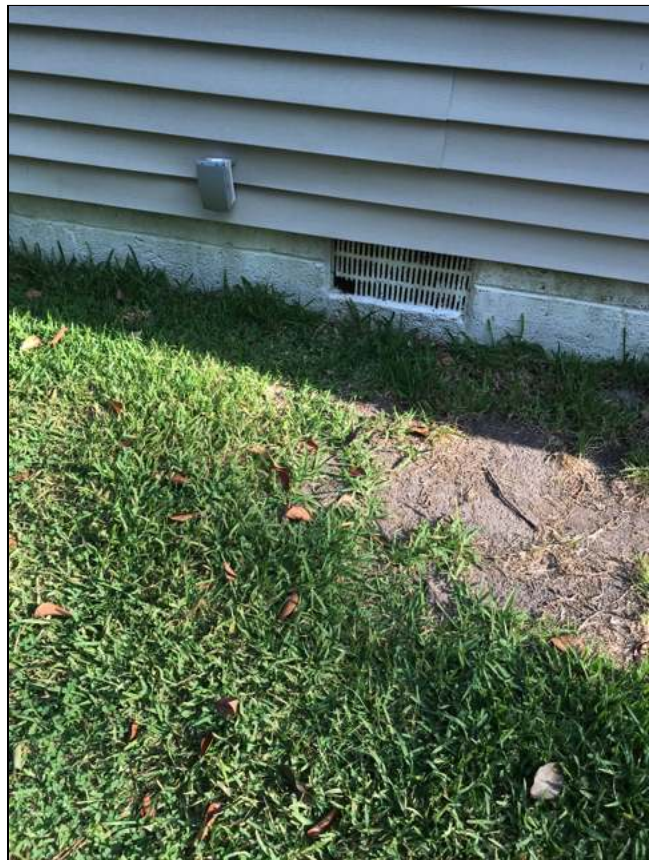
2.0 Item 4(Picture)

2.0 (3) Repair: Screening should be installed over the open crawlspace vents to prevent vermin entry. Some of the vents do not have screening and some are damaged which could easily allow animals to enter.

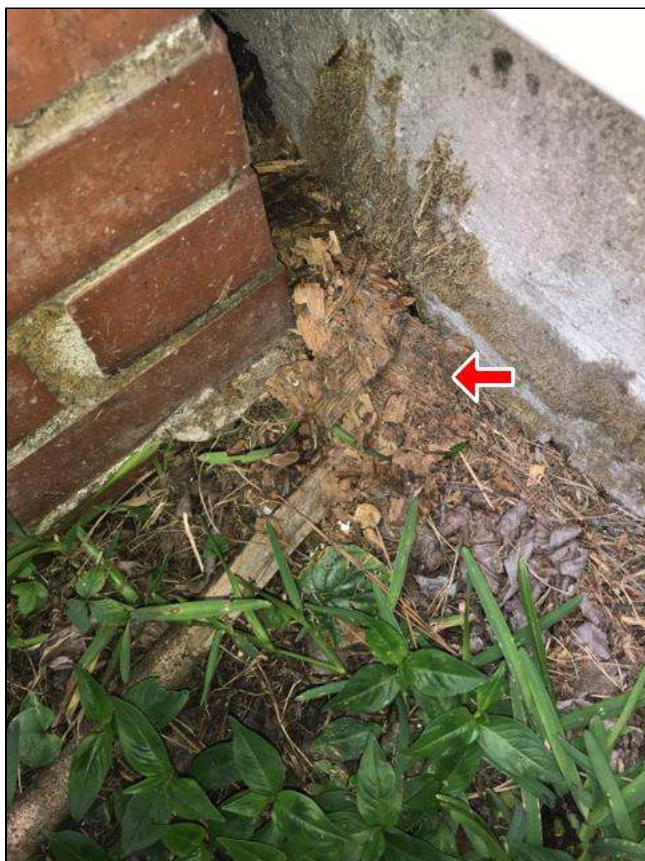
2.0 Item 5(Picture)

2.0 (4) Repair: When the back door was closed, some damage materials fell from behind the siding to the left and right of the back door. Upon further inspection it feels as if the sheathing or material behind the siding may be damaged in some areas, would have this further assessed by a licensed contractor and repair/replacement made as found necessary.

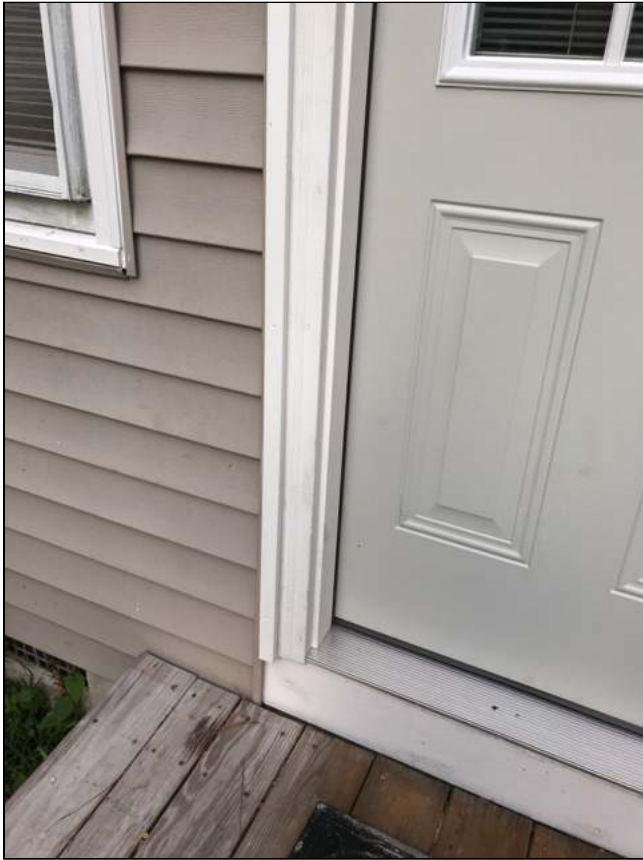
2.1 Item 1(Picture)

2.1 Repair: it does not appear that the rear exterior door has been painted with an exterior grade paint and there are some gaps and openings at the trim that should be caulked/sealed. To help preserve and protect the door as recommended these areas be caulked and painted

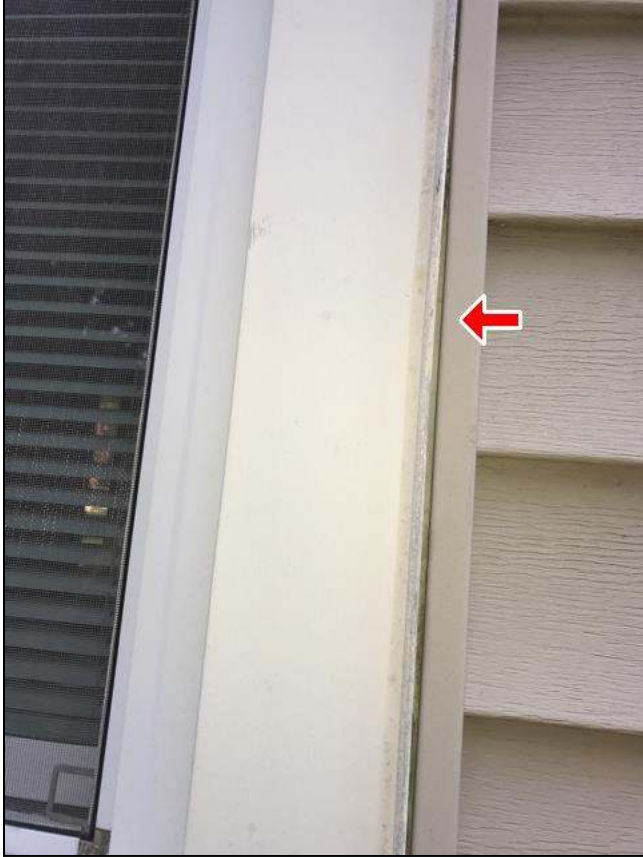
2.2 Item 1(Picture)

2.2 Repair: Gaps between the exterior windows and the vinyl siding need to be further assessed by a qualified professional and caulked/sealed to prevent water infiltration.

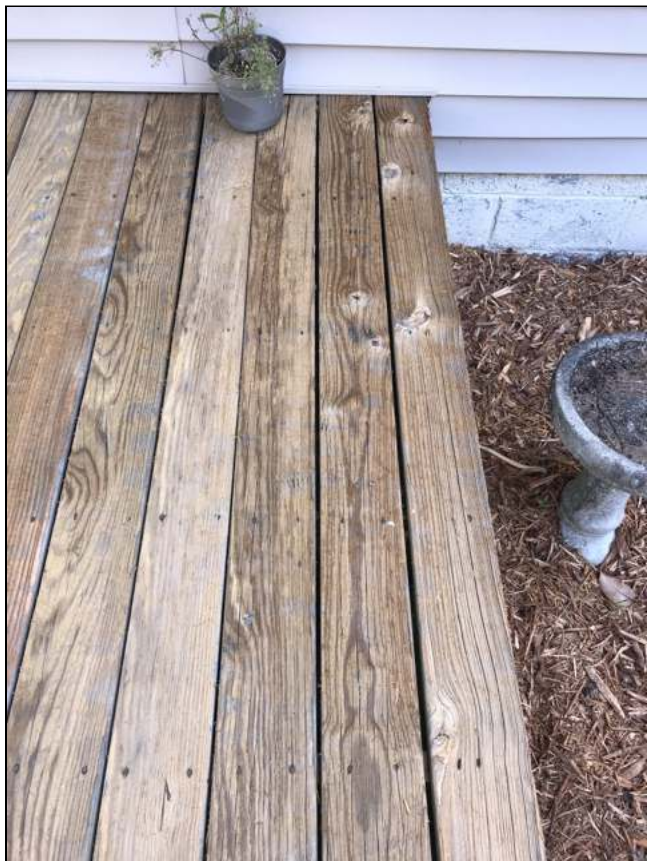
2.3 Item 1(Picture)

2.3 (1) Repair: There are several soft/deflecting deck boards observed on the left and right sides of the decking system. Inspection from the crawl space found that the numerous floor joists below the front porch are rotted/deteriorated. This was seen on the left and right sides of the porch, these need assessment and repair/ replacement by a licensed contractor.

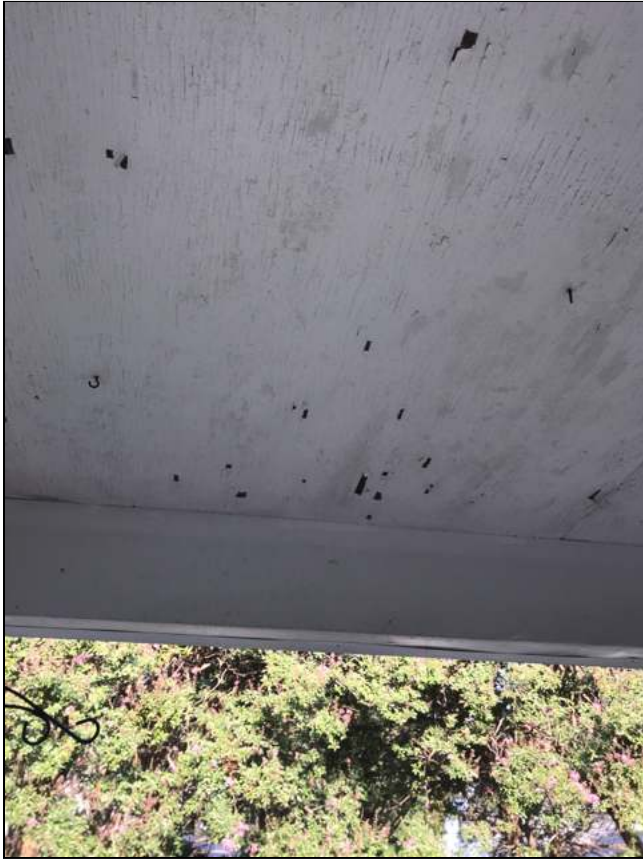
2.3 Item 8(Picture)

2.3 (2) Repair: Front porch ceiling needs to be scraped and painted, threshold for the front door the front porch needs to be scraped and painted.

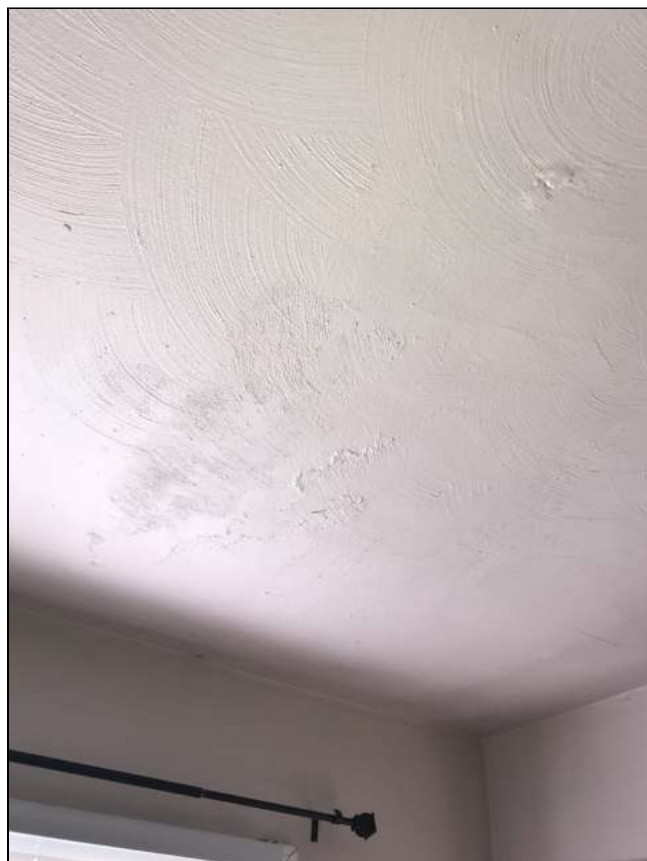
4.0 Item 1(Picture)

4.0 (1) Repair: Bubbling paint, bulging ceiling finish was observed at the ceiling of the back left second-floor bedroom. These are indicators that something has or may still be leaking. Would have the homeowner provide further information on this to determine if a professional repair has been made, if a professional repair has not been made then this could still be active and would need repair.

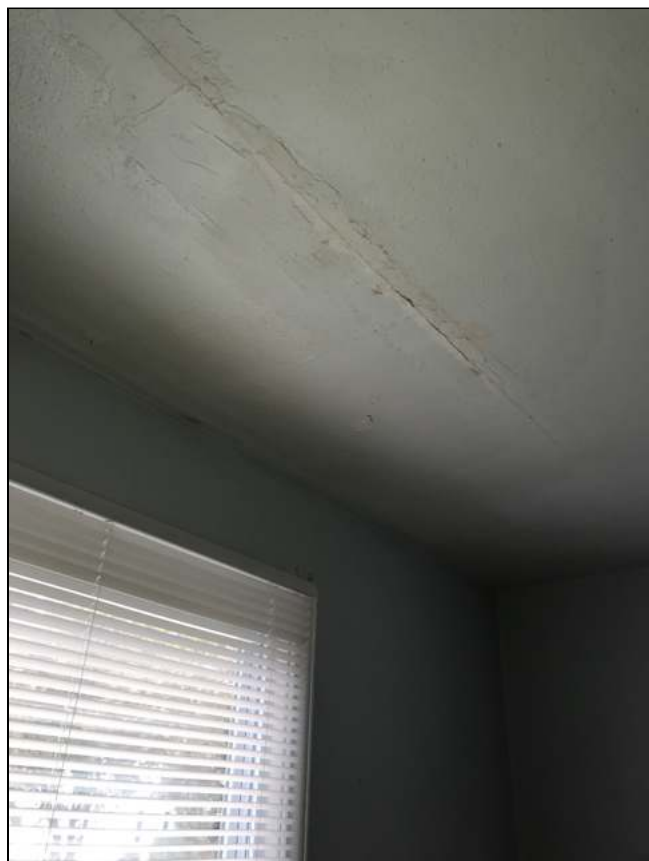
4.0 Item 3(Picture)

4.0 (2) Repair: There are some pronounced cracks observed in the ceiling of the first floor, primarily seen running from left to right in the front living room and the front first floor bedroom. Inspector could not access the structure above this as there is roofing and a finished second floor. Currently any loose ceiling finishes, as seen in the bedroom, should be repaired to keep this from worsening.

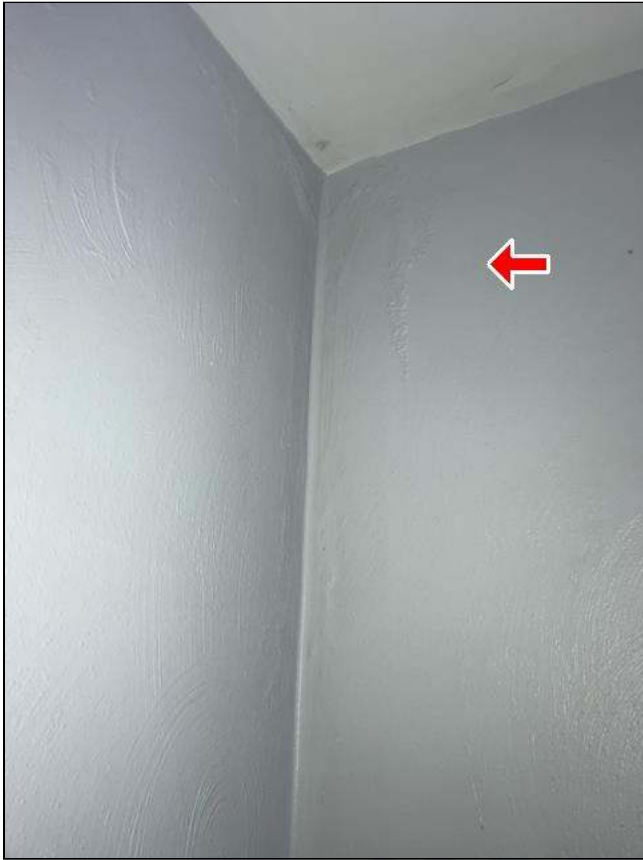
4.1 Item 1(Picture)

4.1 Further Assessment Recommended/Repair: Signs of possible moisture infiltration observed at the back wall of the first floor back left bedroom. Bubbling paint and slightly elevated moisture levels observed, they should be further assessed by a licensed contractor or a qualified professional and repairs made as found necessary.

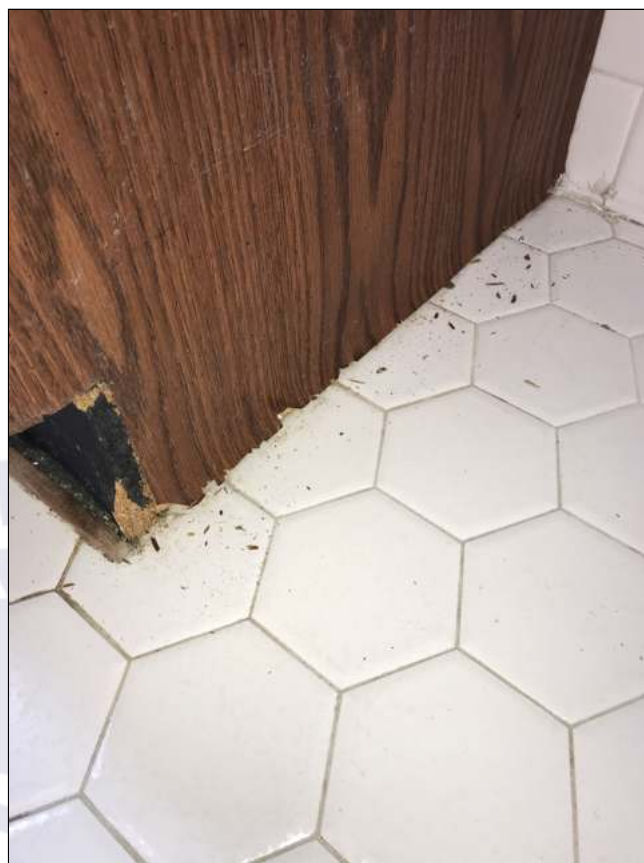
4.2 Item 2(Picture)

4.2 (1) Repair: Soft floor, cracked tile and water damaged cabinet observed in the second-floor bathroom are all indicators that something may have leaked. Tiles, grout, openings and moisture damaged materials should be assessed and repaired/ replaced by a licensed contractor.

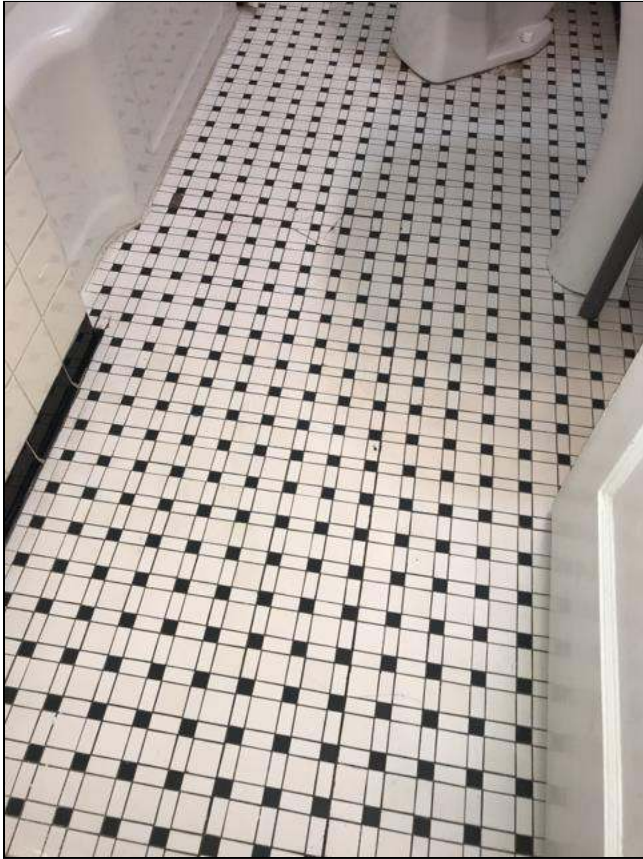
4.2 Item 4(Picture)

4.2 (2) Repair : There are some loose tiles, cracked tiles, damaged tiles and lifted tiles observed in the first floor bathroom. Priority should be given to repairing the cracks/missing tile where water could enter.

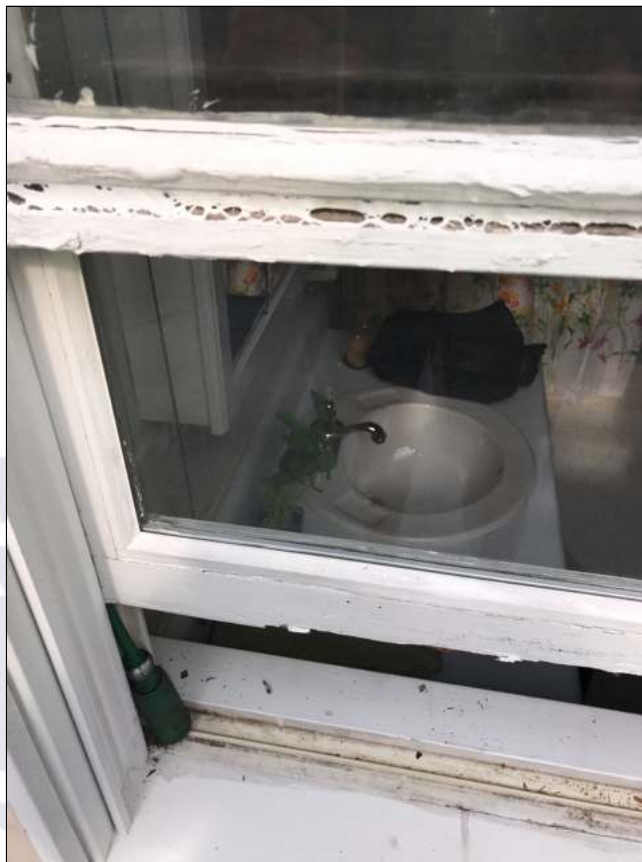
4.6 Item 2(Picture)

4.6 (1) Repair: Rear second-floor window adjacent to the bathroom is rotted/ moisture damaged and the window lifters are inoperative, this should be assessed and repaired/replaced by a licensed contractor. Please also note based on the amount of additional caulking this window appears to have had some previous issues.

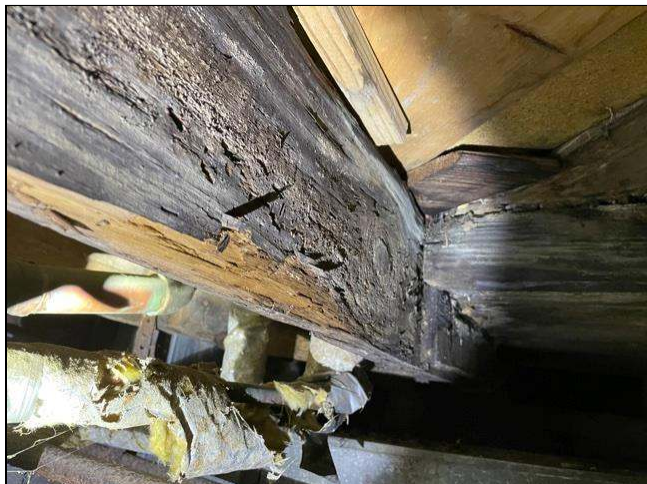
5.3 Item 3(Picture)

5.3 (2) Repair: Damaged floor joists and sub floor seen on the right side and right rear of the crawl space, these need further assessment by a licensed contractor and repair/ replacement made as found necessary.

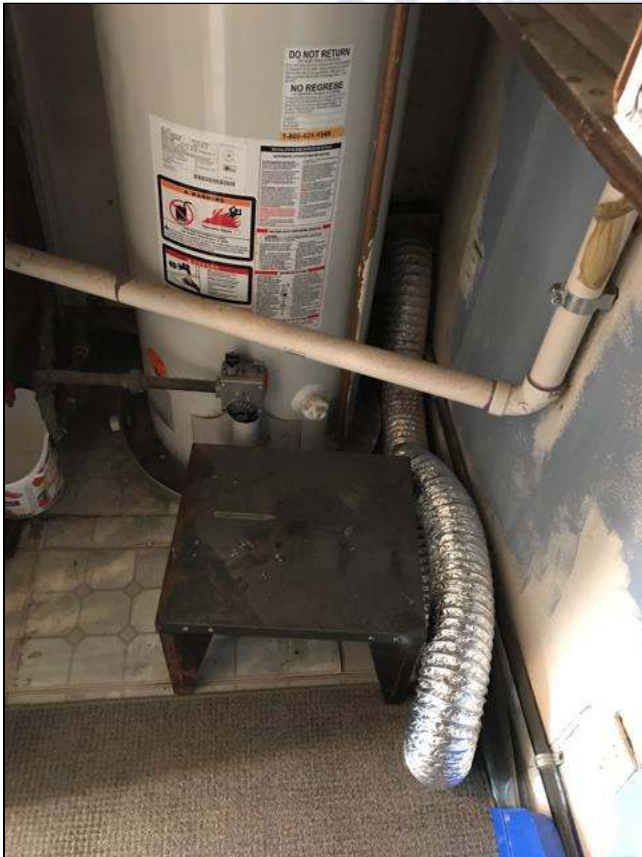
6.0 Item 1(Picture)

6.0 (1) Repair: Drain pipe adjacent to the water heater that appears to service the clothes washer is not properly vented and does not have an air admittance valve. It also does not appear that the drain line for the clothes washer has a trap installed. Would have this piping assessed by a licensed plumber and repair/replacement made as found necessary.

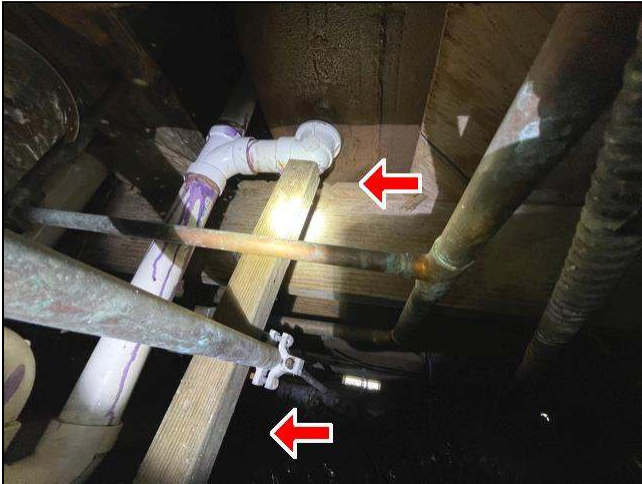
6.0 Item 5(Picture)

6.0 (4) Repair: The drain piping under the first floor bathroom is being held up by a piece of wood sitting on top of a cut pipe. This is not standard, recommend licensed plumber further assess and handle repair as found necessary.

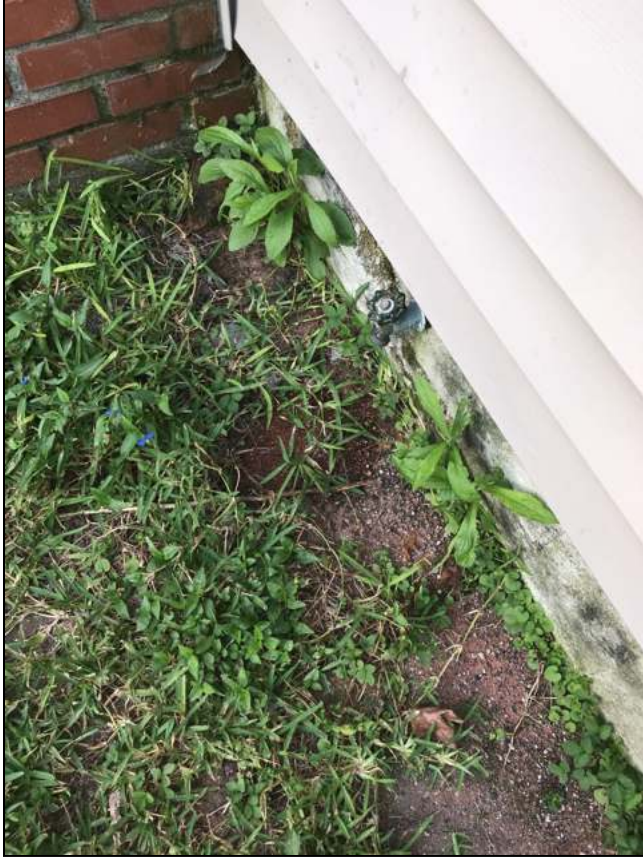
6.1 Item 1(Picture)

6.1 (1) Repair: The hose bib is loose and needs to be secured in place to prevent damage to to the piping or fixture. This needs repair by licensed plumber. This was observed. Back of the house.

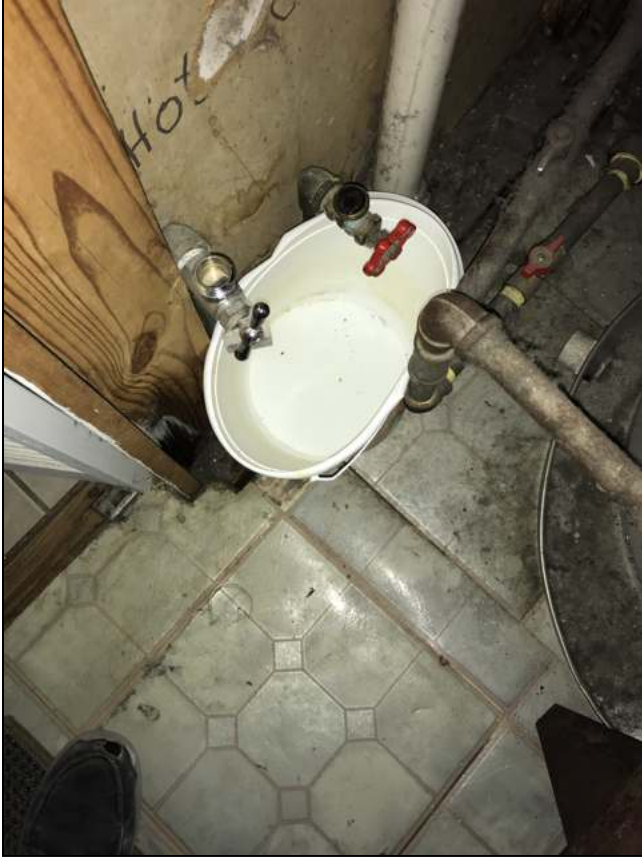
6.1 Item 2(Picture)

6.1 (2) Repair: Isolating valves for the clothes washer appear to be leaking and need repair/replacement by a licensed plumber.

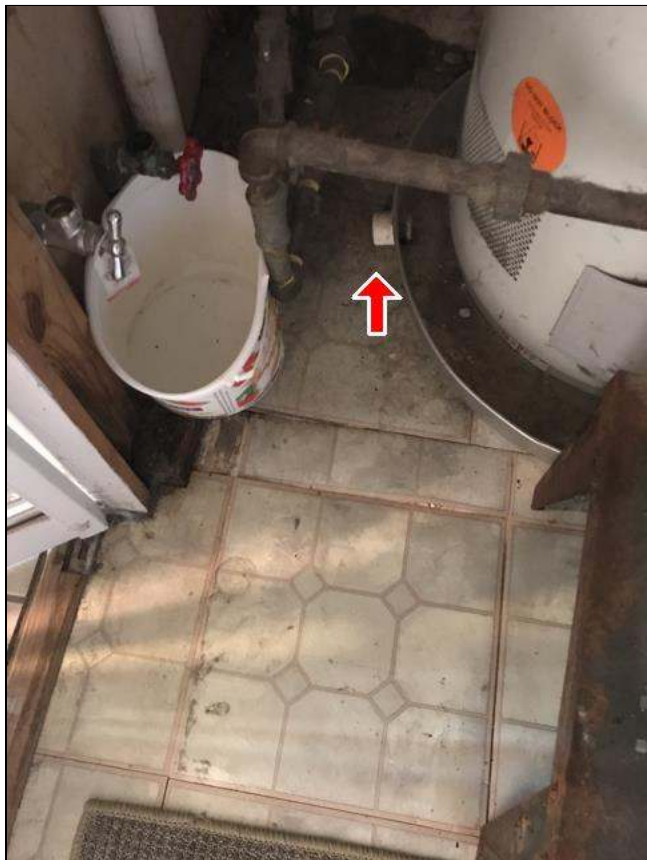
6.2 Item 1(Picture)

6.2 (1) Repair/ Concern: The water heater needs to have a pan with drain to exterior installed in order to catch and direct leaking to the exterior of the house. This needs repair by licensed plumber.

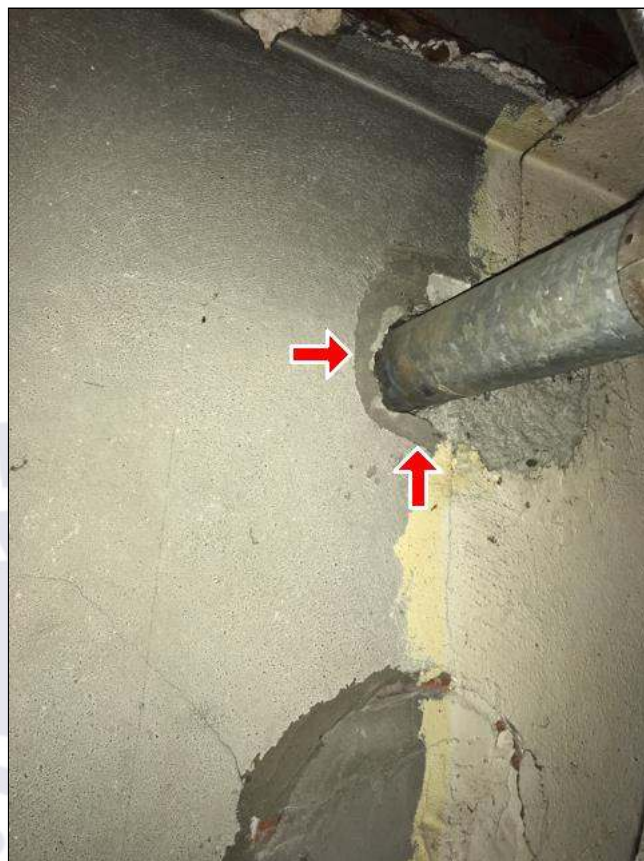
6.2 Item 3(Picture)

6.2 (2) Repair: The following repairs need to be assessed and handled by a licensed plumber for the water heater flue: there is a section of flue material that does not appear to be rated for this application and is not mechanically attached to the adjacent areas, gaps and openings around the flue penetration into the chimney need to be properly sealed as there appears to be spillage occurring.

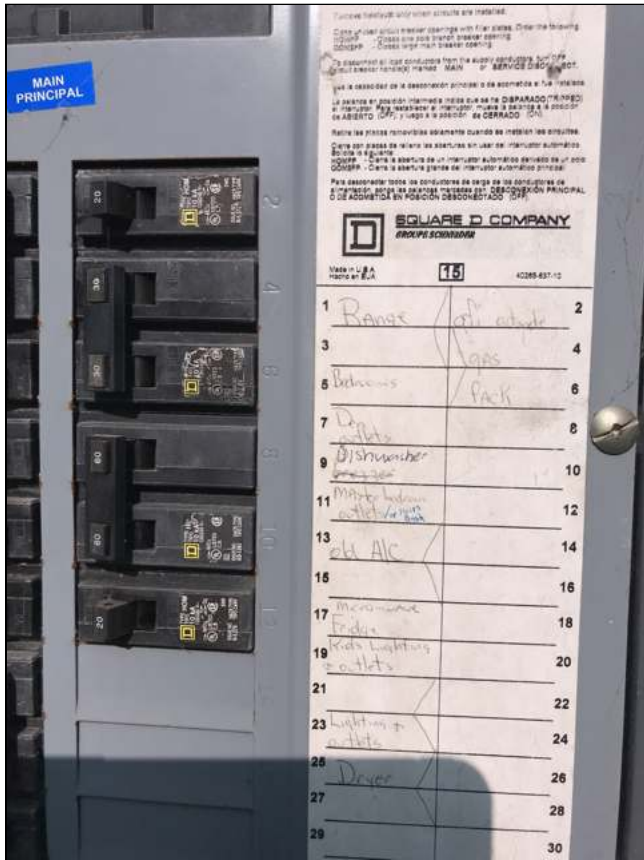
7.1 Item 2(Picture)

7.1 (2) Repair/ Limitation: The panel is not clearly or thoroughly labeled. This limited the inspection, it is recommended a licensed electrician throughly/ clearly label the panel. Circuit number eight and 10 and number 12 are not labeled.

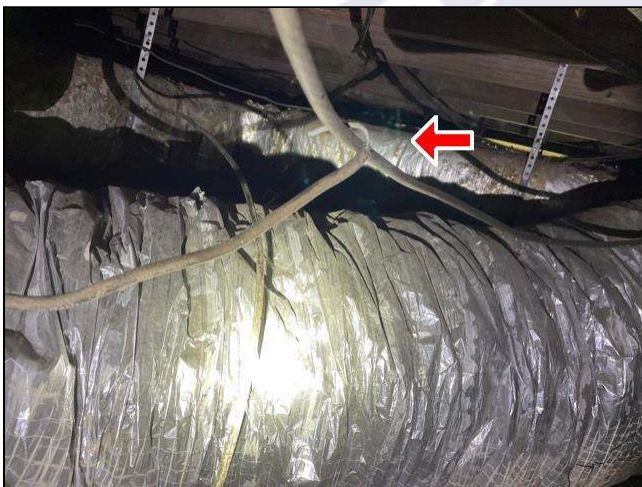
7.2 Item 1(Picture)

7.2 (1) Repair: Improperly abandoned wiring in the crawl space needs to be removed or terminate inside a properly rated junction box, recommend licensed electrician assess and handle repairs.

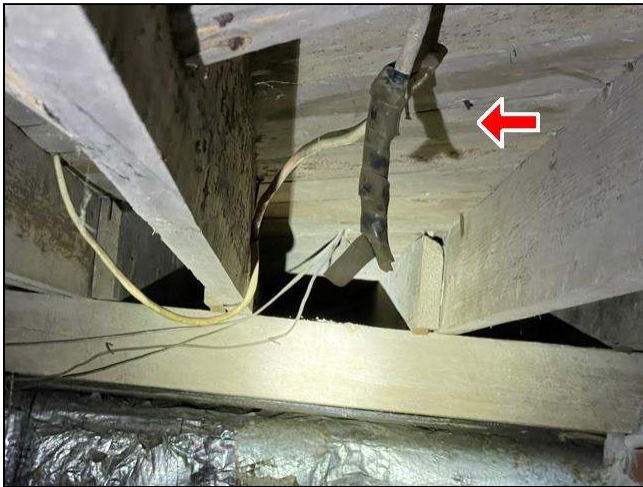
7.2 Item 3(Picture)

7.2 (2) Repair: Open wiring connections/ splices should be made inside a properly rated/ covered junction box. This needs to be assessed and repaired by a licensed electrician. This was observed in the following locations: front of the

crawl space.

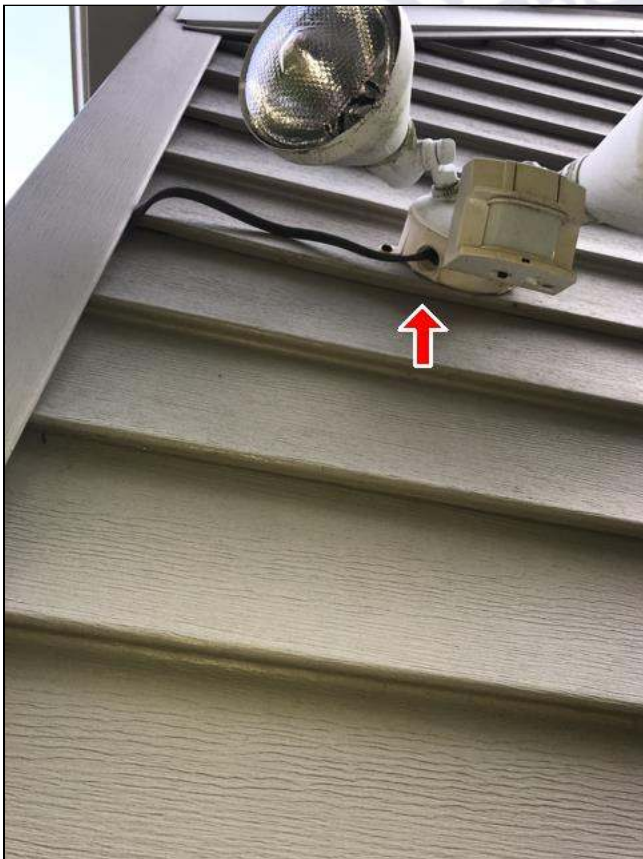
7.3 Item 1(Picture)

7.3 (1) Repair: Electrical wiring to the right side light needs a proper bracket/attachment where it enters the junction box. Recommend licensed electrician assess and handle repair as necessary.

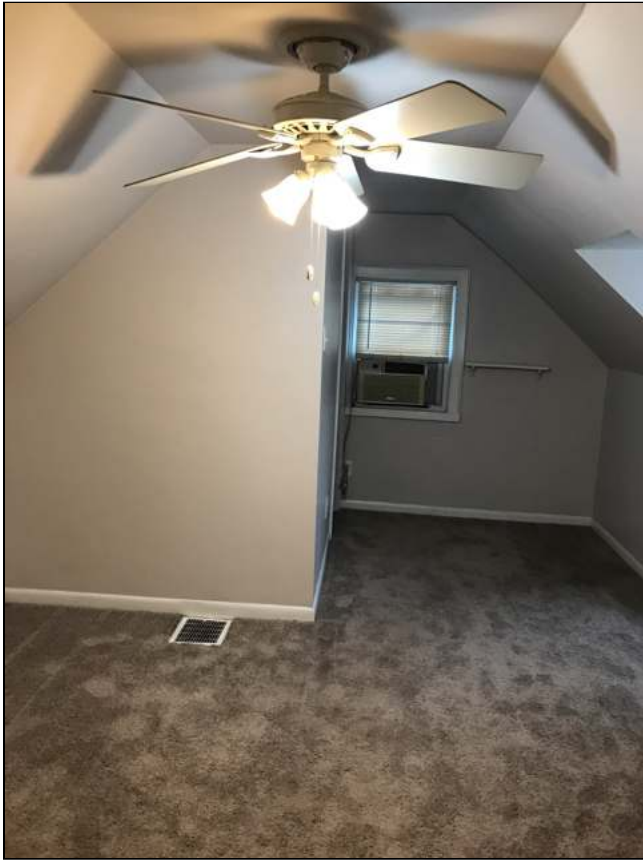
7.3 Item 2(Picture)

7.3 (2) Repair: Ceiling fan clearance in the second floor right side bedroom does not appear to be adequate and could cause injury due to its low clearance. This could allow someone's head or body to be struck by the fan when it is running. This should be assessed and repaired/replaced by a qualified professional.

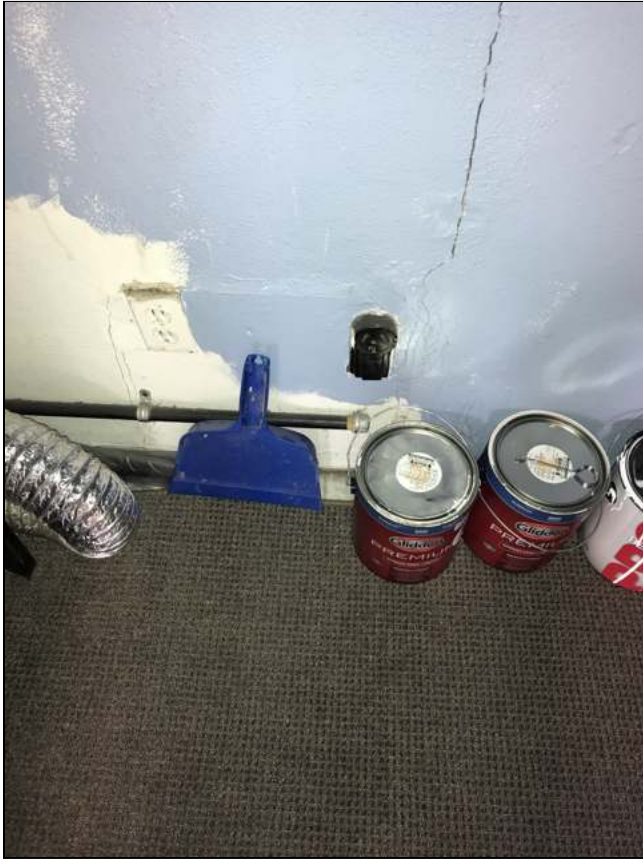
7.3 Item 3(Picture)

7.3 (3) Repair: Little to no voltage was detected at the dryer receptacle, two different testers were used with the same result. It should be assessed and repaired by a licensed electrician.
