COASTAL INSPECTION SERVICES LLC

Inspection Report

Sample Report - 04

Date: 9/8/2021	Time: 8:30am	Report ID: Sample Report -04
Property: Sample Report Norfolk VA 23505	Customer: Sample Report - 04	Real Estate Professional: Paul Farrell

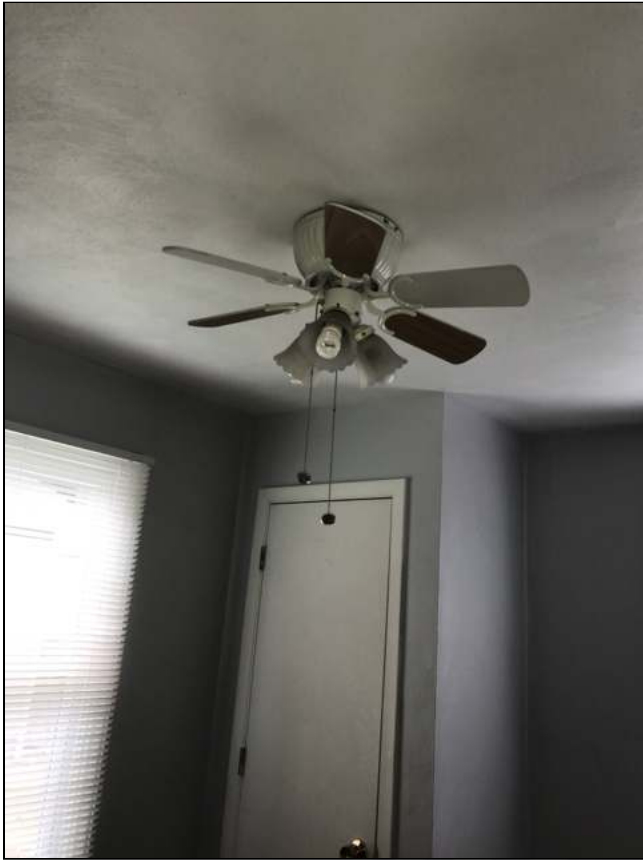
7.3 Item 4(Picture)

7.3 (4) Repair: Ceiling fan in the back left first floor bedroom was turned on at the pull, the fan stayed on for a quick second, made a noise and then shut off. It appears there is an issue with this fixture and/ or the circuit. This needs to be assessed and repaired by a licensed electrician.

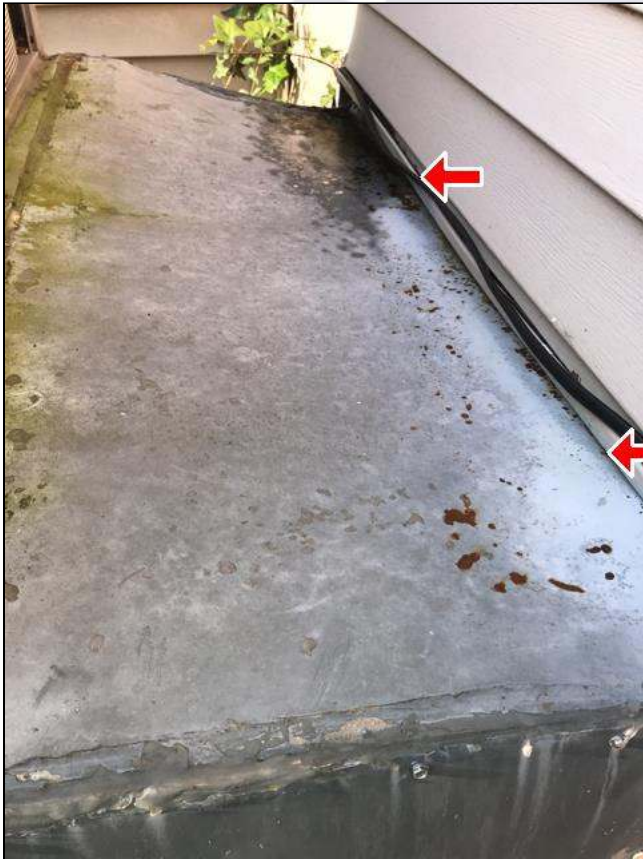
8.0 Item 1(Picture)

8.0 Repair: The doghouse for the gas pack needs to be re-secured in place, scraped, painted, caulked and graded so water will run off of this area. Recommend qualified professional assess and handle repair as found necessary.

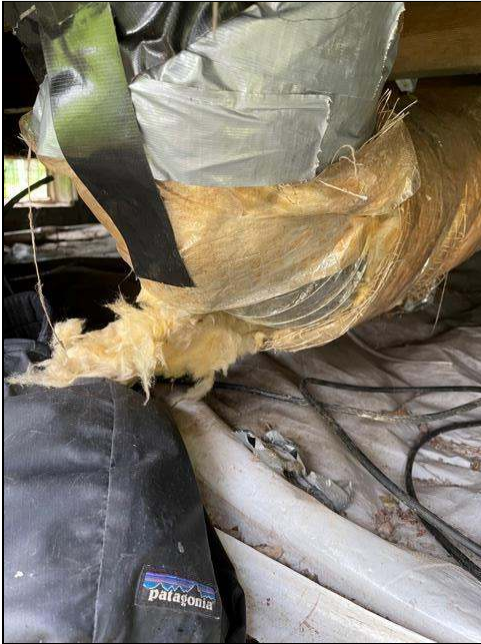
8.3 Item 1(Picture)

8.3 (2) Repair: The following ductwork repairs are needed by a licensed HVAC professional in the crawl space, recommend qualified HVAC professional assess and handle the following repairs: damaged ductwork insulation near the entry, un-insulated ductwork near the center of the crawl space needs repair, unsupported ductwork lying on the ground of the crawl space (seen in numerous locations) needs to be secured up and off the floor.

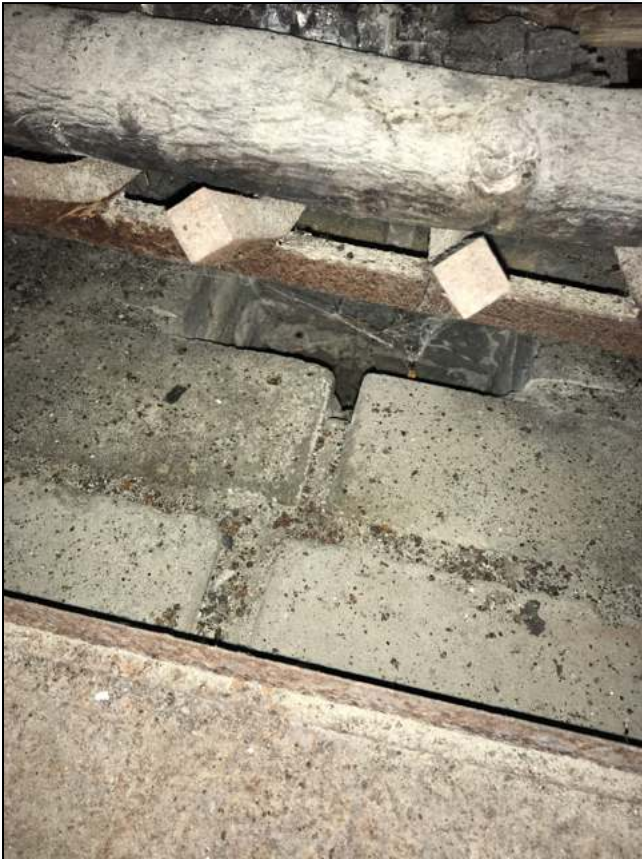
8.6 Item 1(Picture)

8.6 (2) Repair: Cover for the ash collection point is missing from the bottom of the fireplace, outer access cover is also missing. The piece of metal has been installed outside does not appear to allow for easy access to this area. These items should be further assessed by a licensed fireplace technician and repairs/replacement made as found necessary.

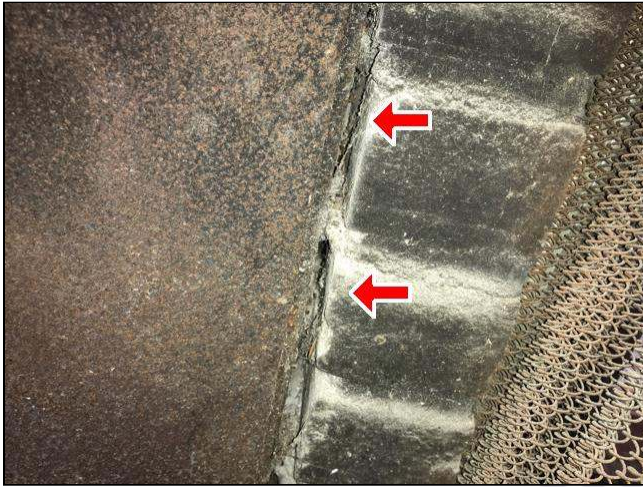
8.6 Item 3(Picture)

8.6 (3) Repair: Gaps and openings at the fire box for the wood-burning fireplace are an indicator that something has moved/separated. These gaps and openings should be assessed by a licensed fireplace professional and repairs/replacement made as necessary.

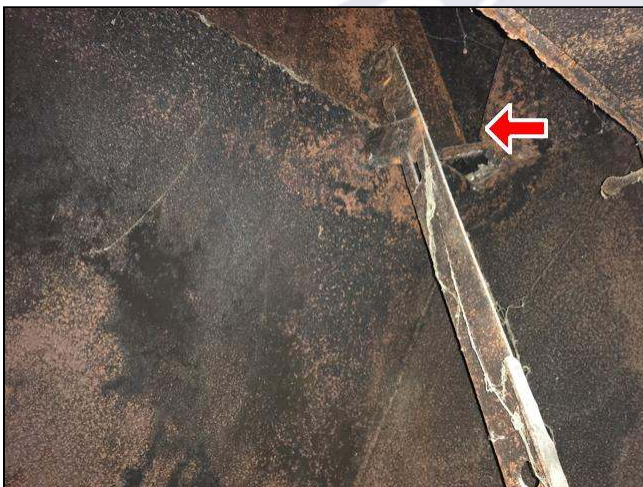
8.6 Item 5(Picture)

8.6 (4) Repair: The damper for the fireplace appears to be damaged/ inoperative, this needs repair/replacement by a licensed fireplace technician.

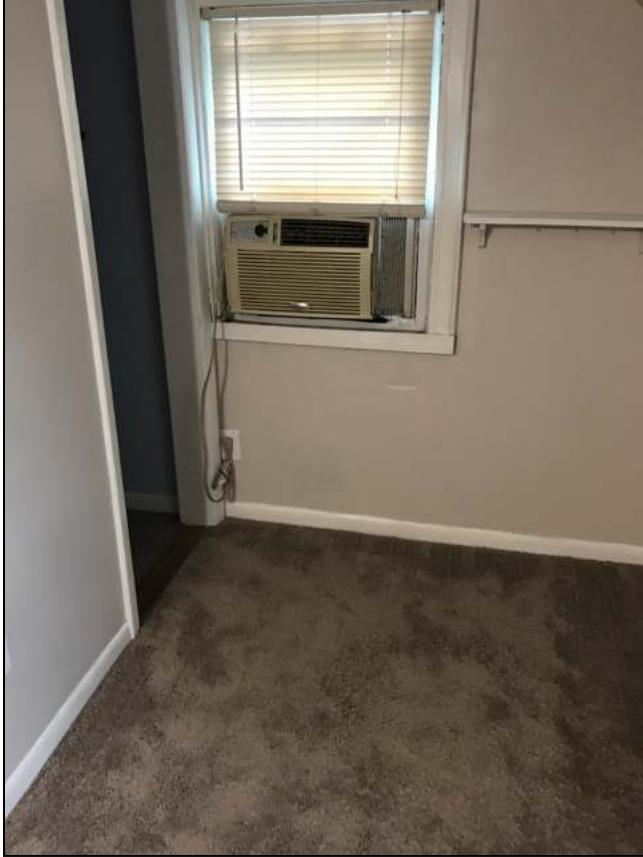
8.8 Item 1(Picture)

8.8 Informational: It appears that both bedrooms on the second floor have additional window air-conditioning units installed. This is typically an indicator that the central air conditioning system may not be keeping up with the demand,

often times older houses that have had additions installed on the second floor struggle to keep all areas fully conditioned without having separate zones.

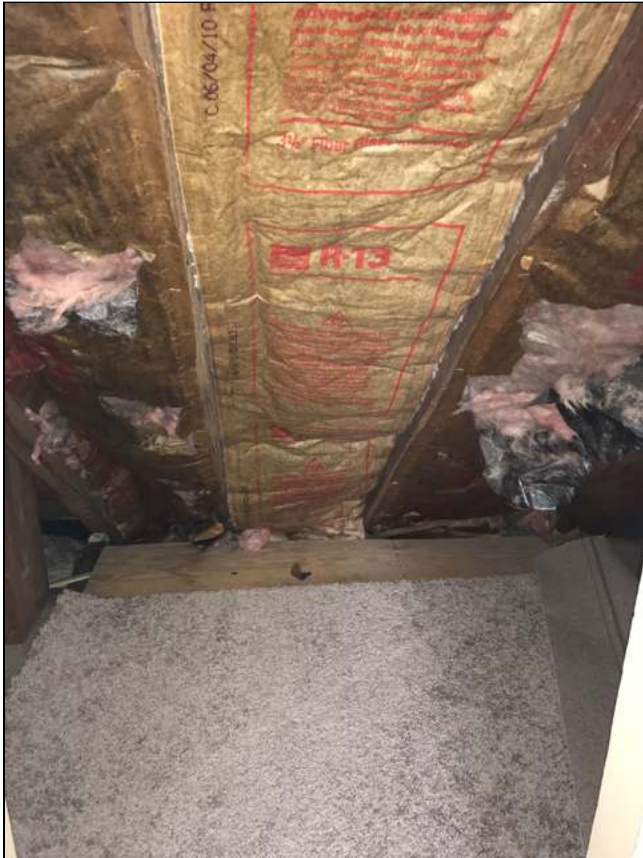
9.0 Item 1(Picture)

9.0 Repair: Insulation in the rafter cavities has been installed with the paper backing left exposed, please note this paper backing is flammable and according to the insulation instructions is not to be left exposed. Would have this assessed by a qualified professional and repairs made as necessary.

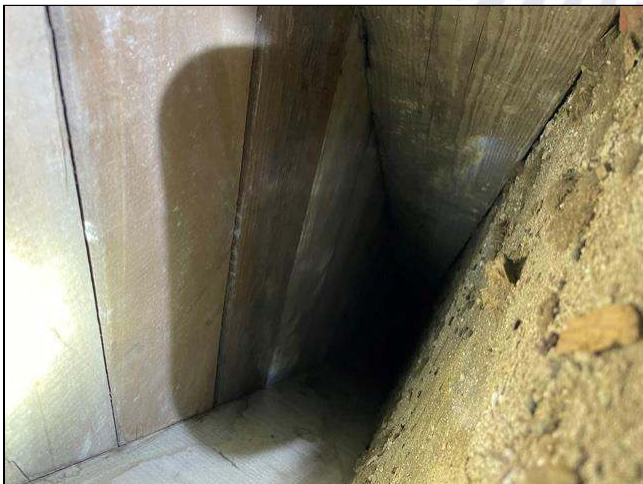
9.2 Item 1(Picture)

9.2 Repair: There are some areas of vermin feces and debris seen in the crawl space, This was seen on some of the HVAC trunk line, inside old plenum material and some on top of the plastic vapor barrier. This material should be cleaned out/ removed and then vermin prevention should be installed. It is recommended a licensed pest control company assess this issue and handle repairs as necessary.

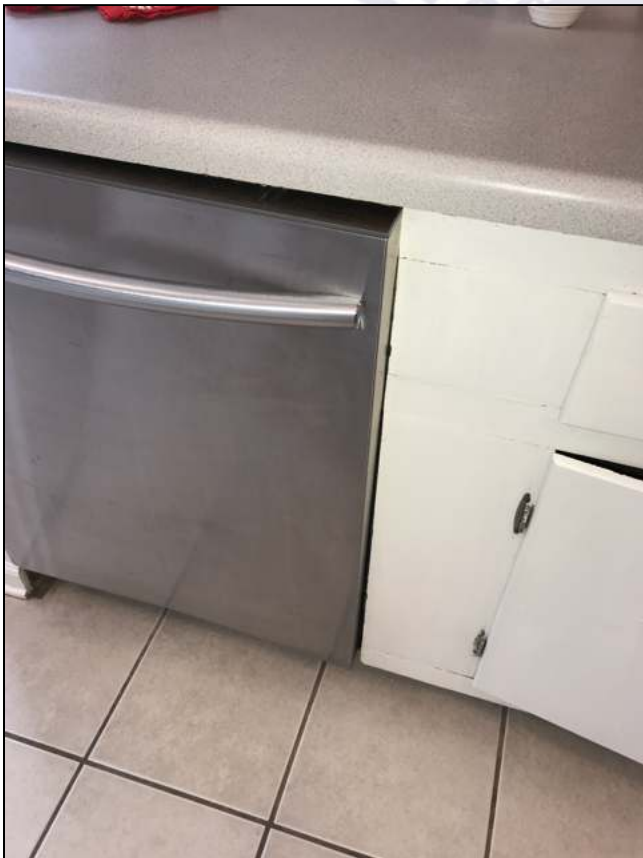
10.0 Item 1(Picture)

10.0 Repair: Dishwasher door is not fitting in the opening properly/closing properly, unit is hitting the cabinet on the right side. The door has to be lifted/twisted so it will close, this should be assessed and repaired by a licensed technician.

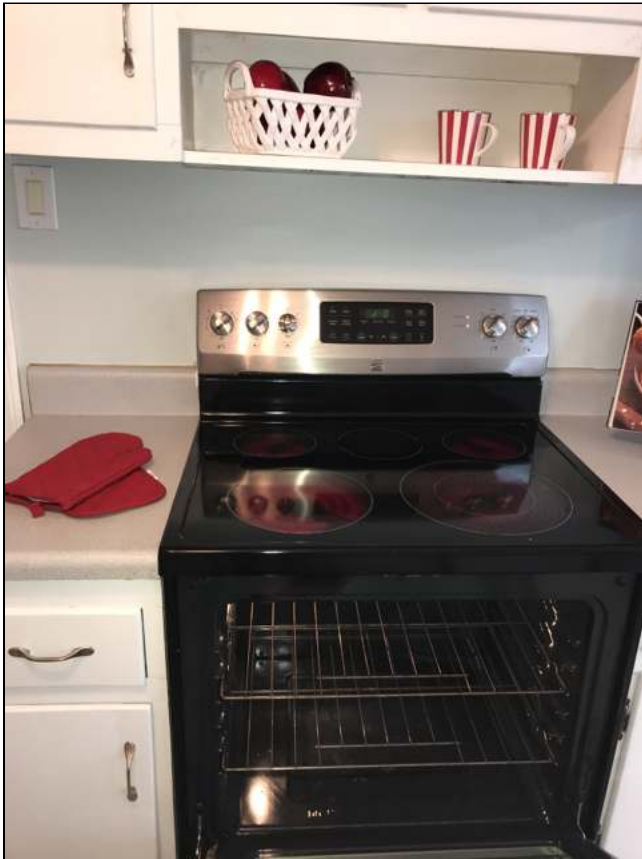
10.2 Item 1(Picture)

10.2 Improve: To help with removing heat in and around the range and to protect cabinets above the range, it is highly recommended you consider the installation of a hood or a microwave hood unit.

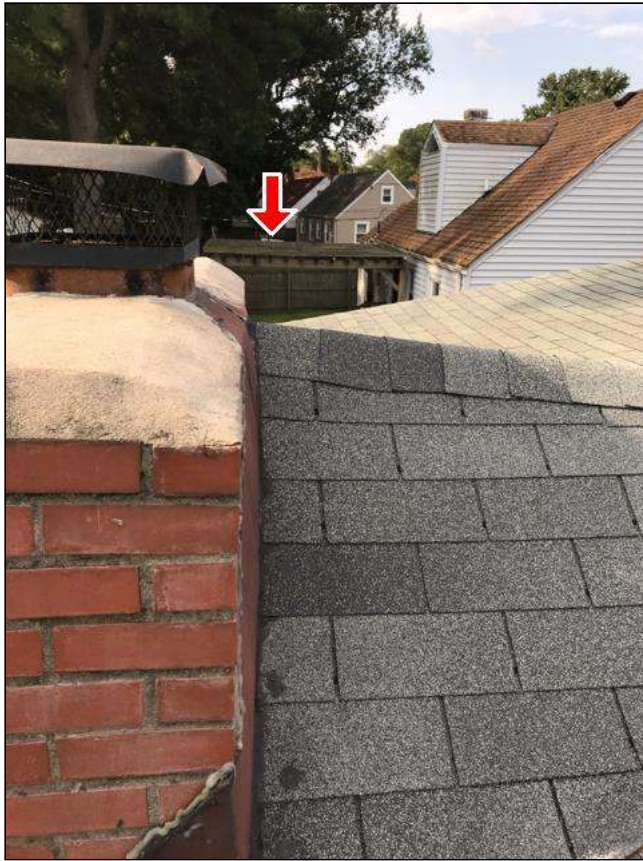
1.0 Item 1(Picture)

(1) Repair: The cricket for the rear chimney has some non standard conditions as it runs up to the top of the chimney crown, this upward angle means that water that gets on top of the cricket will flow back against the direction of the ridge shingles/shingles. There are gaps and openings at the flashings and multiple lines of caulking which are indicative of previous issues. It would be wise to have a licensed roofer assess this area and if necessary repairs should be made as necessary.

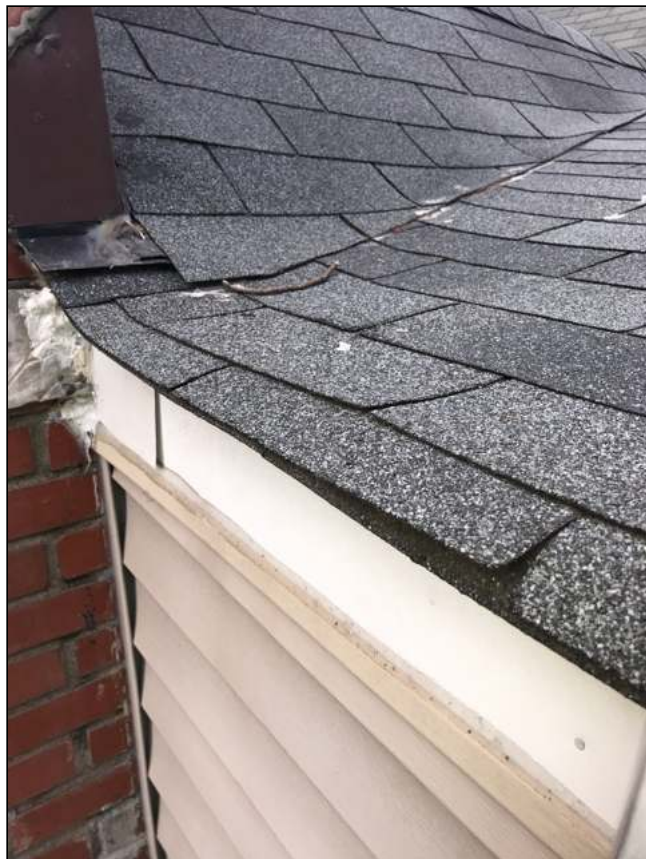
1.0 Item 5(Picture)

(2) Monitor: There are some very low slope/flat areas of the shingle roofing system that are vulnerable to water

infiltration due to a lack of slope. This is primarily seen close to the edges of the roofing system near the rear chimney system. Please be aware of the possibility for an increased level of maintenance in these areas and an increased potential for water infiltration.

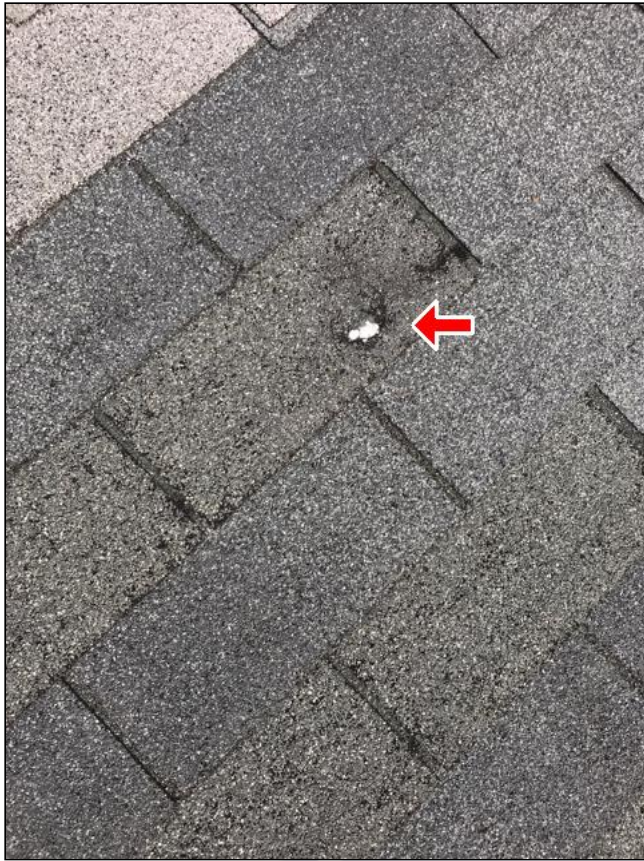
1.0 Item 6(Picture)

(4) Repair: The following shingle/roofing repairs are needed by a licensed roofer at the main house roofing system: hole in the shingle back of the house near the second-floor window, nail pops/damaged shingles need repair, exposed nail heads at the rear chimney/cricket need to be sealed, damaged shingles from old diverter flashing back of the house need repair/replacement.

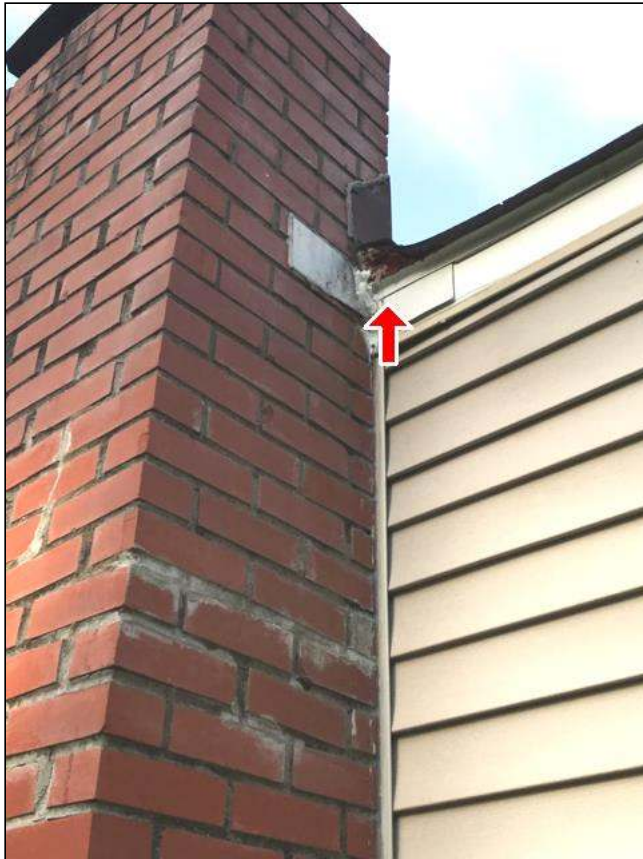
1.1 Item 2(Picture)

(2) Repair: A couple different types of foam have been installed at the flashings adjacent to the rear lower chimney system. This is not ideal nor recommended as this is considered a temporary repair and is not standard for this particular application. It is recommended you consider having a licensed roofer assess and permanent/ standard repairs be made in this area.

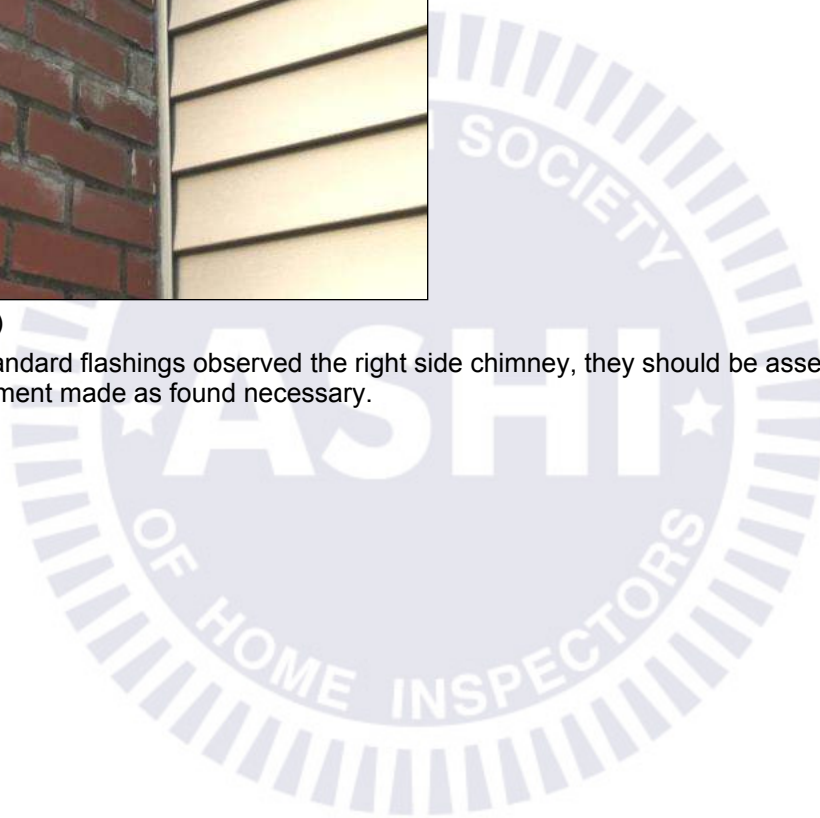
1.1 Item 3(Picture)

(3) Repair: Non-standard flashings observed the right side chimney, they should be assessed by a licensed roofer and repair/replacement made as found necessary.

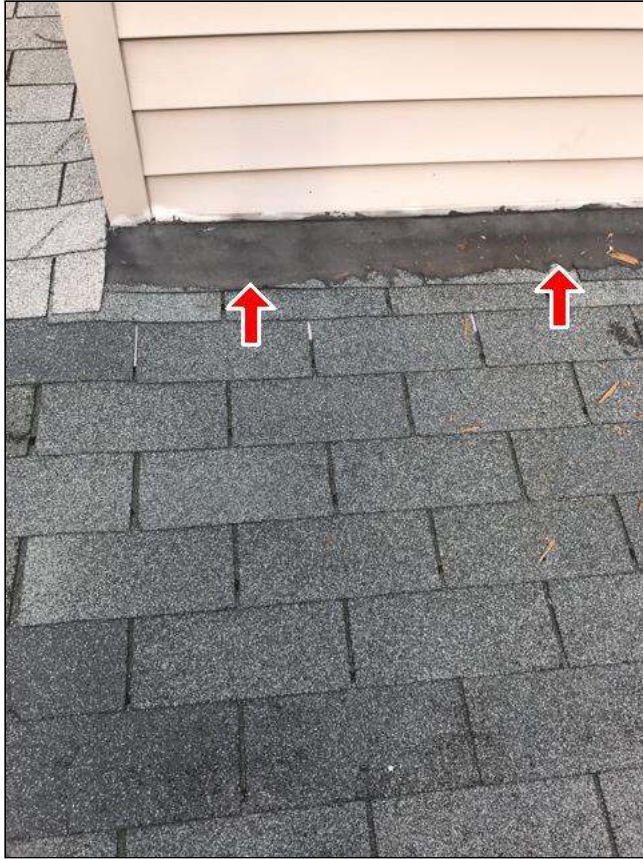
1.1 Item 4(Picture)

(4) Monitor: Flashing integration between the second-floor addition and the lower roofing at the back of the house has had a large amount of sealant installed in this area. This is not standard and is typically an indicator of a previous issue. Inspector could not see what is below this, is there flashing? Please be aware of this issue

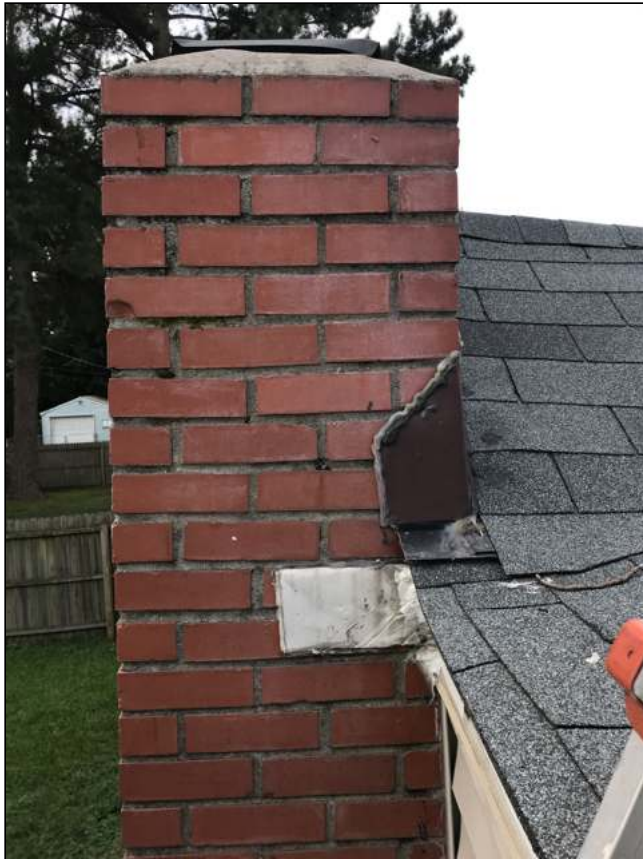
1.2 Item 1(Picture)

(1) Monitor: The upper 1/3 of the chimney is leaning towards the house noticeably, one side has some cracking and it also appears that some repairs were made to some mortar and brick at this chimney as well. Chimney appears to be functional based on exterior visual assessment, but this is something to be aware of and monitor and it is highly recommended you have the interior of the chimney inspected to make sure this movement has not damaged the flue.

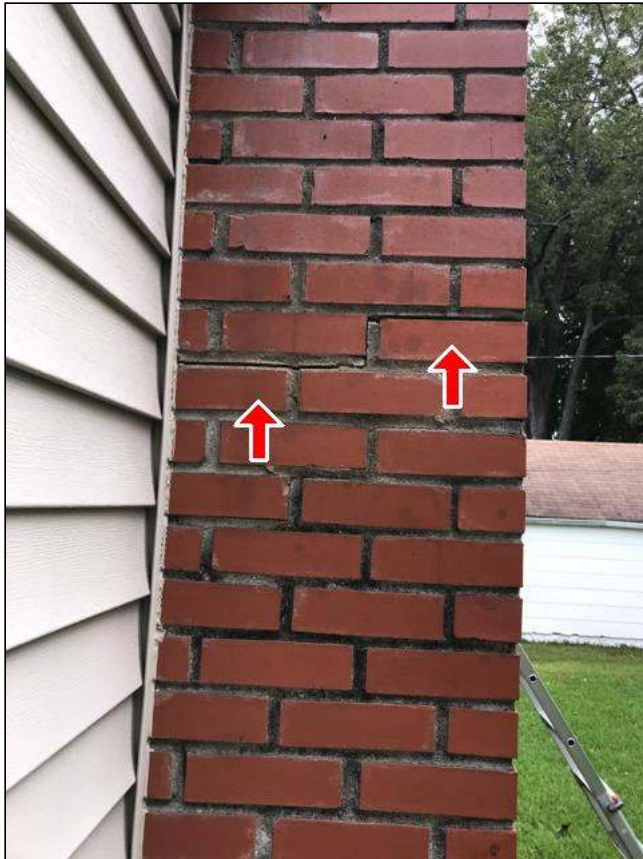
1.2 Item 5(Picture)

(3) Repair: Cracking in the chimney chase, back of the house, needs repaired by licensed mason. It is recommended while this is being assessed you have the mason determine whether or not other repairs are needed to the structure of this in order to keep the cracking/ movement from occurring further.

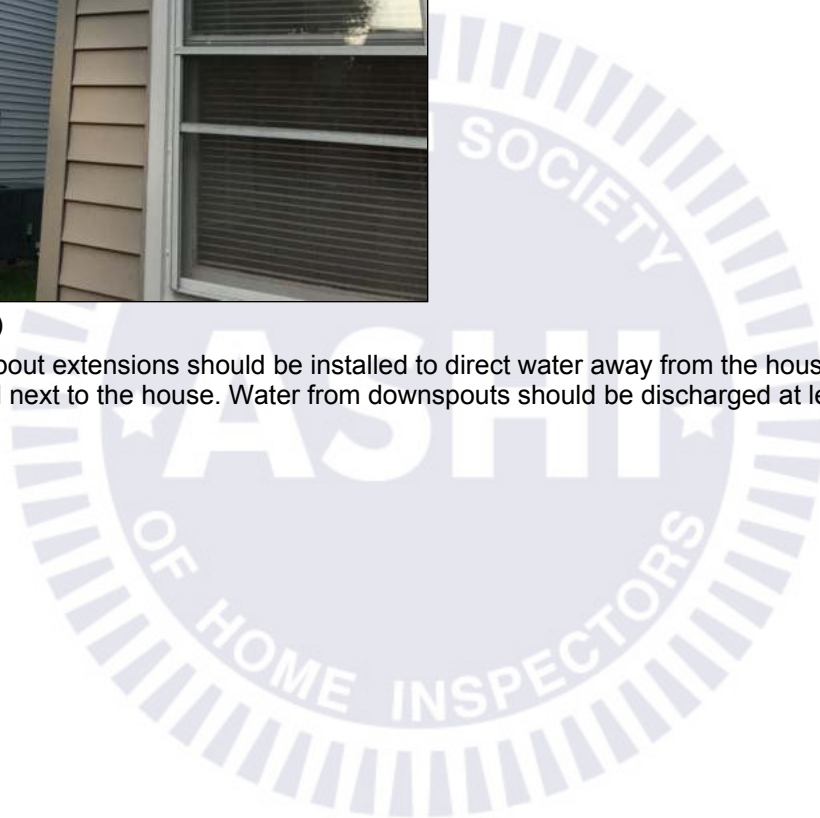
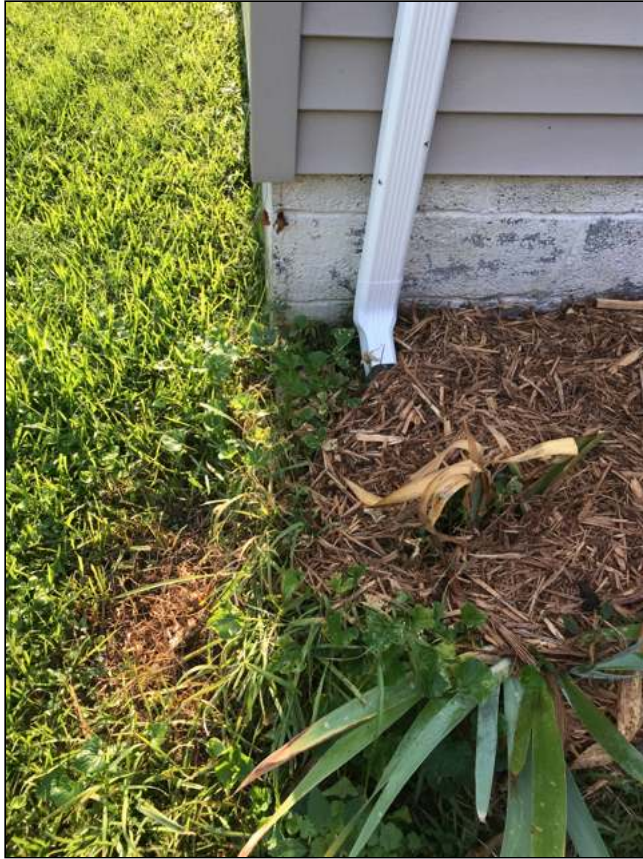
1.3 Item 2(Picture)

(2) Repair: Downspout extensions should be installed to direct water away from the house and keep moisture from collecting near and next to the house. Water from downspouts should be discharged at least 5 feet away from the house.

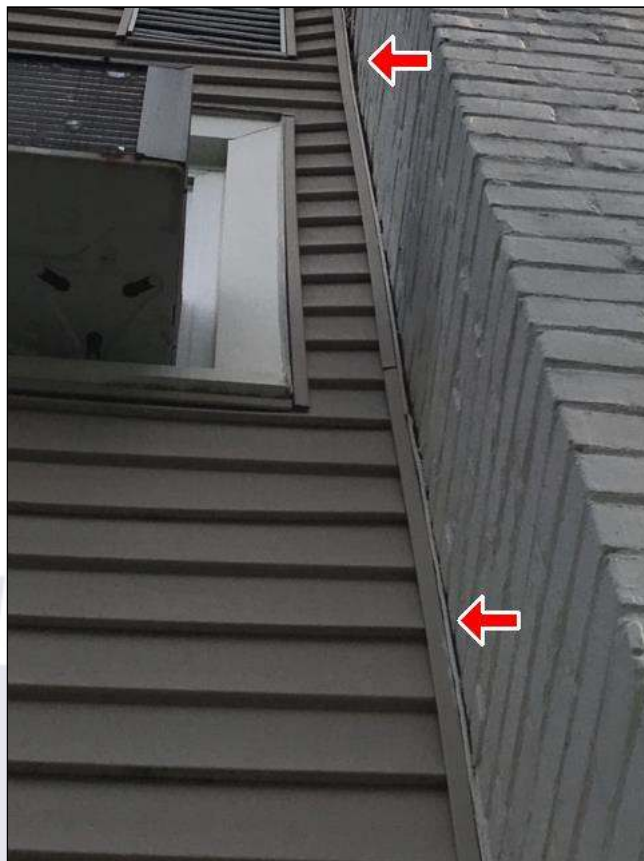
2.0 Item 2(Picture)

(1) Repair: Gaps/openings between the chimney chase and the vinyl siding on the right side of the house need to be caulked/sealed.

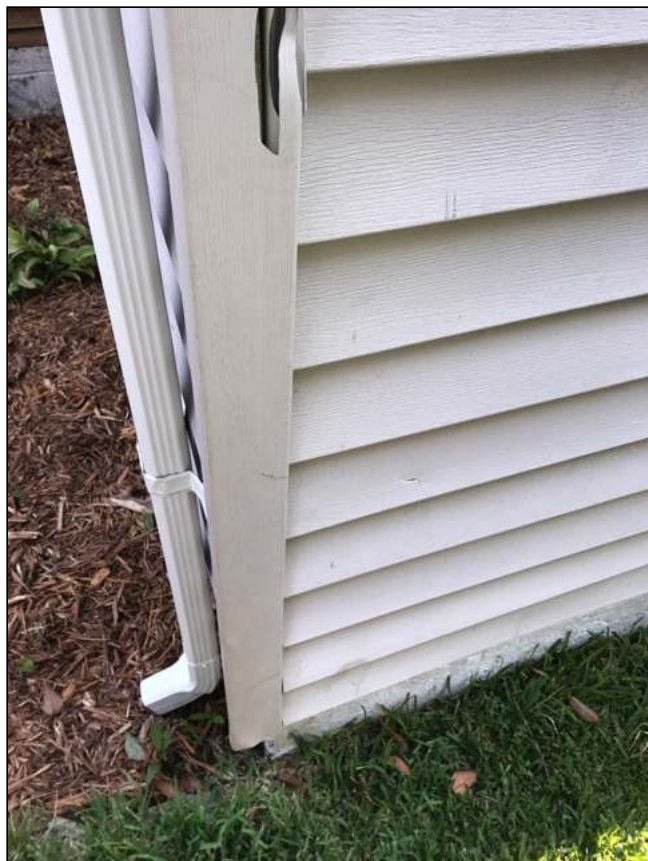
2.0 Item 3(Picture)

(2) Repair: Damaged siding needs to be assessed and repaired/ replaced by licensed siding professional or licensed contractor. This was observed: right side of the house, front right corner of the house.

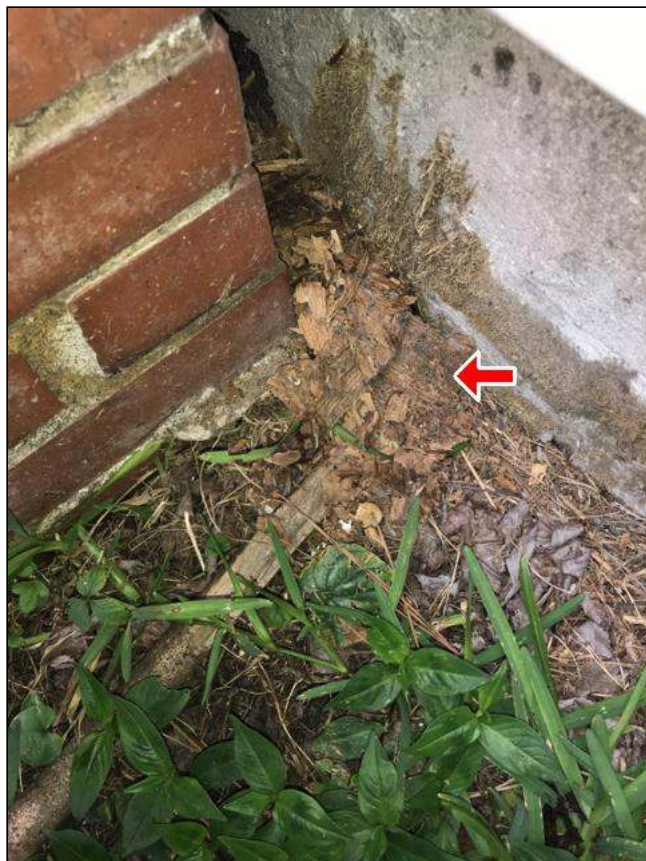
2.0 Item 5(Picture)

(4) Repair: When the back door was closed, some damage materials fell from behind the siding to the left and right of the back door. Upon further inspection it feels as if the sheathing or material behind the siding may be damaged in some areas, would have this further assessed by a licensed contractor and repair/replacement made as found necessary.

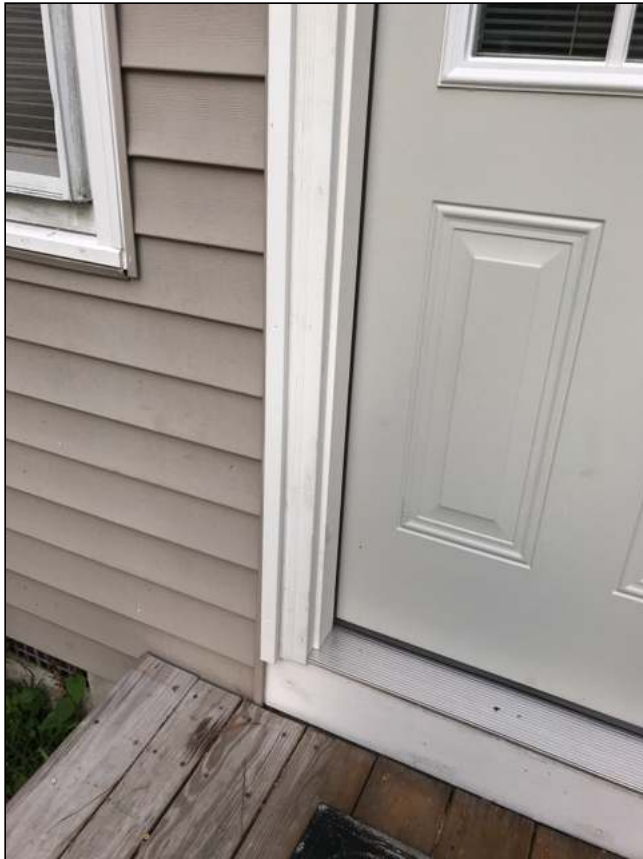
2.1 Item 1(Picture)

Repair: it does not appear that the rear exterior door has been painted with an exterior grade paint and there are some gaps and openings at the trim that should be caulked/sealed. To help preserve and protect the door as recommended these areas be caulked and painted

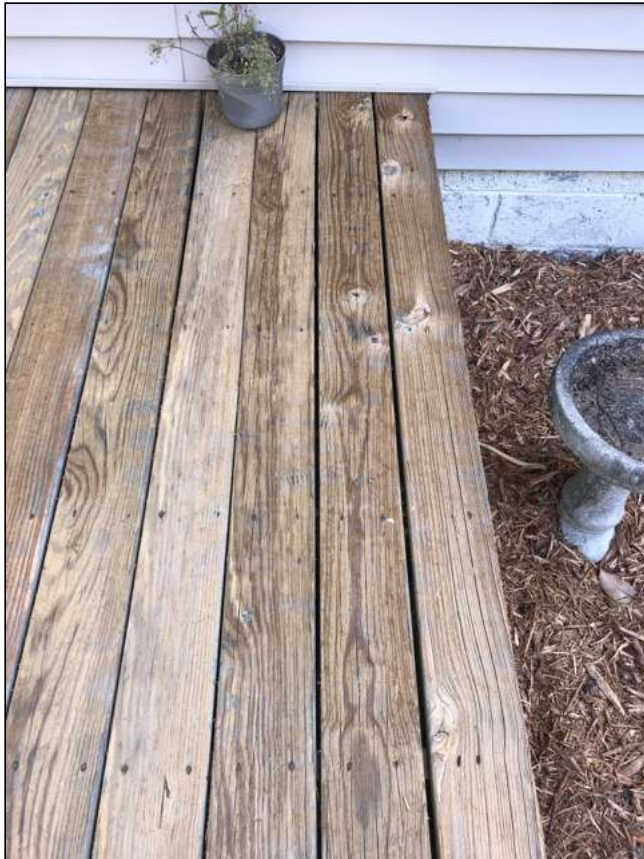
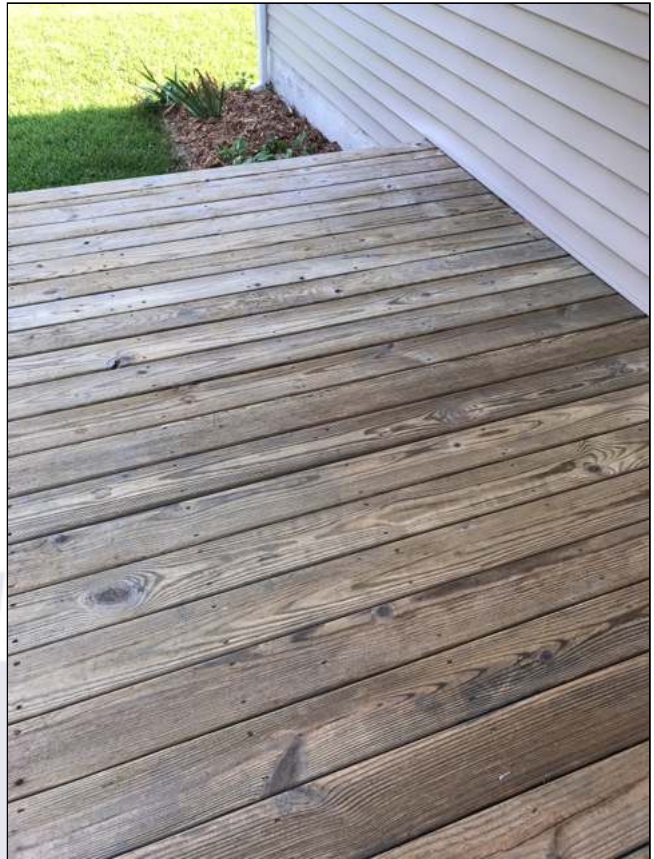
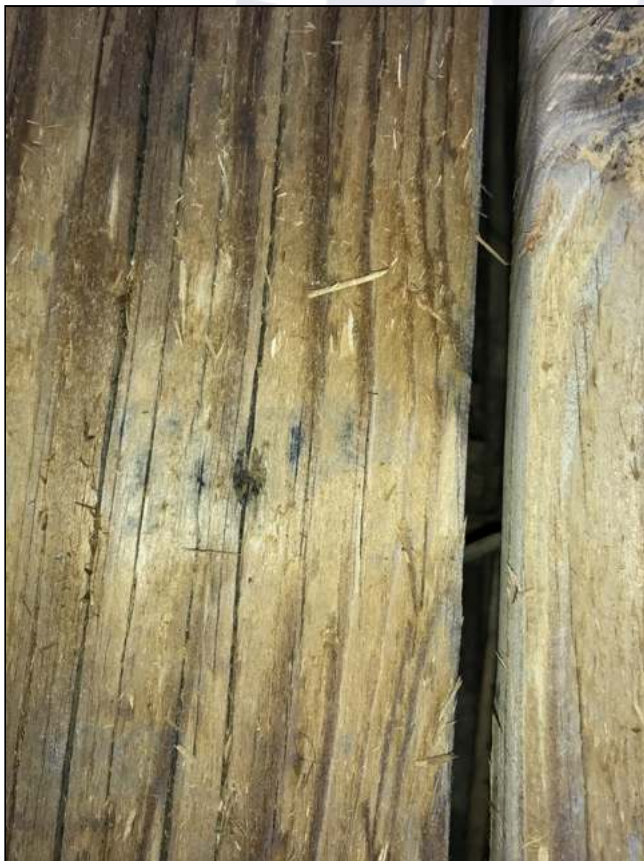
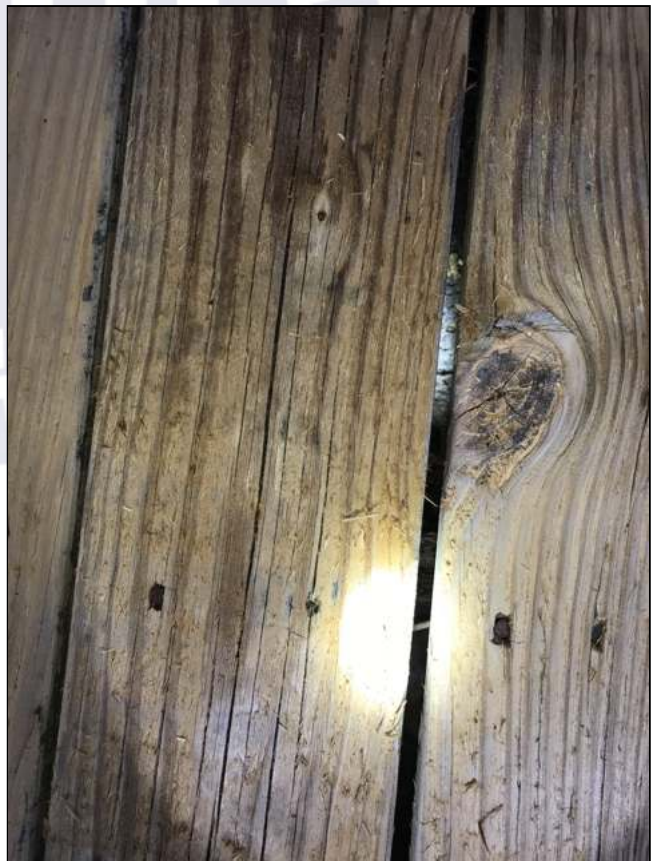
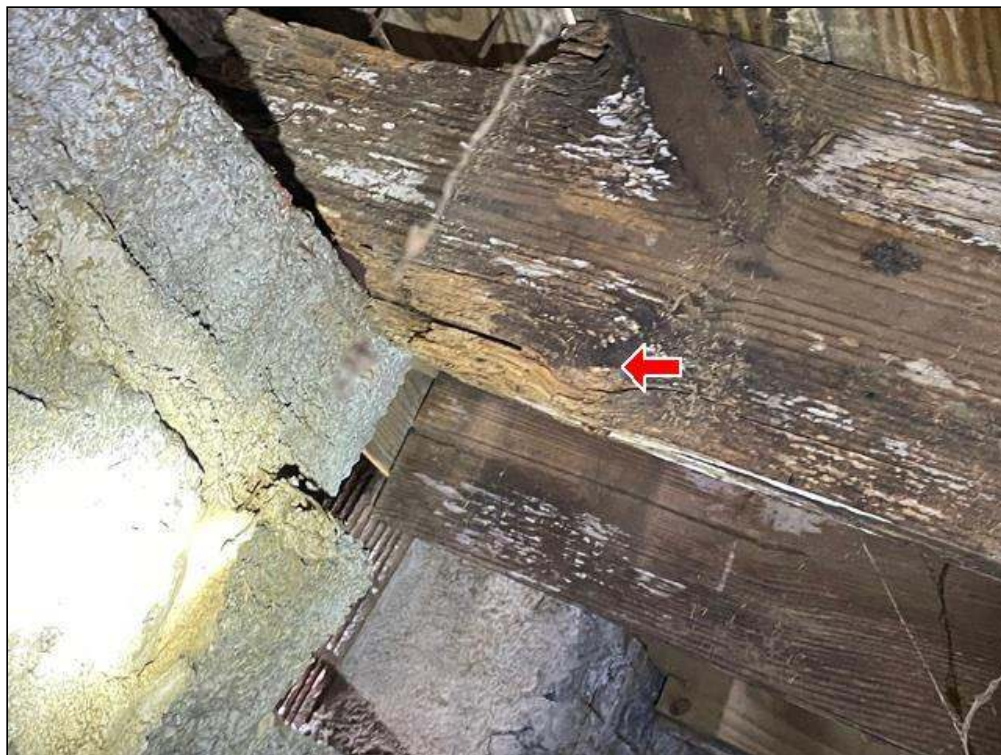
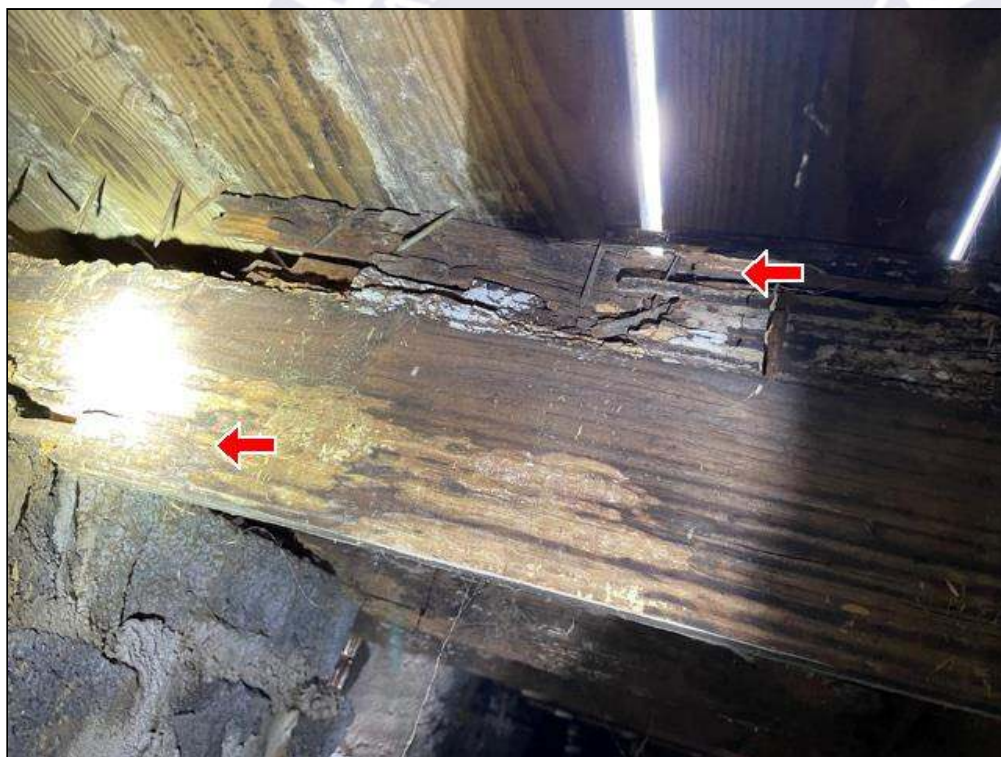
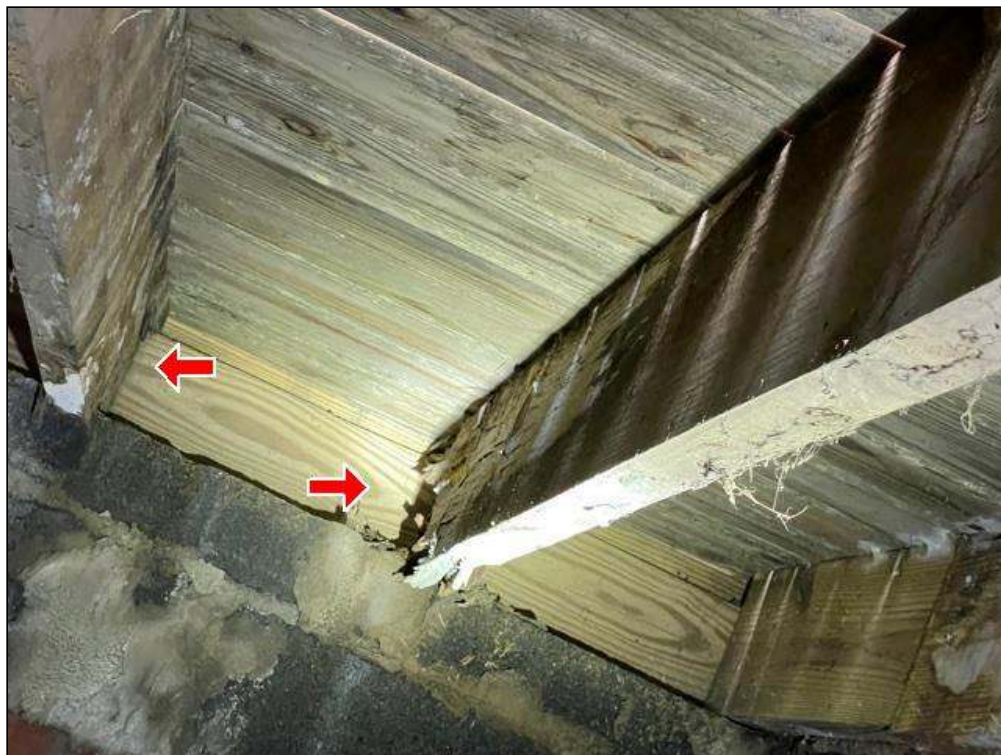
(1) Repair: There are several soft/deflecting deck boards observed on the left and right sides of the decking system. Inspection from the crawl space found that the numerous floor joists below the front porch are rotted/ deteriorated. This was seen on the left and right sides of the porch, these need assessment and repair/ replacement by a licensed contractor.

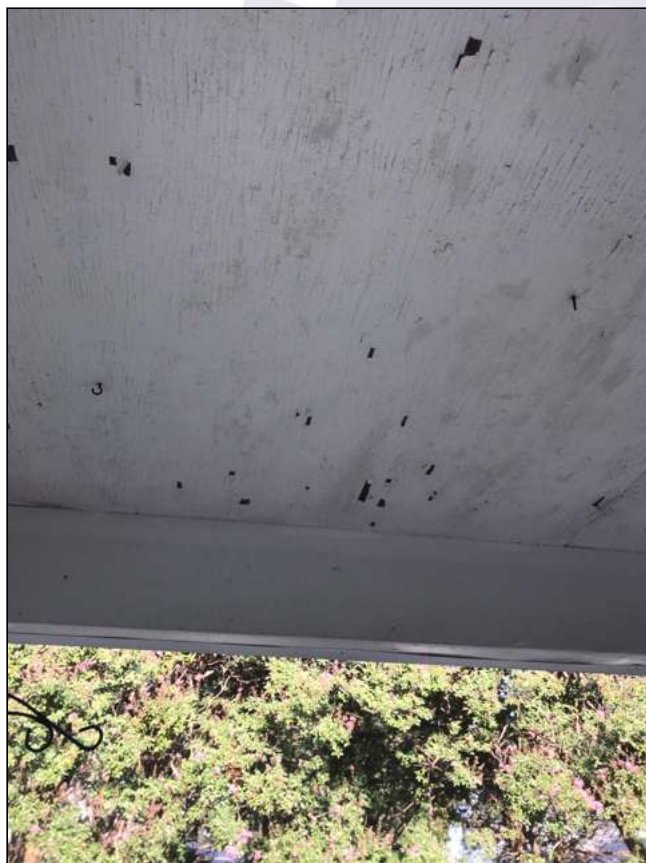
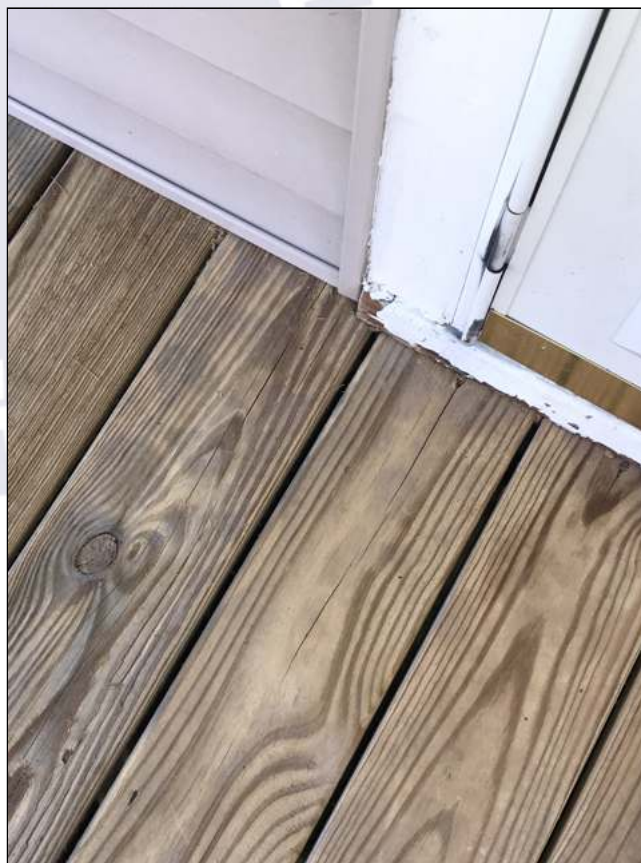
(2) Repair: Front porch ceiling needs to be scraped and painted, threshold for the front door the front porch needs to be scraped and painted.

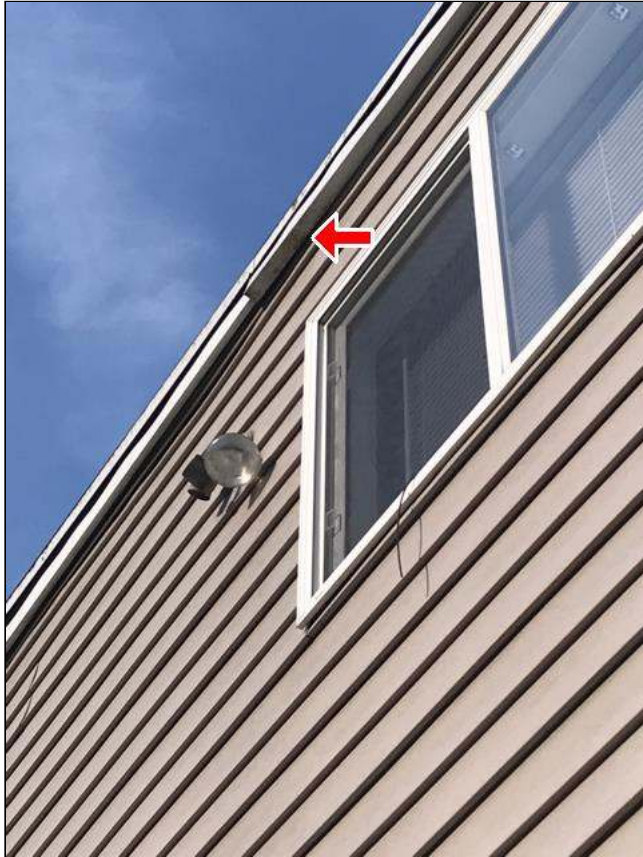
2.5 Item 1(Picture)

Repair: Loose flashing at the roof edge back left corner of the house needs repair by a qualified professional.

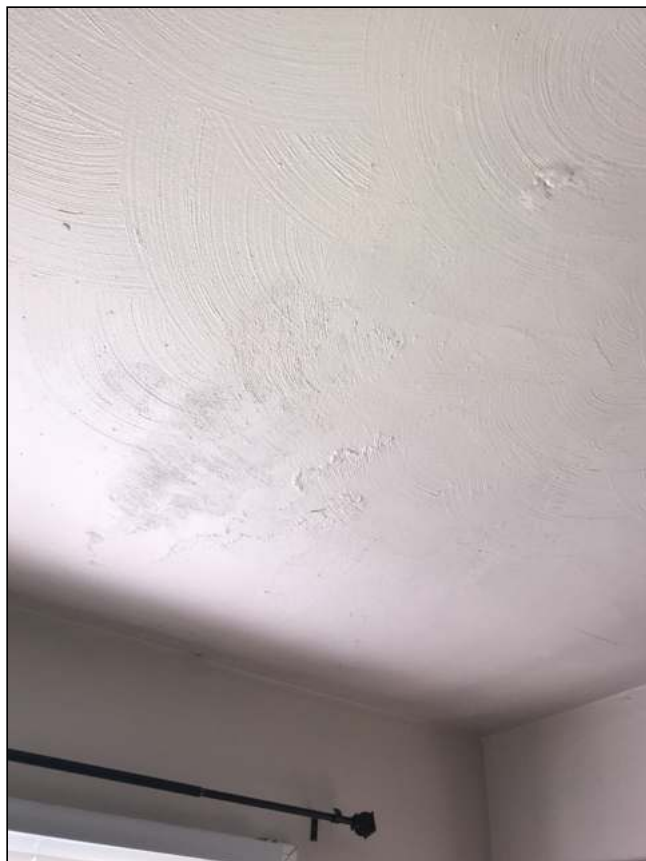
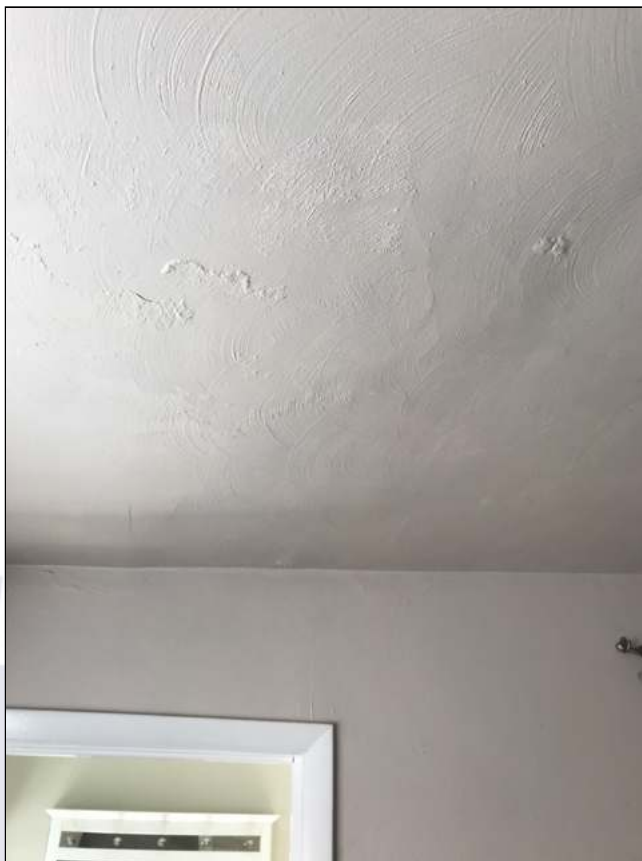
(1) Repair: Bubbling paint, bulging ceiling finish was observed at the ceiling of the back left second-floor bedroom. These are indicators that something has or may still be leaking. Would have the homeowner provide further information on this to determine if a professional repair has been made, if a professional repair has not been made then this could still be active and would need repair.
