COASTAL INSPECTION SERVICES LLC

Inspection Report

Sample Report - 04

Date: 9/8/2021	Time: 8:30am	Report ID: Sample Report -04
Property: Sample Report Norfolk VA 23505	Customer: Sample Report - 04	Real Estate Professional: Paul Farrell

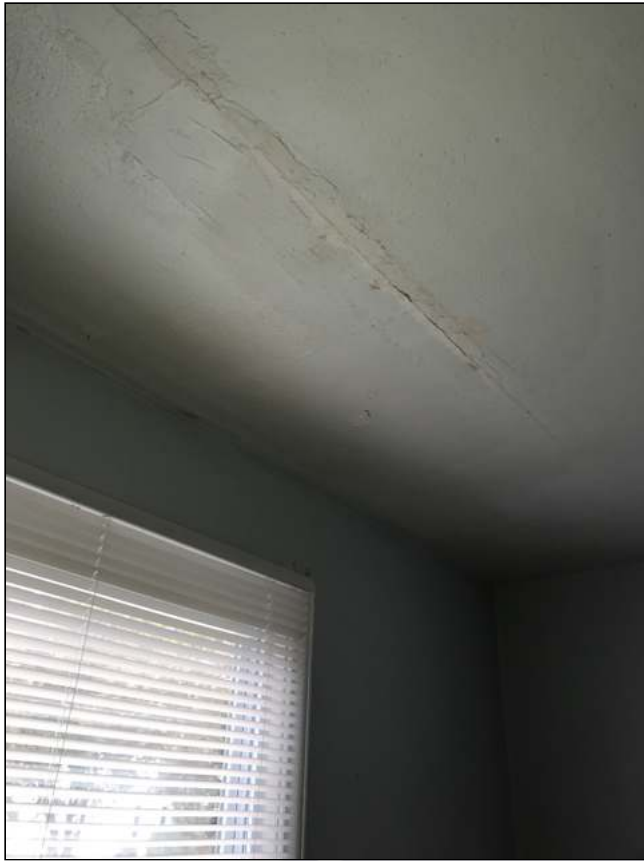
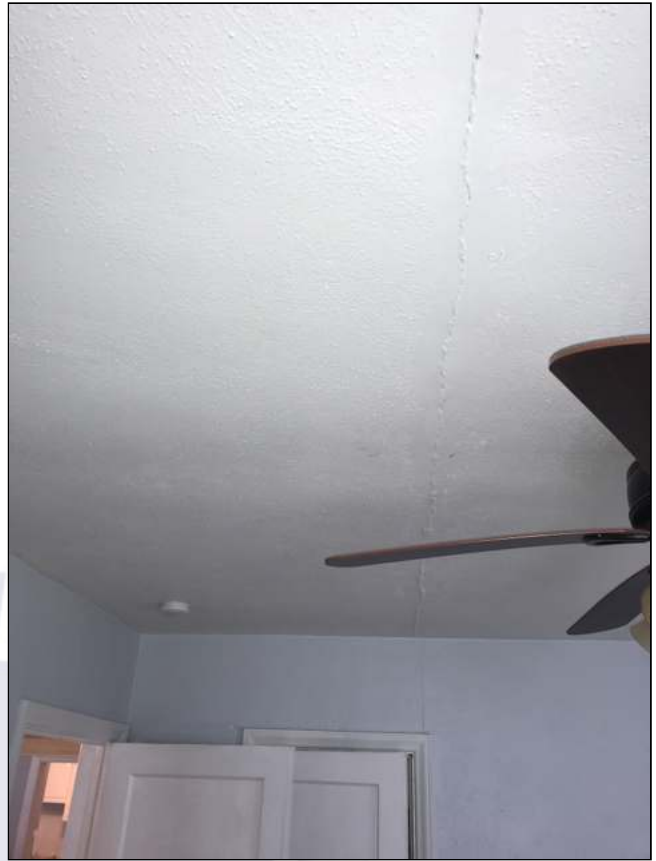
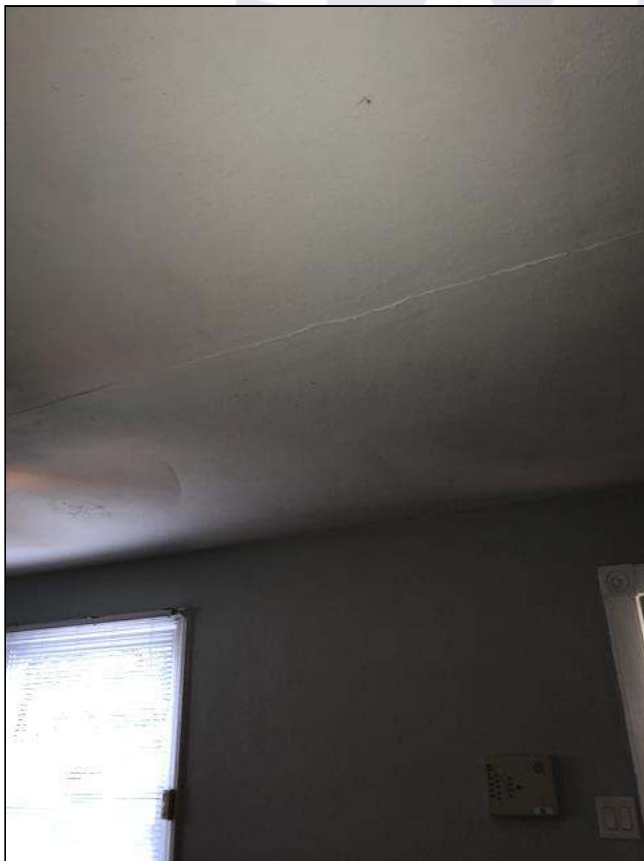
(2) Repair: There are some pronounced cracks observed in the ceiling of the first floor, primarily seen running from left to right in the front living room and the front first floor bedroom. Inspector could not access the structure above this as there is roofing and a finished second floor. Currently any loose ceiling finishes, as seen in the bedroom, should be repaired to keep this from worsening.

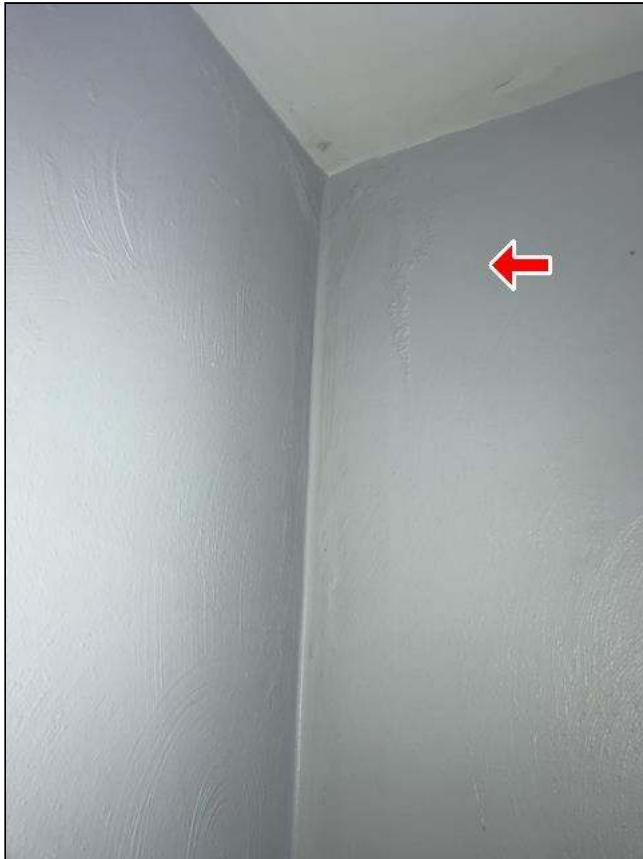
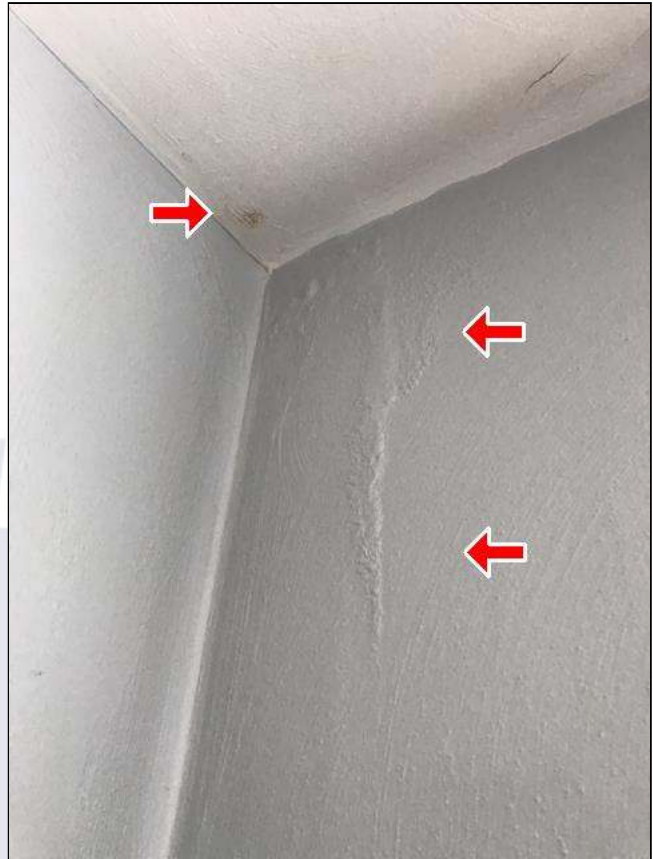
Further Assessment Recommended/Repair: Signs of possible moisture infiltration observed at the back wall of the first floor back left bedroom. Bubbling paint and slightly elevated moisture levels observed, they should be further assessed by a licensed contractor or a qualified professional and repairs made as found necessary.

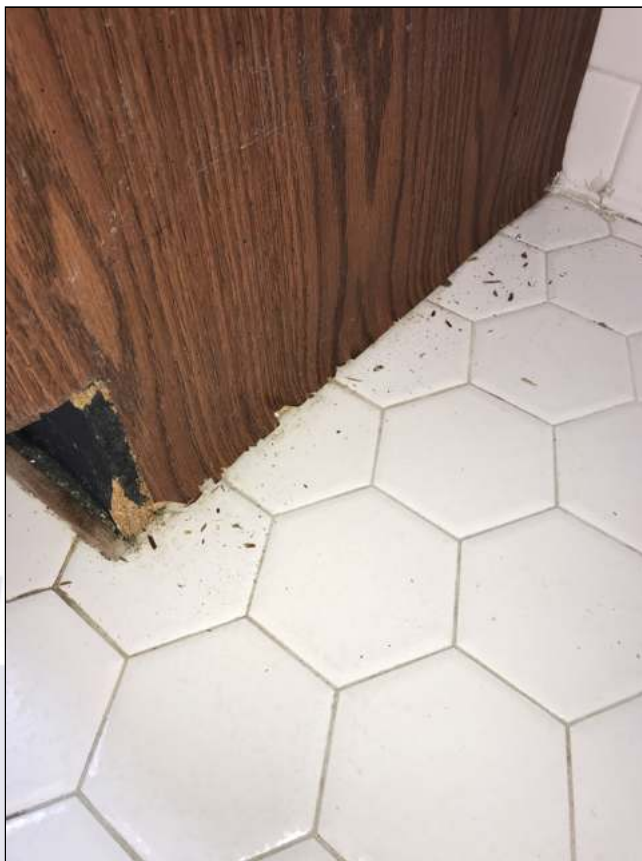
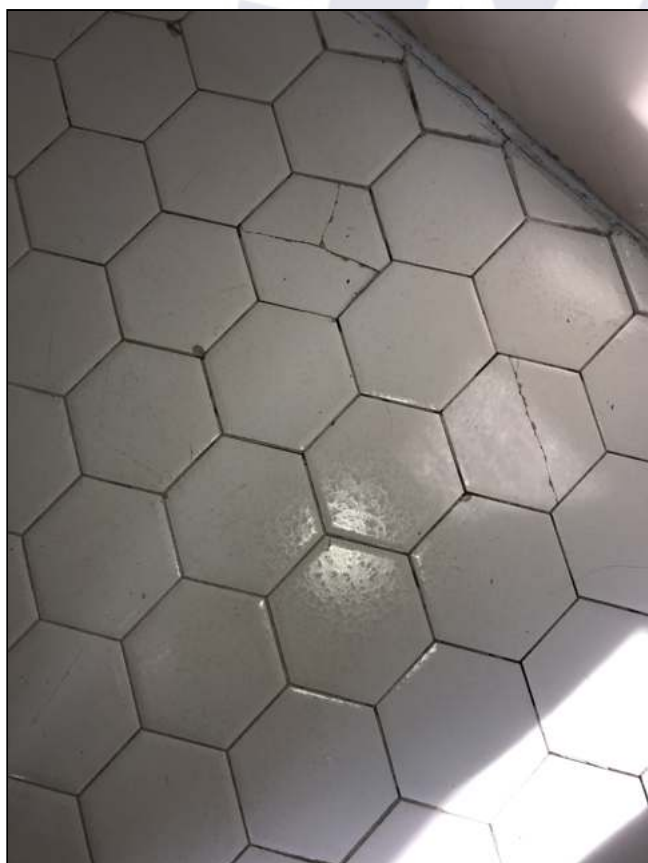
(1) Repair: Soft floor, cracked tile and water damaged cabinet observed in the second-floor bathroom are all indicators that something may have leaked. Tiles, grout, openings and moisture damaged materials should be assessed and repaired/ replaced by a licensed contractor.

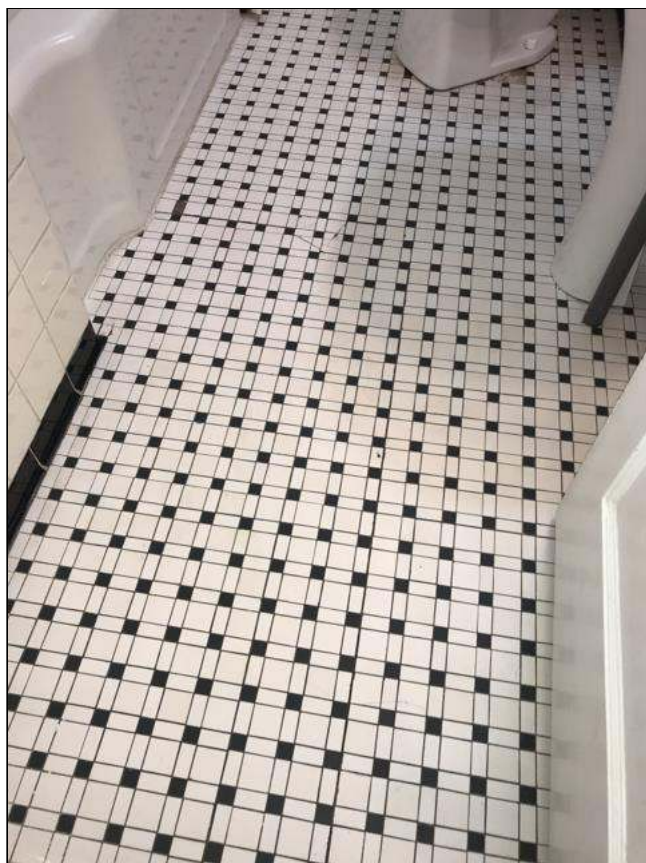
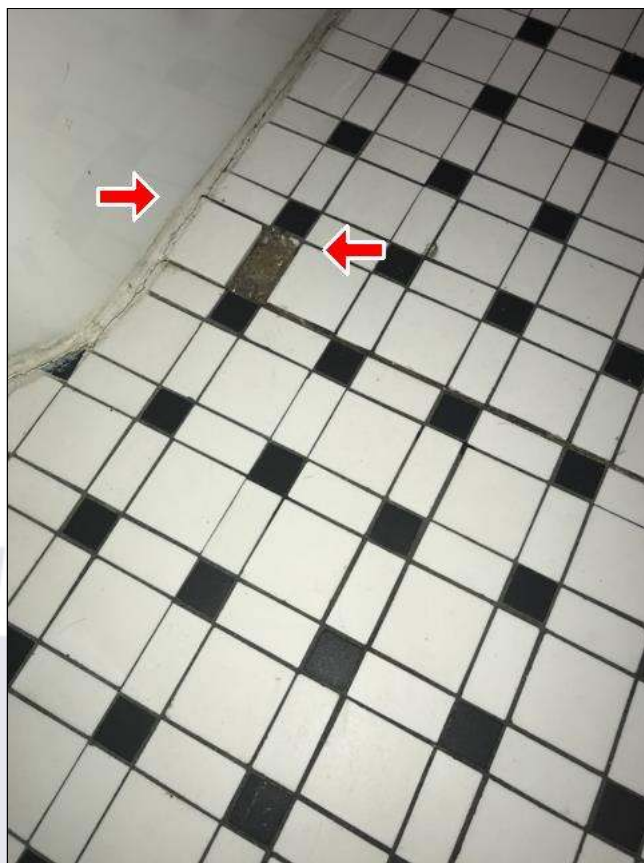
(2) Repair : There are some loose tiles, cracked tiles, damaged tiles and lifted tiles observed in the first floor

bathroom. Priority should be given to repairing the cracks/missing tile where water could enter.

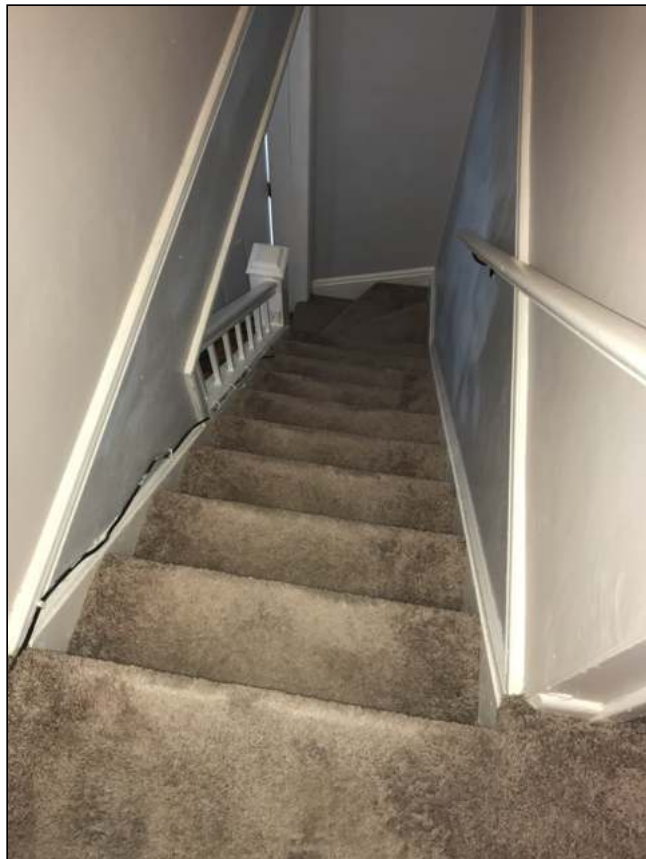
4.3 Item 1(Picture)

Repair: A proper railing should be installed at the stair system, lower railing is difficult to use and not standard. Even though this is an old house, railings should still be added for safety purposes.

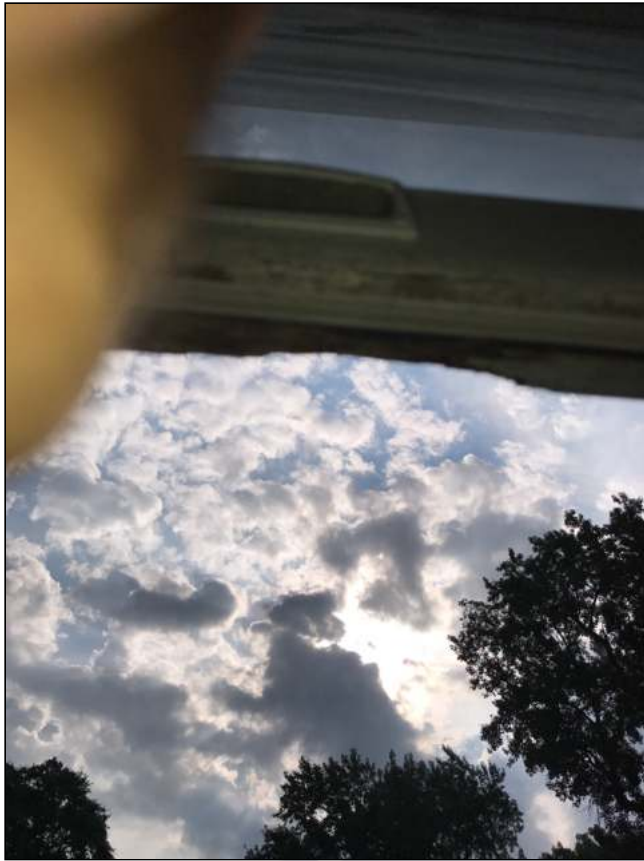
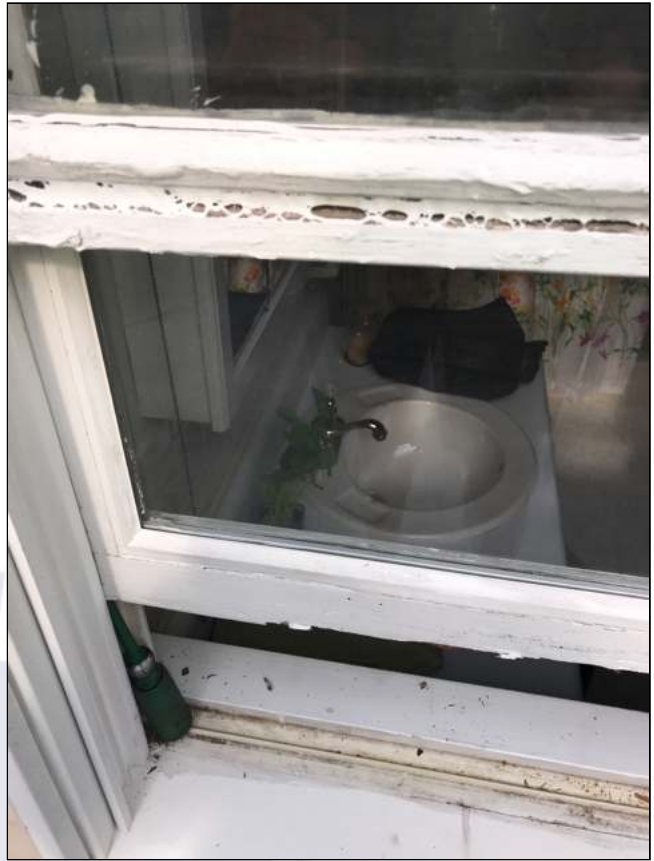
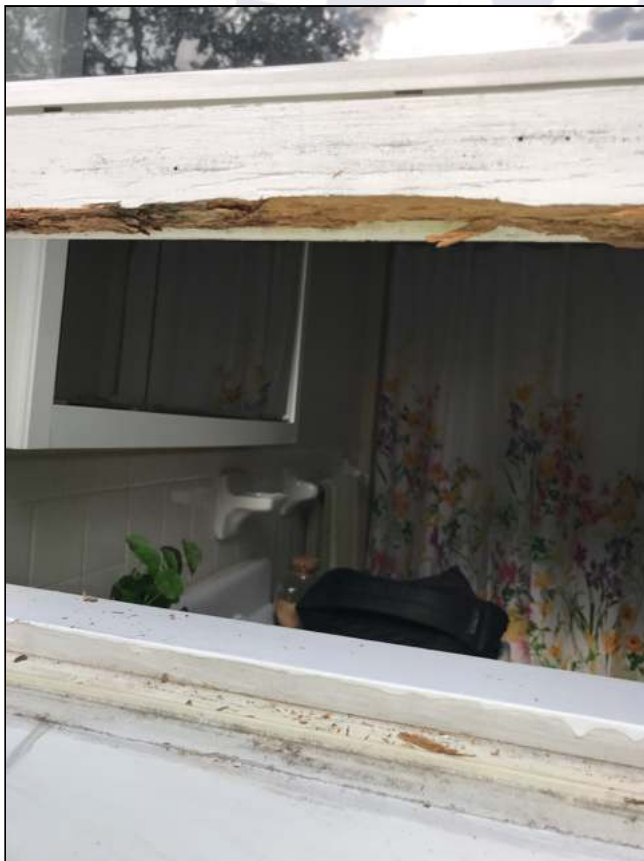
(1) Repair: Rear second-floor window adjacent to the bathroom is rotted/ moisture damaged and the window lifters are inoperative, this should be assessed and repaired/replaced by a licensed contractor. Please also note based on the amount of additional caulking this window appears to have had some previous issues.

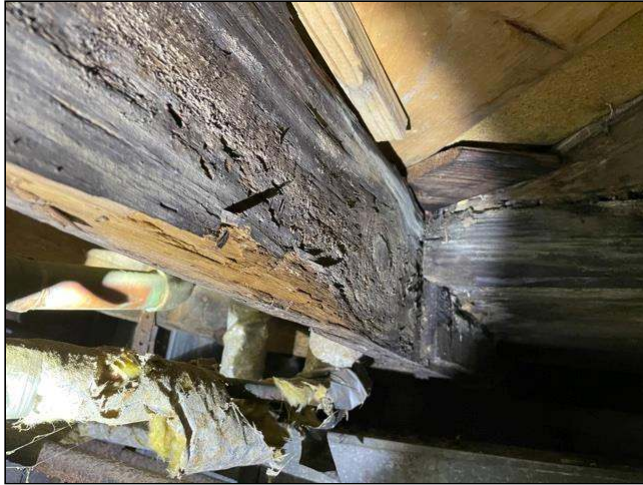
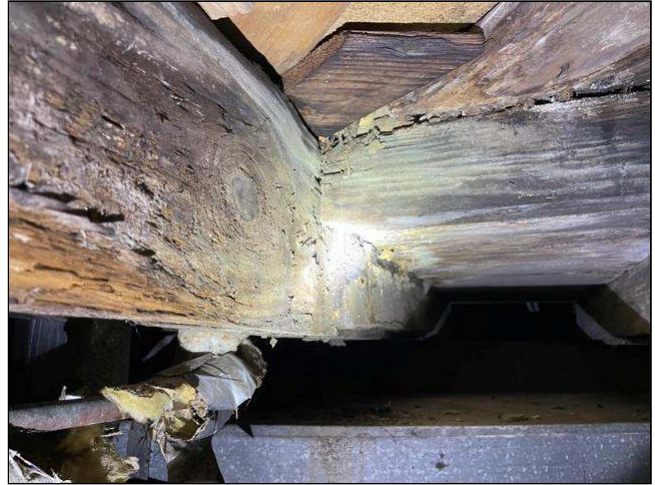
(2) Repair: Damaged floor joists and sub floor seen on the right side and right rear of the crawl space, these need further assessment by a licensed contractor and repair/ replacement made as found necessary.

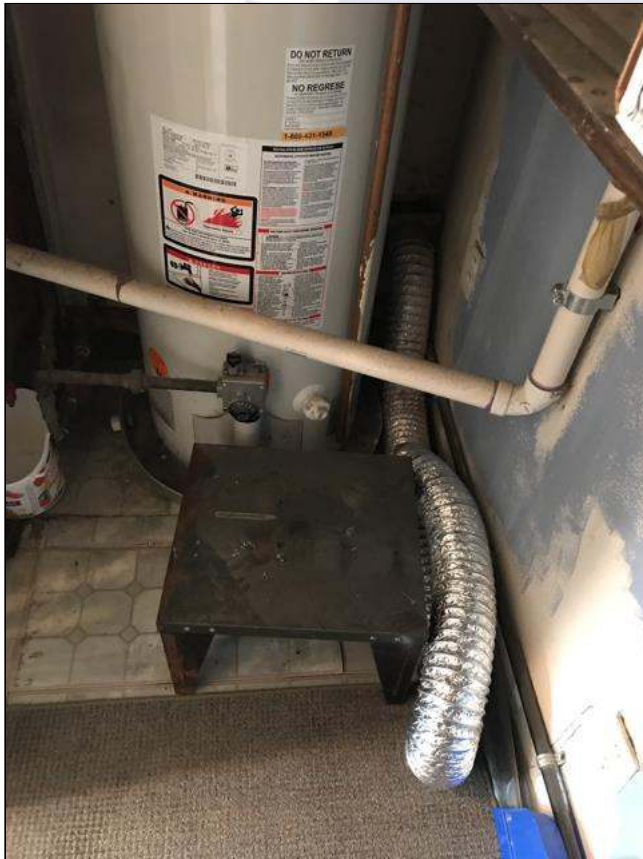
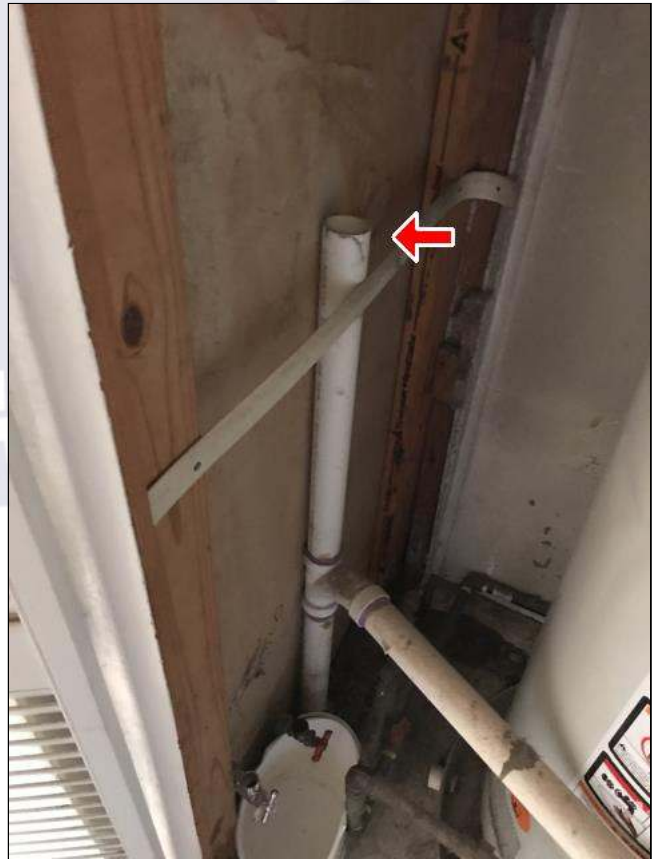
(1) Repair: Drain pipe adjacent to the water heater that appears to service the clothes washer is not properly vented and does not have an air admittance valve. It also does not appear that the drain line for the clothes washer has a trap installed. Would have this piping assessed by a licensed plumber and repair/replacement made as found necessary.

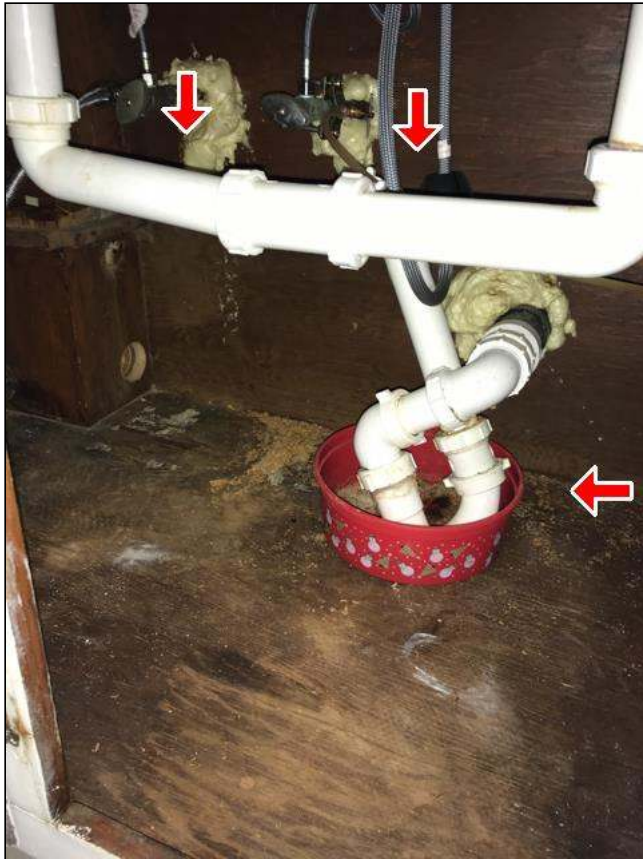
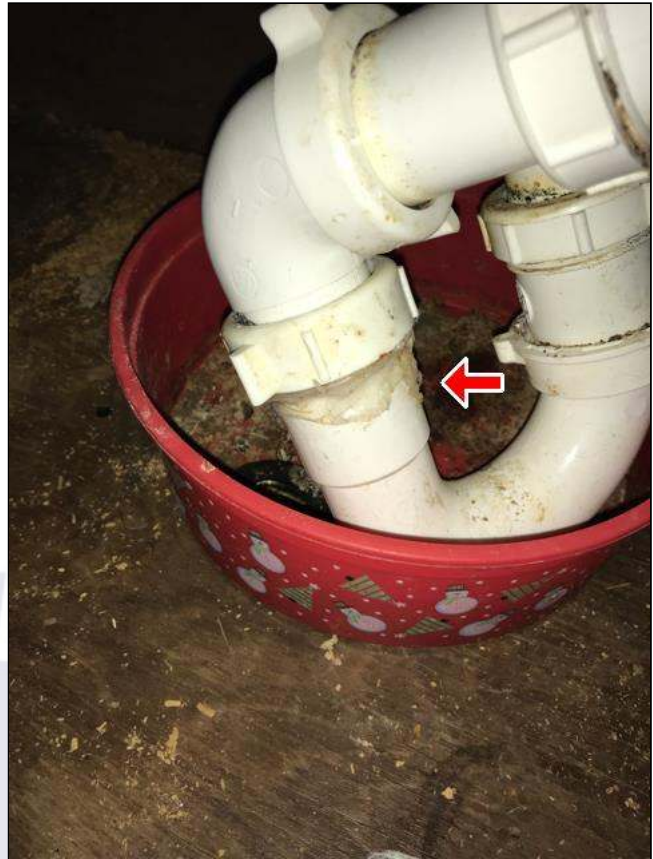
(2) Repair: Drain line trap under the kitchen sink is not standard/not installed properly. This should be assessed and repaired/replaced by a licensed plumber. Reworking of all of the sink drain lines appear to be needed as well (lots of caulk lines and based on presence of a bowl it appears to have had prior leaking issues).

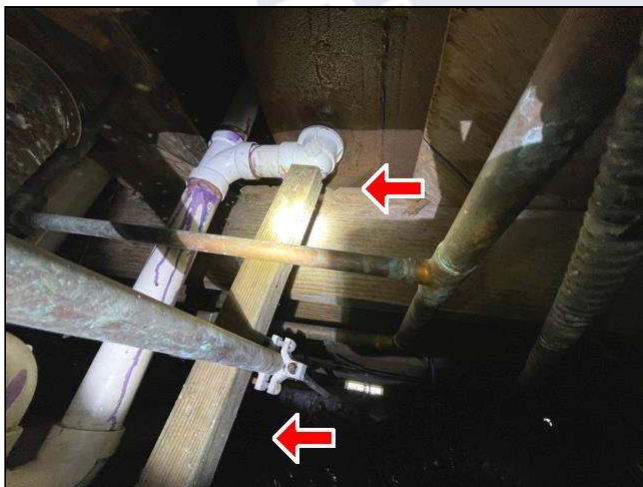
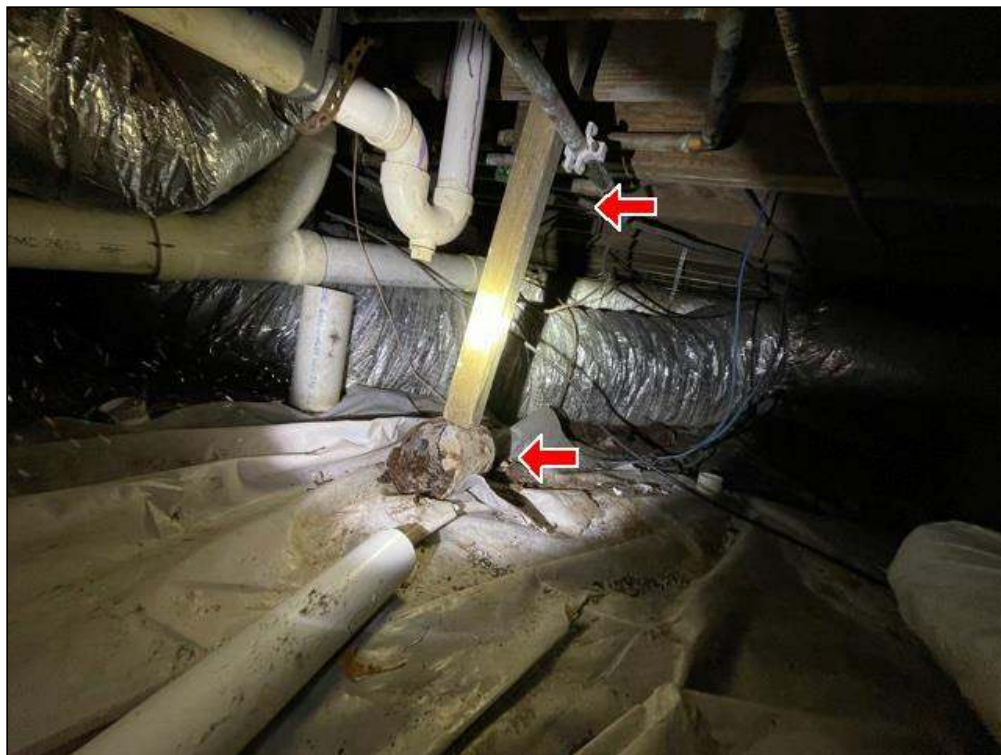
(4) Repair: The drain piping under the first floor bathroom is being held up by a piece of wood sitting on top of a cut pipe. This is not standard, recommend licensed plumber further assess and handle repair as found necessary.

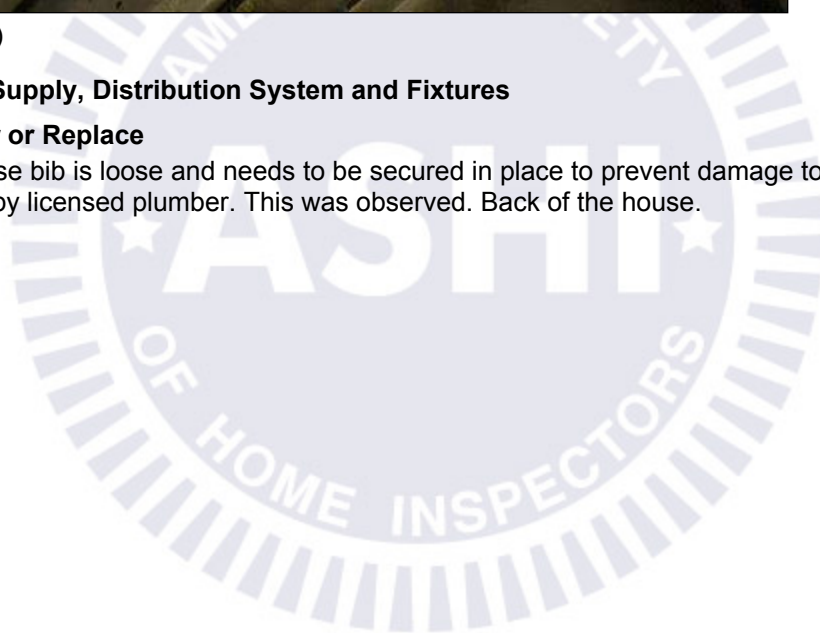
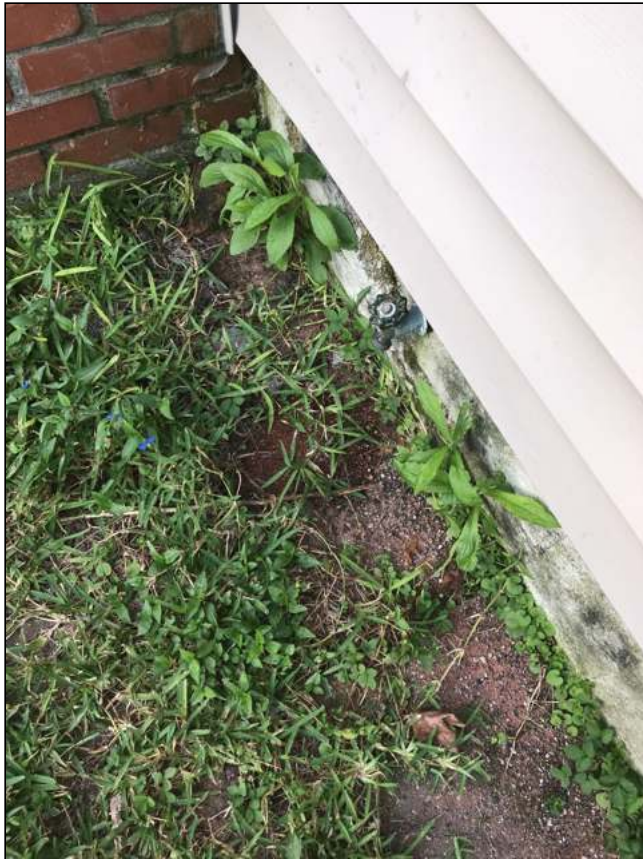
6.1 Item 1(Picture)

(1) Repair: The hose bib is loose and needs to be secured in place to prevent damage to to the piping or fixture. This needs repair by licensed plumber. This was observed. Back of the house.

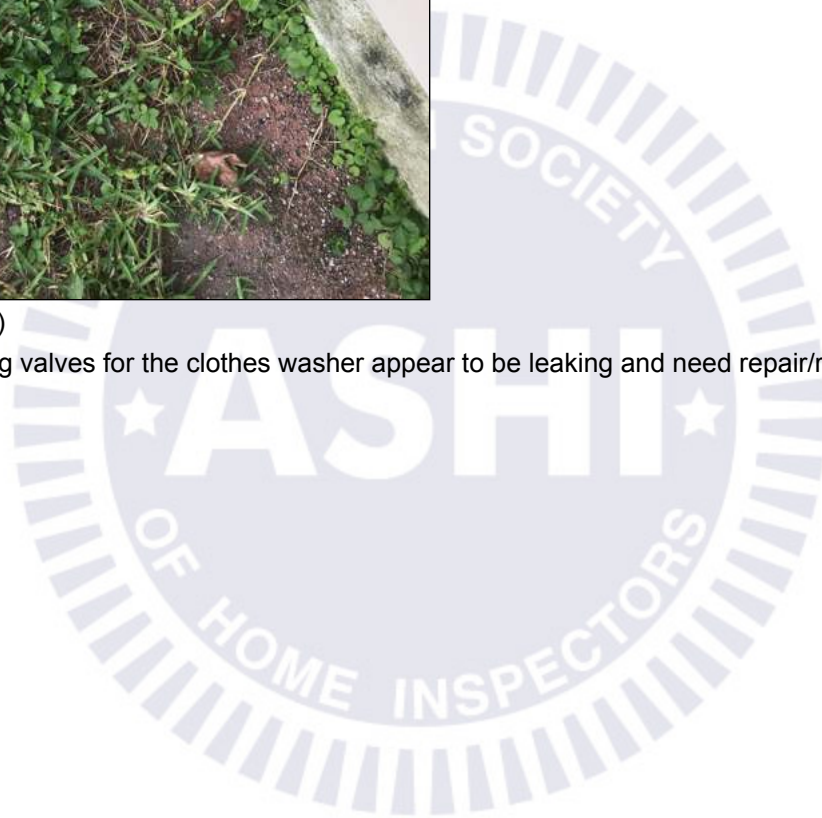
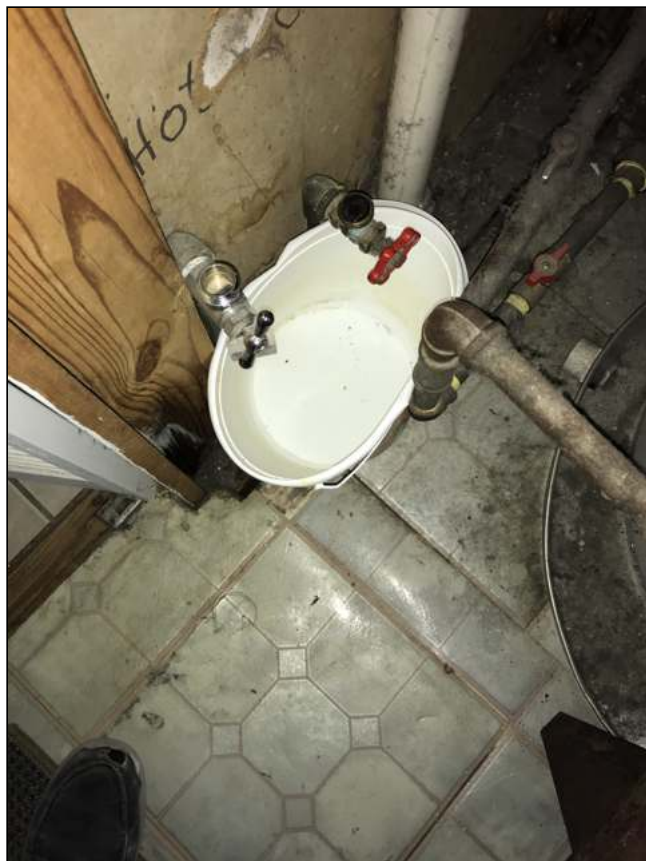
6.1 Item 2(Picture)

(2) Repair: Isolating valves for the clothes washer appear to be leaking and need repair/replacement by a licensed plumber.

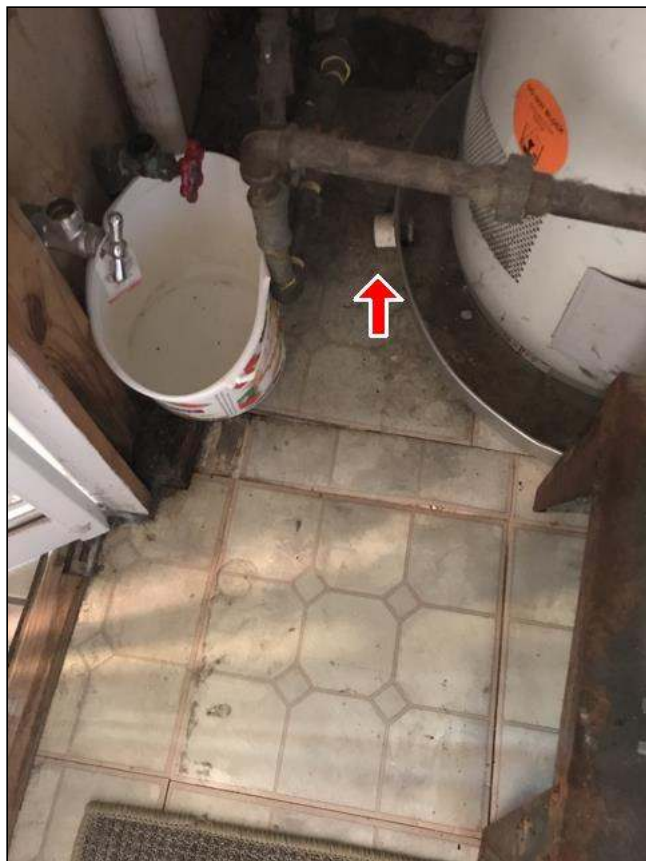
6.2 Item 1(Picture)

(1) Repair/ Concern: The water heater needs to have a pan with drain to exterior installed in order to catch and direct leaking to the exterior of the house. This needs repair by licensed plumber.

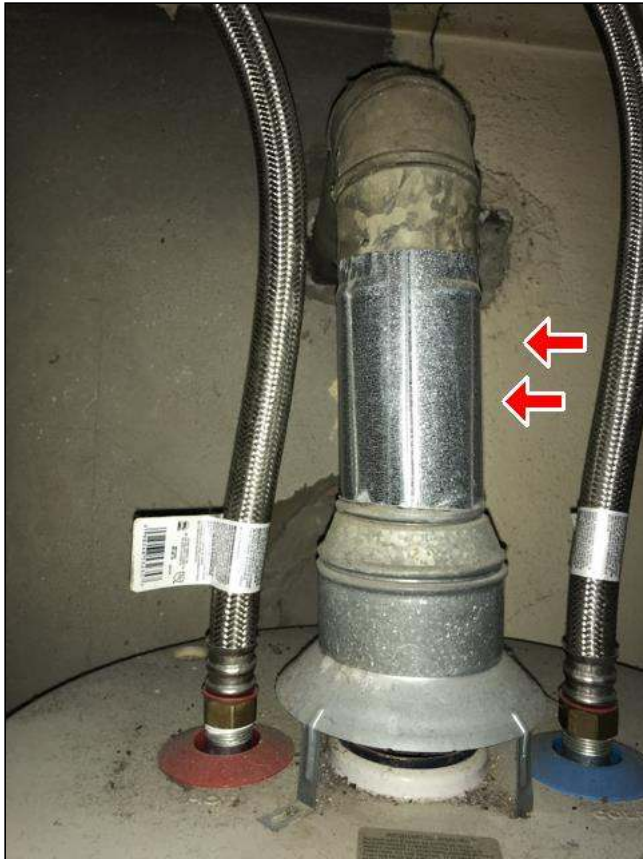
6.2 Item 2(Picture)

(2) Repair: The following repairs need to be assessed and handled by a licensed plumber for the water heater flue: there is a section of flue material that does not appear to be rated for this application and is not mechanically attached to the adjacent areas, gaps and openings around the flue penetration into the chimney need to be properly sealed as there appears to be spillage occurring.

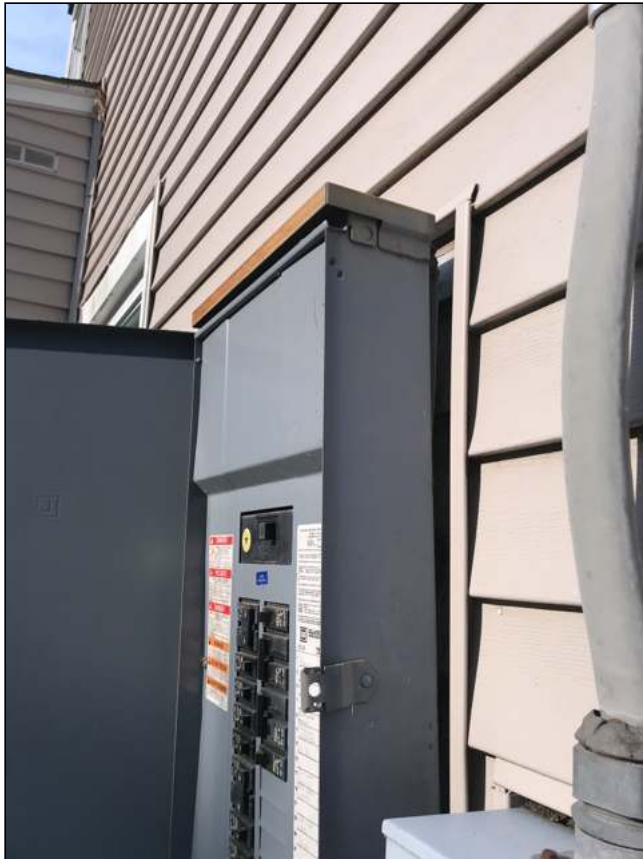
7.1 Item 1(Picture)

(1) Repair/ Concern: The main electrical panel is falling off the exterior wall of the house, this is a safety concern that needs assessment and repair by a licensed electrician.

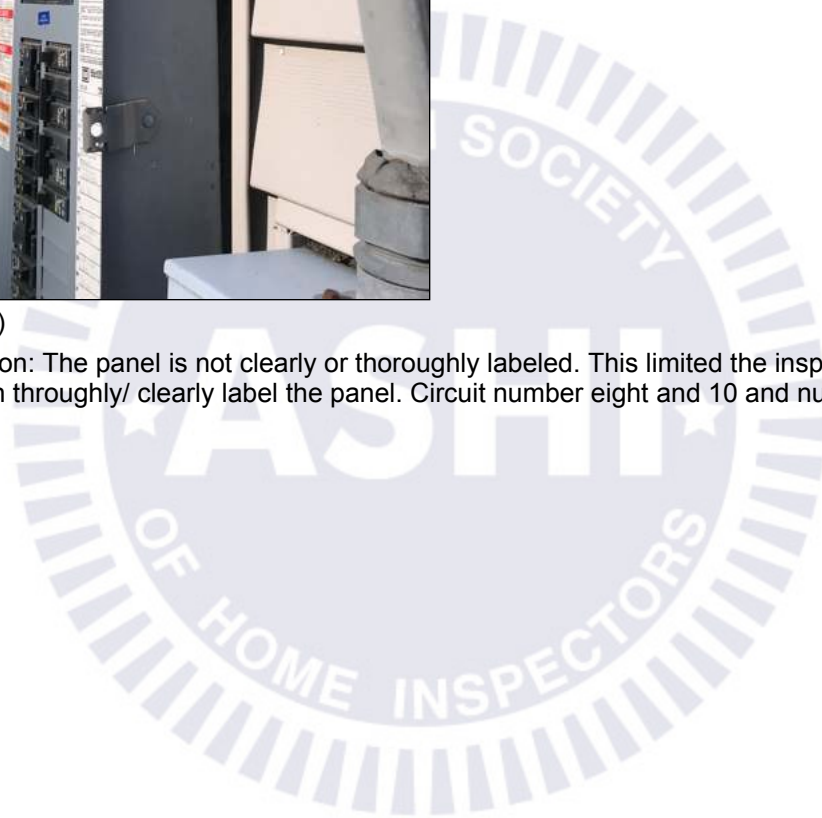
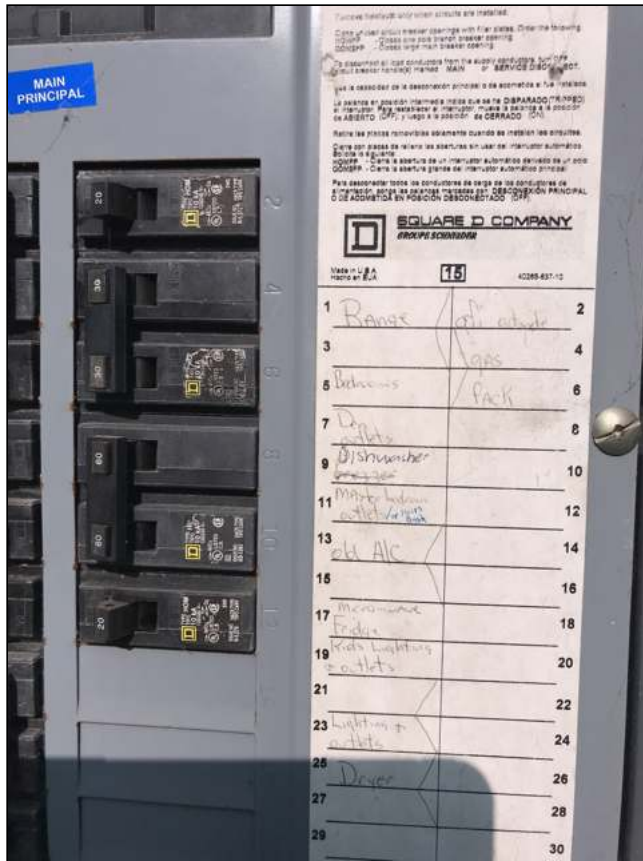
7.1 Item 2(Picture)

(2) Repair/ Limitation: The panel is not clearly or thoroughly labeled. This limited the inspection, it is recommended a licensed electrician thoroughly/ clearly label the panel. Circuit number eight and 10 and number 12 are not labeled.

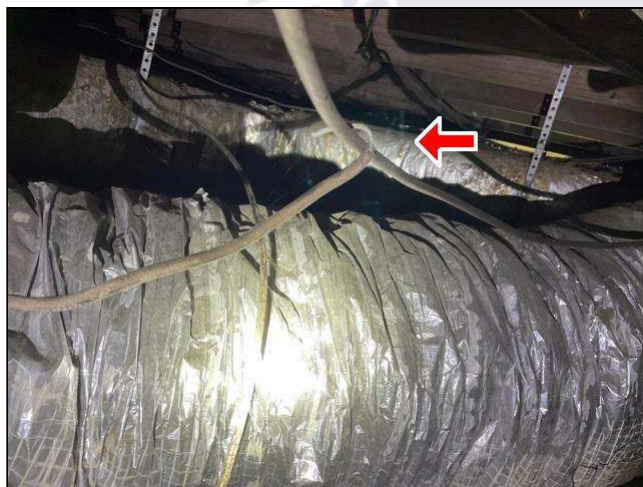
7.2 Item 1(Picture)

(1) Repair: Improperly abandoned wiring in the crawl space needs to be removed or terminate inside a properly rated junction box, recommend licensed electrician assess and handle repairs.

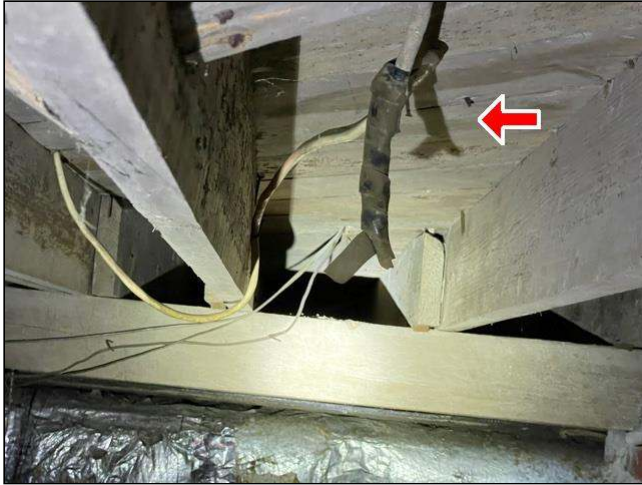
7.2 Item 3(Picture)

(2) Repair: Open wiring connections/ splices should be made inside a properly rated/ covered junction box. This needs to be assessed and repaired by a licensed electrician. This was observed in the following locations: front of the crawl space.

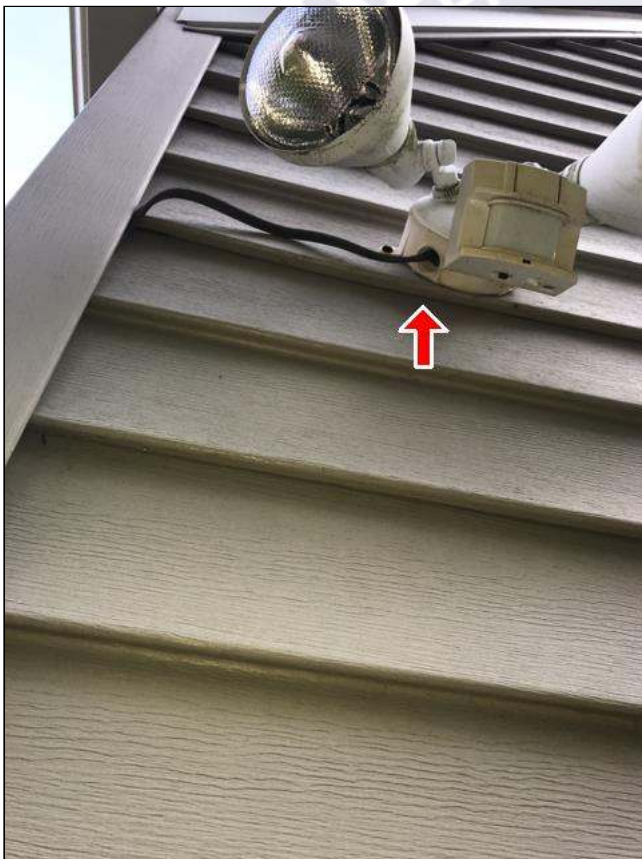
7.3 Item 1(Picture)

(1) Repair: Electrical wiring to the right side light needs a proper bracket/attachment where it enters the junction box. Recommend licensed electrician assess and handle repair as necessary.

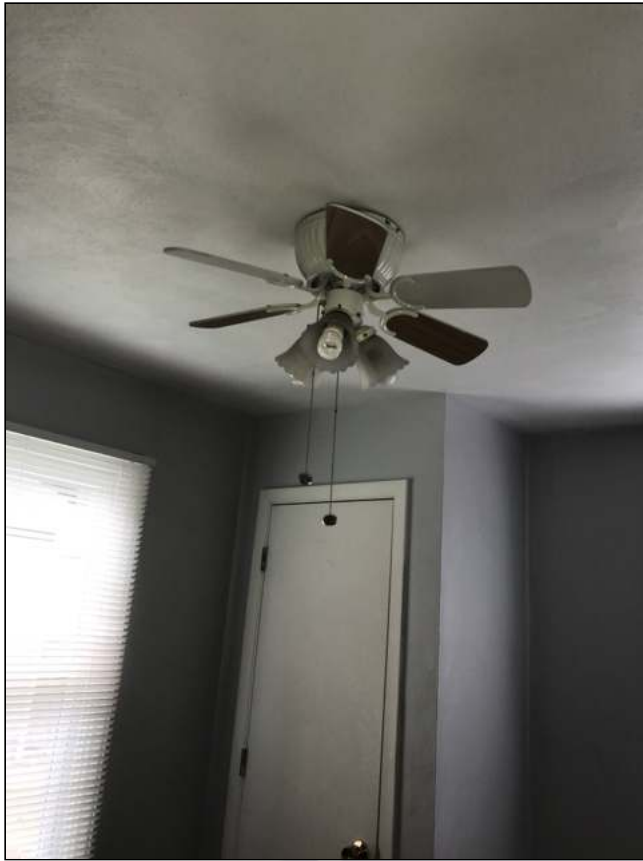
7.3 Item 4(Picture)

(4) Repair: Ceiling fan in the back left first floor bedroom was turned on at the pull, the fan stayed on for a quick second, made a noise and then shut off. It appears there is an issue with this fixture and/ or the circuit. This needs to be assessed and repaired by a licensed electrician.

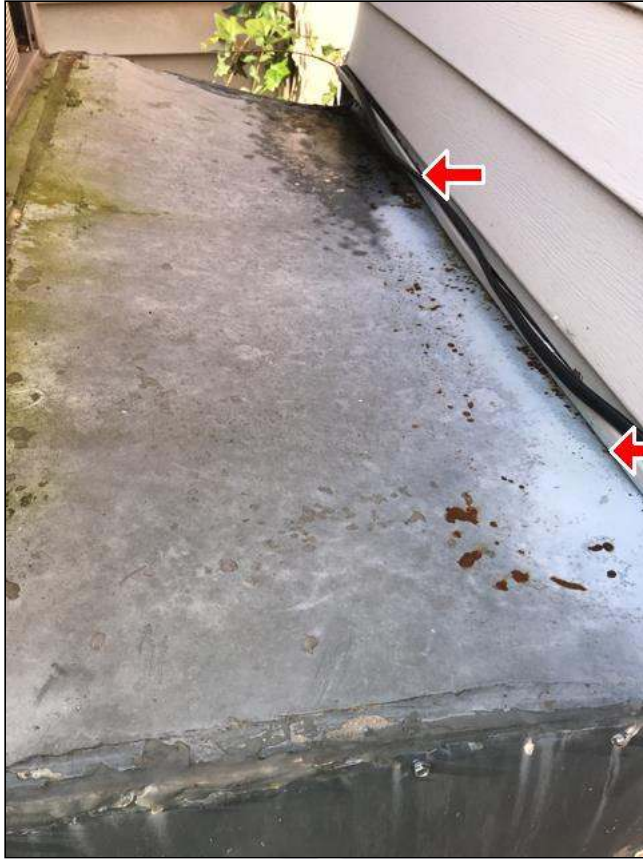
8.0 Item 1(Picture)

Repair: The doghouse for the gas pack needs to be re-secured in place, scraped, painted, caulked and graded so water will run off of this area. Recommend qualified professional assess and handle repair as found necessary.

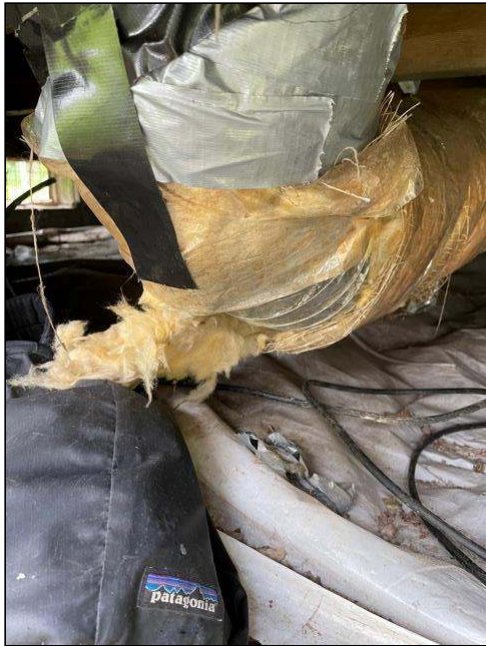
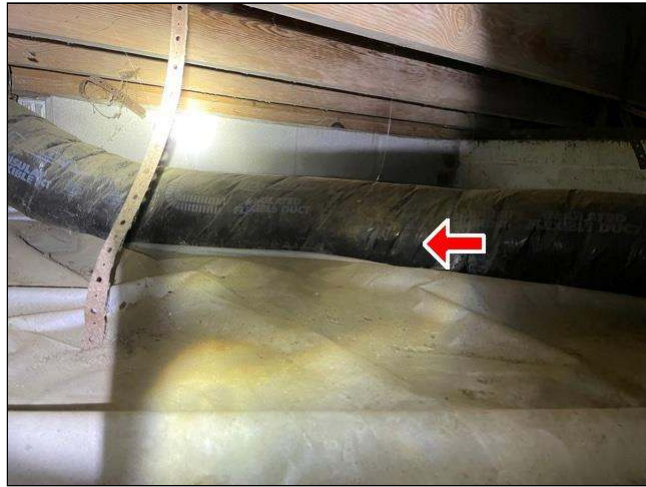
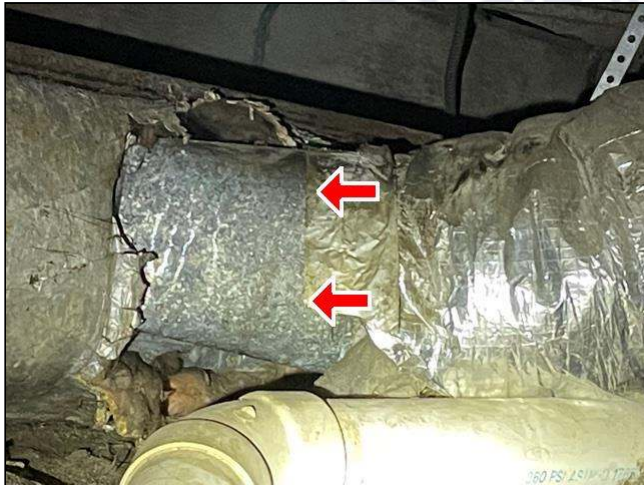
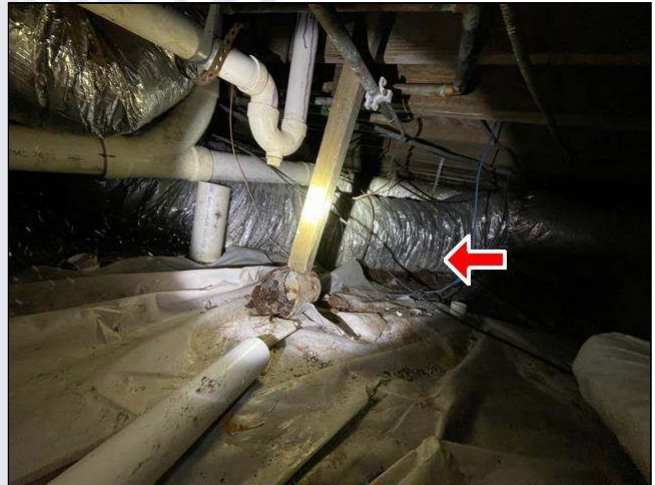
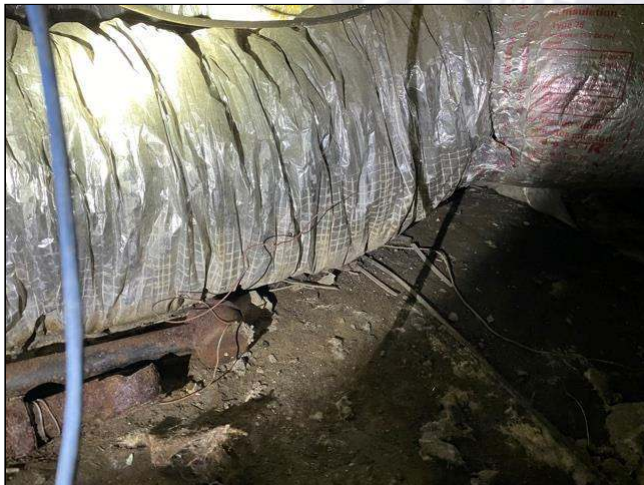
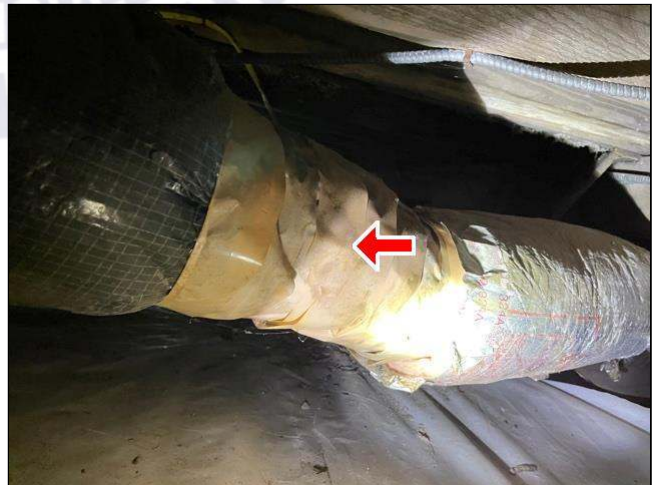
(2) Repair: The following ductwork repairs are needed by a licensed HVAC professional in the crawl space, recommend qualified HVAC professional assess and handle the following repairs: damaged ductwork insulation near the entry, un-insulated ductwork near the center of the crawl space needs repair, unsupported ductwork lying on the ground of the crawl space (seen in numerous locations) needs to be secured up and off the floor.

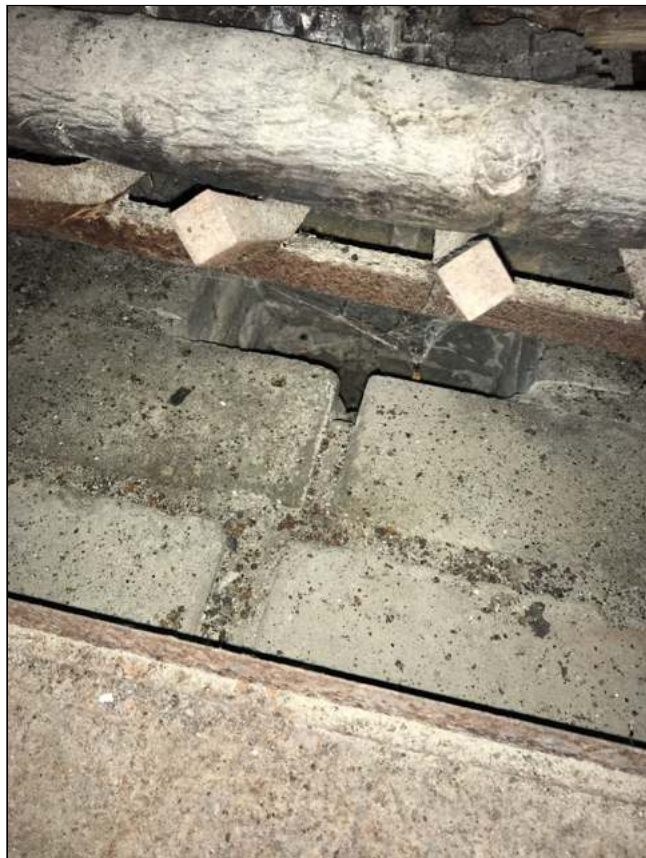
8.6 Item 1(Picture)

(2) Repair: Cover for the ash collection point is missing from the bottom of the fireplace, outer access cover is also missing. The piece of metal has been installed outside does not appear to allow for easy access to this area. These items should be further assessed by a licensed fireplace technician and repairs/replacement made as found necessary.
