COASTAL INSPECTION SERVICES LLC

Inspection Report

Sample Report - 04

Date: 9/8/2021	Time: 8:30am	Report ID: Sample Report -04
Property: Sample Report Norfolk VA 23505	Customer: Sample Report - 04	Real Estate Professional: Paul Farrell

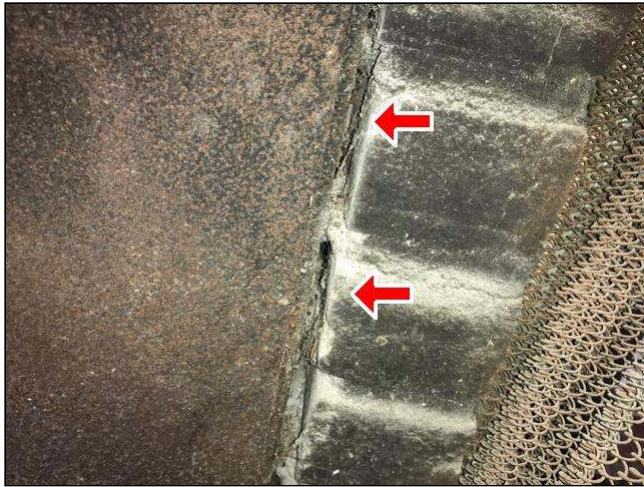
8.6 Item 3(Picture)

(3) Repair: Gaps and openings at the fire box for the wood-burning fireplace are an indicator that something has moved/separated. These gaps and openings should be assessed by a licensed fireplace professional and repairs/replacement made as necessary.

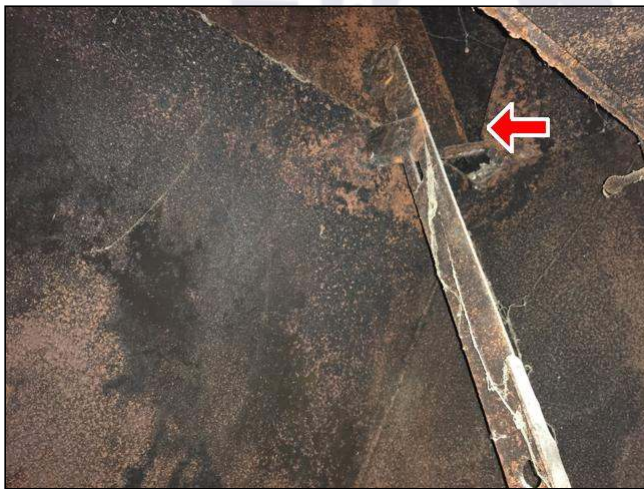
8.6 Item 5(Picture)

(4) Repair: The damper for the fireplace appears to be damaged/ inoperative, this needs repair/replacement by a licensed fireplace technician.

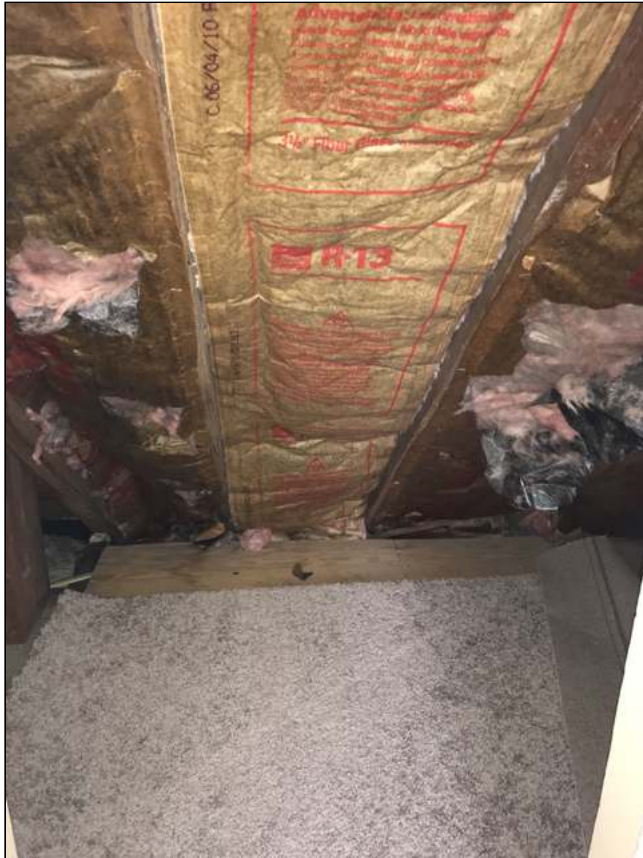
9.0 Item 1(Picture)

Repair: Insulation in the rafter cavities has been installed with the paper backing left exposed, please note this paper

backing is flammable and according to the insulation instructions is not to be left exposed. Would have this assessed by a qualified professional and repairs made as necessary.

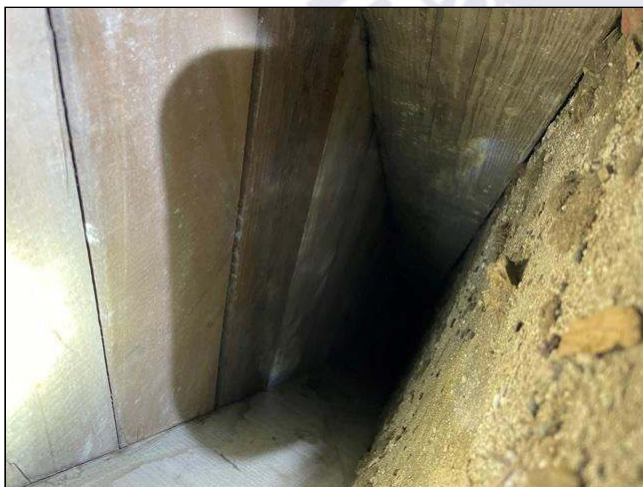
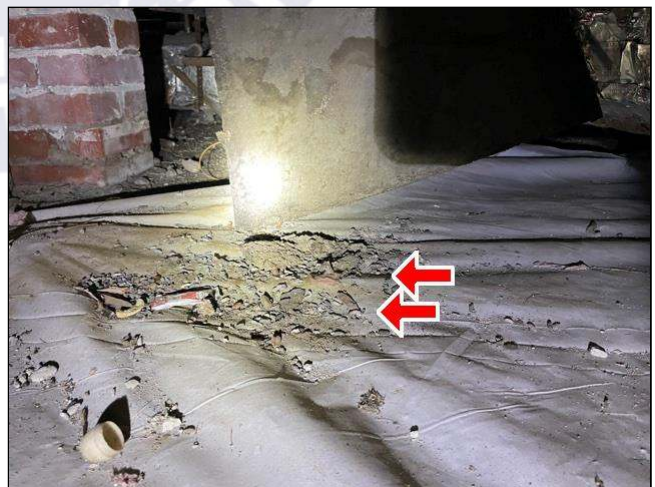
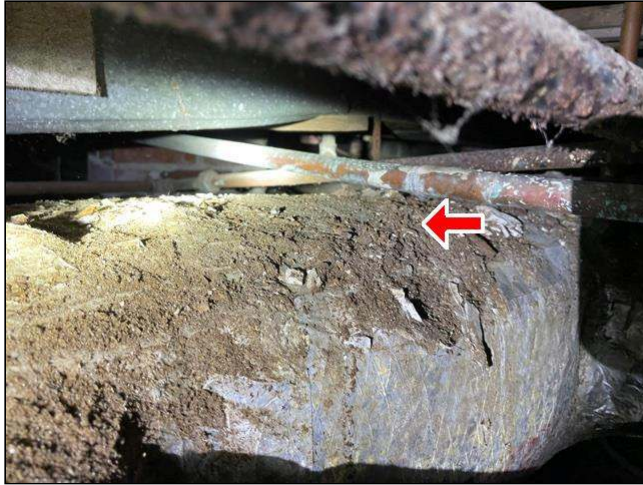
Repair: There are some areas of vermin feces and debris seen in the crawl space, This was seen on some of the HVAC trunk line, inside old plenum material and some on top of the plastic vapor barrier. This material should be cleaned out/ removed and then vermin prevention should be installed. It is recommended a licensed pest control company assess this issue and handle repairs as necessary.

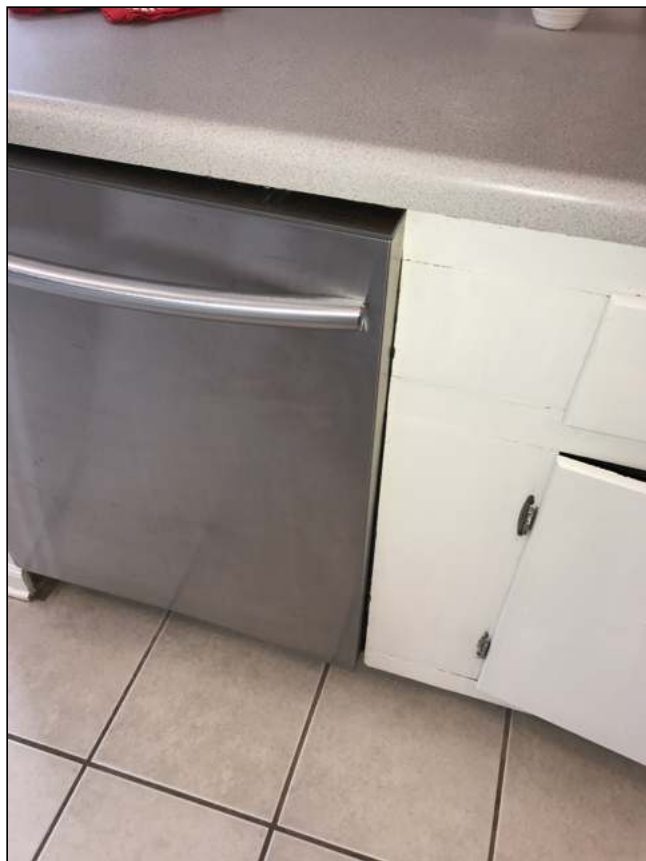
10.0 Item 1(Picture)

Repair: Dishwasher door is not fitting in the opening properly/closing properly, unit is hitting the cabinet on the right side. The door has to be lifted/twisted so it will close, this should be assessed and repaired by a licensed technician.
